Land Stability Assessment Areas

Ikitara Road, Bastia Hill & Durie Hill

Risk Study Report

Date: May 2014
Reference: GER 2014-20
Status: Final

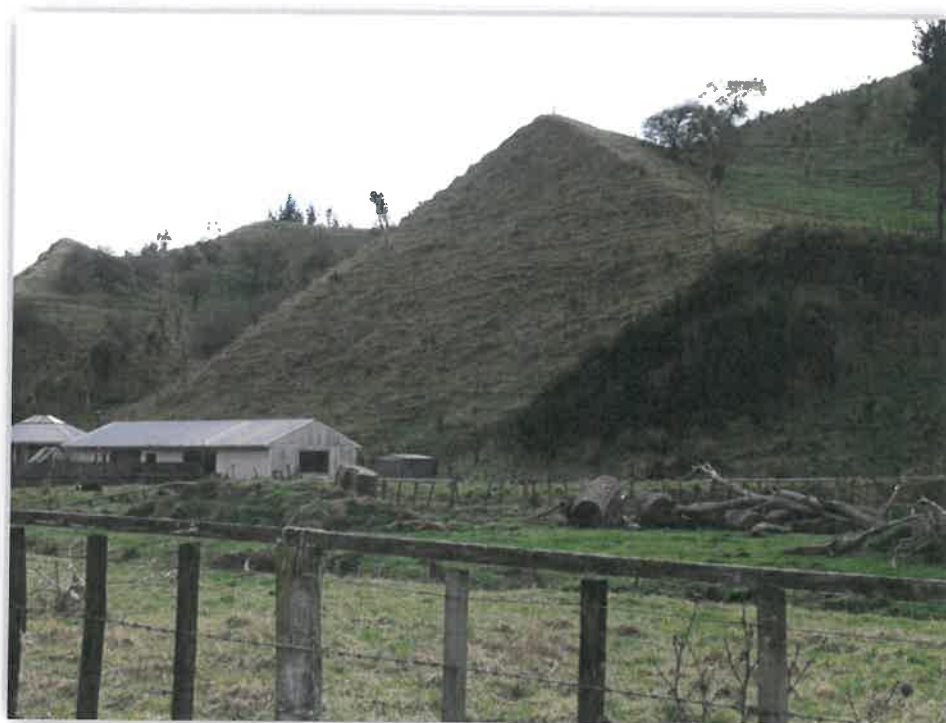
In some localised areas, slopes of less than 40° also showed instability features, however this was generally restricted to shallow translational failures of topsoil/regolith, such as the hillslopes to the north of Turoa Road. Slopes with angles of 30° to 40° are marginally stable and may pose a risk to development.

Illustration 2 Deflated/evacuated hillslope to the north of Turoa Road.

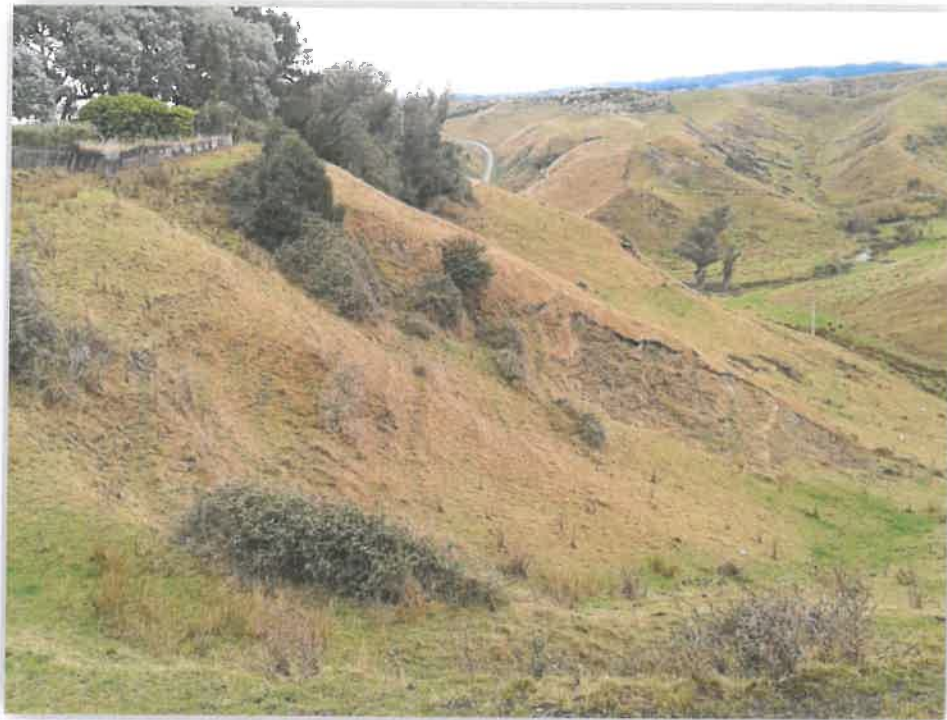
Illustration 3 Shallow seated slips on steep hillslopes below Portal Street.

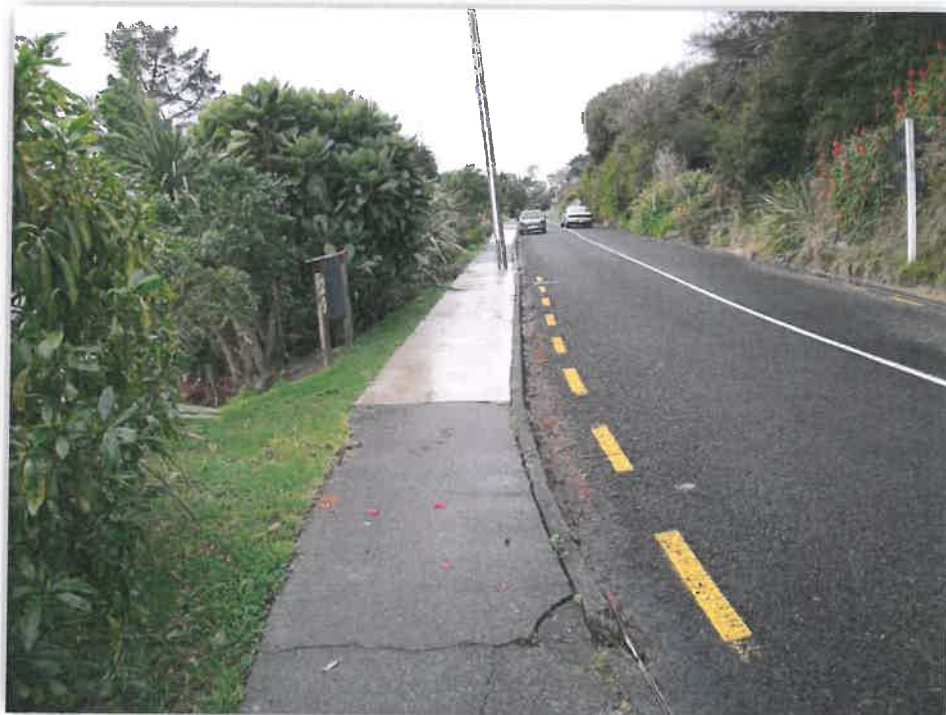
Illustration 4 Progressive failure/rotation of the footpath along Wairere Road.

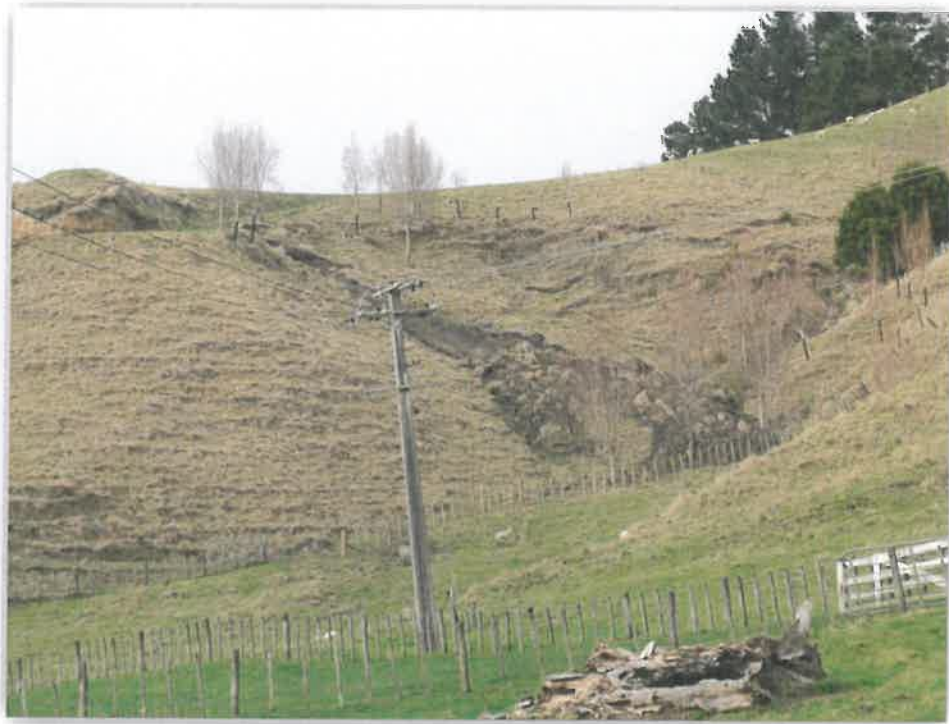
Illustration 5 Earthflow-type failure of hillslopes to the southeast of Turoa Road.
