Wanganui District Council

Land Stability Assessment Areas Mowhanau & Roberts-Patterson

Risk Study Report

Telephone:	+64 4 471 7000
Facsimile:	+64 4 471 1397
Date:	July 2015
Reference:	GER 2015-02
Status:	Issue 1
Project No:	5W1100.13

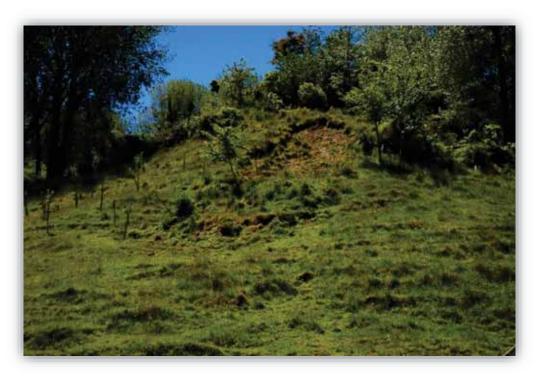
Illustration 2 Shallow slip in topsoil, near Patterson Street.

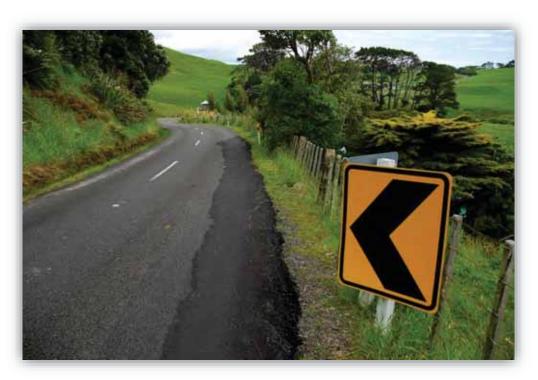
Excavation into natural slopes may cause instability by oversteepening of the slope, particularly if the excavation is into the toe of a slope. The formation of fill embankments may also contribute to landsliding, due to the increased load on slopes. Evidence of deformation of the road pavement due to downslope movement of the soil at the crest of the slope was observed at Handley Road in Mowhanau (Illustration 3).

Illustration 3 Area of repaired cracking/settlement in the road pavement and shoulder, with tilted fence indicating soil creep below Handley Road, Mowhanau.

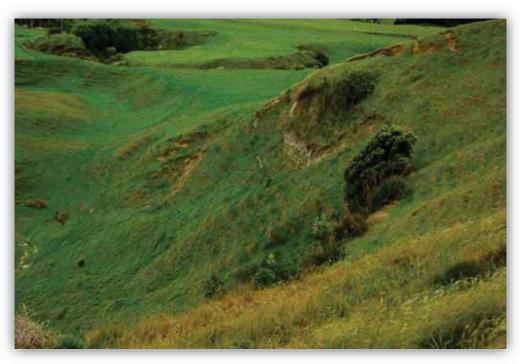
Illustration 4 Shallow seated slips on steep hillslopes below Broadview Heights, Mowhanau.

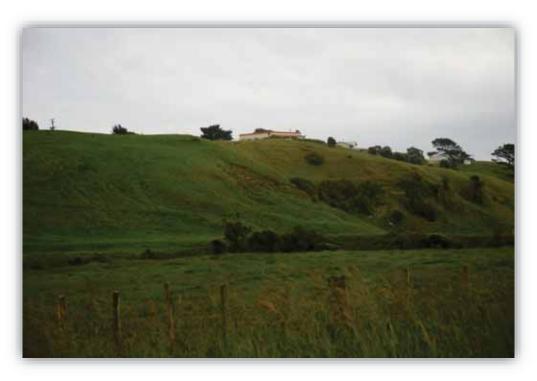
Illustration 5 Slips on steep slopes below terrace surface, Broadview Heights, Mowhanau.

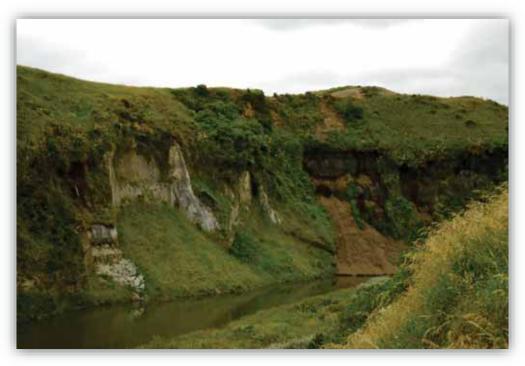
Illustration 6

Steep bluffs showing evidence for slumping/collapse, with accumulation of slip debris at toe, Kai Iwi Stream, Mowhanau.
