# **Land Stability Assessment Areas**

## **Mowhanau & Roberts- Paterson**

**Risk Study Report**

Project No: 5W1100.13

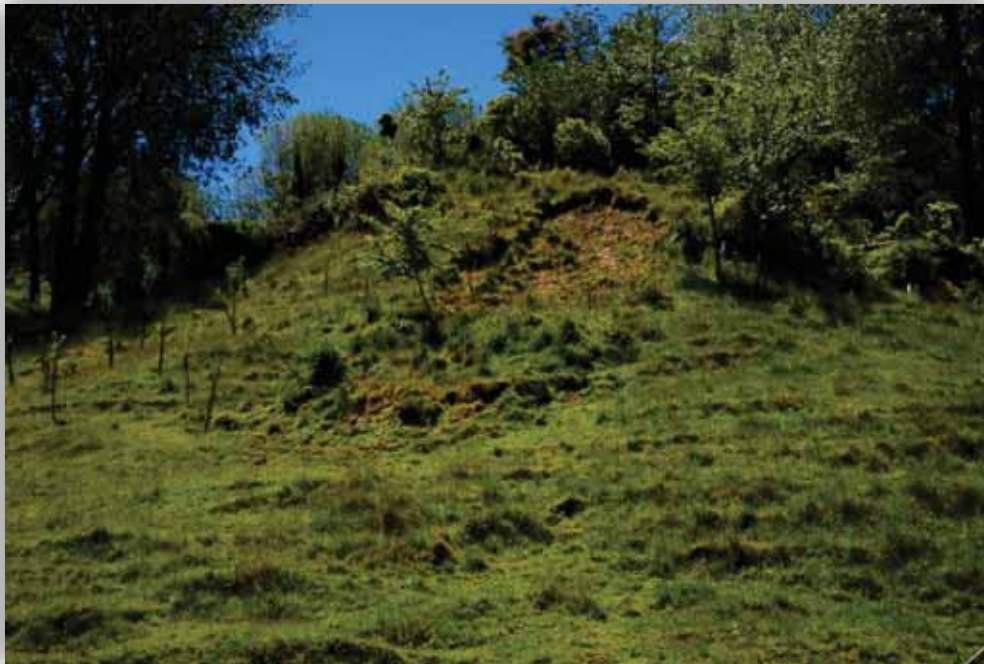
**Illustration 2** Shallow slip in topsoil, near Paterson Street.

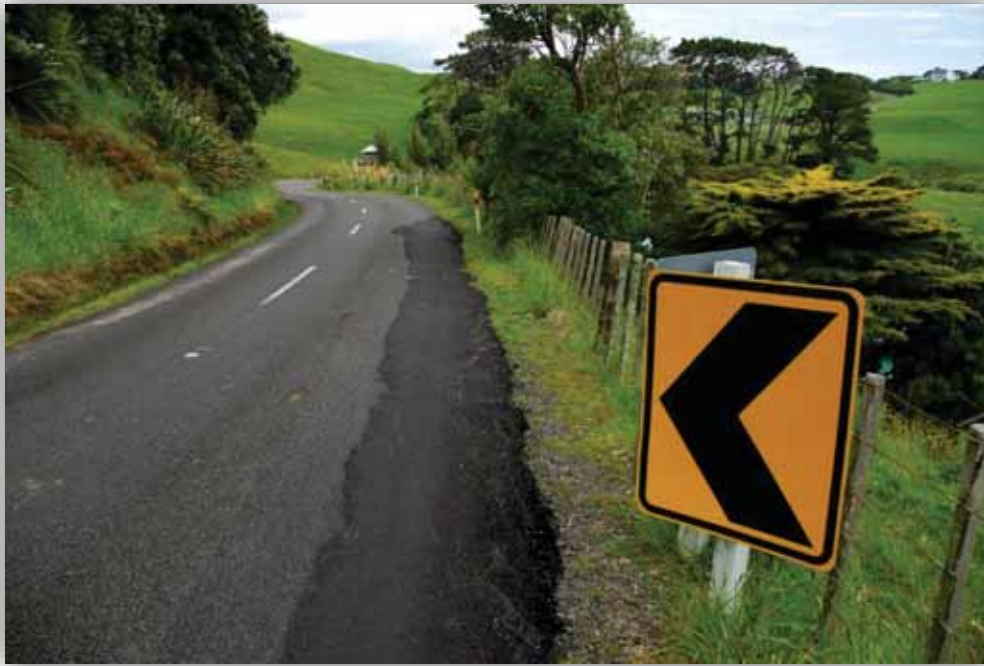
Excavation into natural slopes may cause instability by oversteepening of the slope, particularly if the excavation is into the toe of a slope. The formation of fill embankments may also contribute to landsliding, due to the increased load on slopes. Evidence of deformation of the road pavement due to downslope movement of the soil at the crest of the slope was observed at Handley Road in Mowhanau (Illustration 3).

**Illustration 3** Area of repaired cracking/settlement in the road pavement and shoulder, with tilted fence indicating soil creep below Handley Road, Mowhanau.

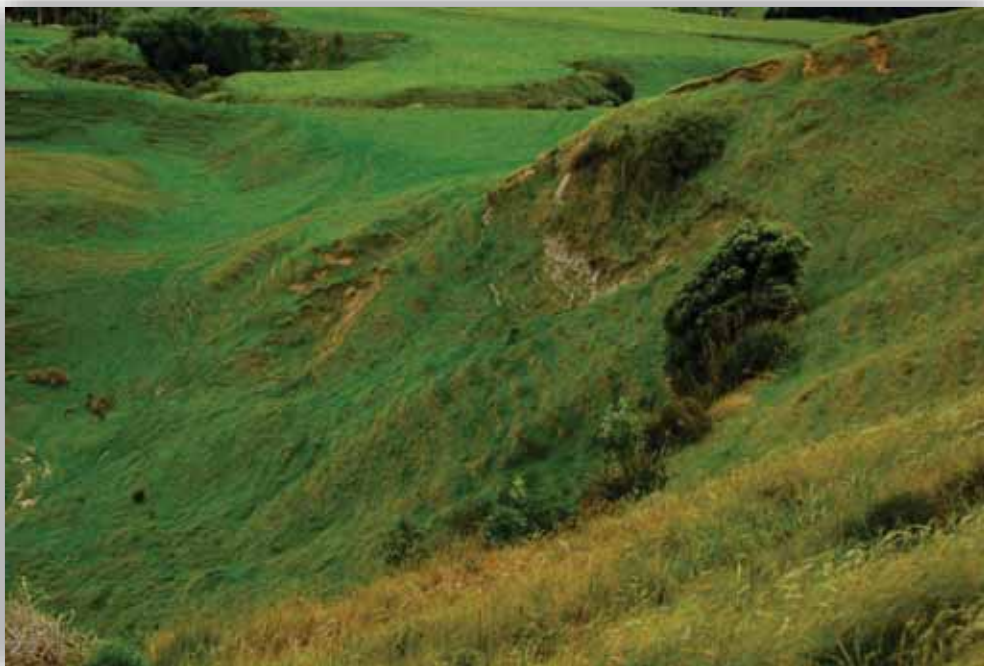
**Illustration 4** Shallow seated slips on steep hillslopes below Broadview Heights, Mowhanau.

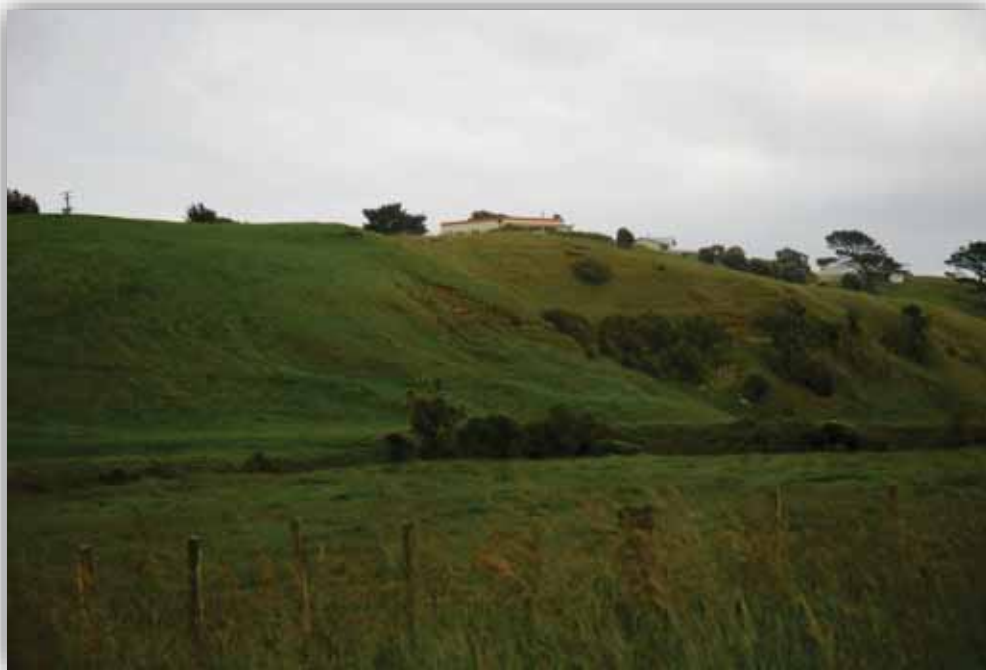
**Illustration 5** Slips on steep slopes below terrace surface, Broadview Heights, Mowhanau.

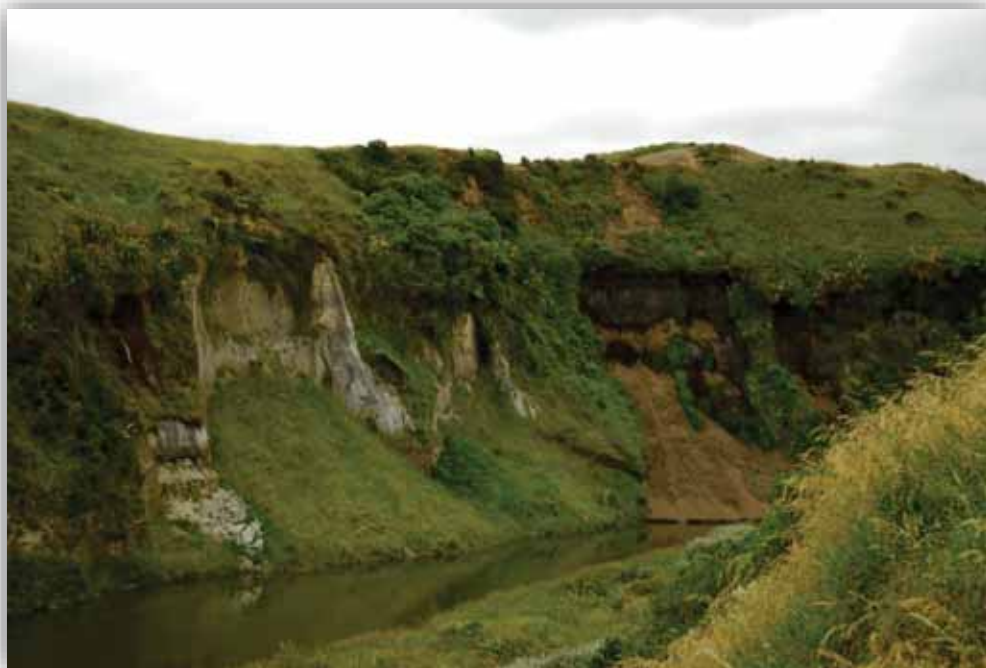
**Illustration 6** Steep bluffs showing evidence for slumping/collapse, with accumulation of slip debris at toe, Kai Iwi Stream, Mowhanau.
