# Whanganui Land Stability Assessment Areas

## Stage 4

### Risk Study Report

Date: 4 December 2018  
Reference: GER 2018-53  
Status: Issue 2

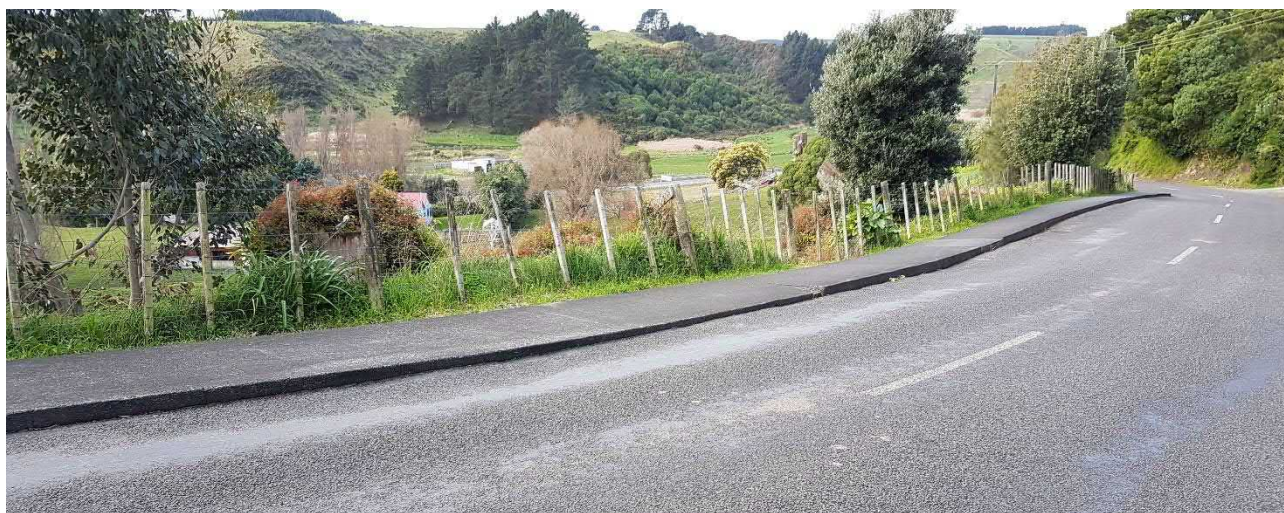
Excavation into natural slopes may cause instability by over-steepening of the slope, particularly if the excavation is into the toe of a slope. The formation of fill embankments may also contribute to landsliding, due to the increased load on slopes. Evidence of minor deformation of the road/footpath pavement due to downslope movement of the soil at the crest of the slope was observed at Marybank Road in Marybank (Illustration 5-1).

Illustration 5-1 : Minor deformation of pavement on Marybank Road

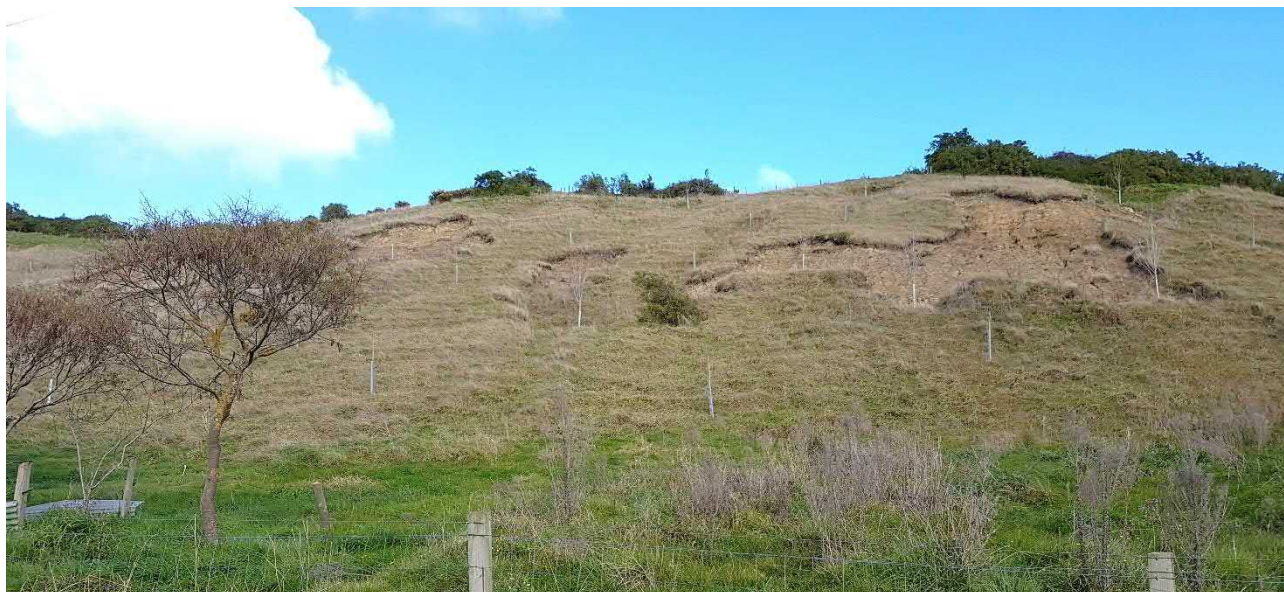
*Illustration 5-2 : Shallow landslides in surficial topsoil/regolith*

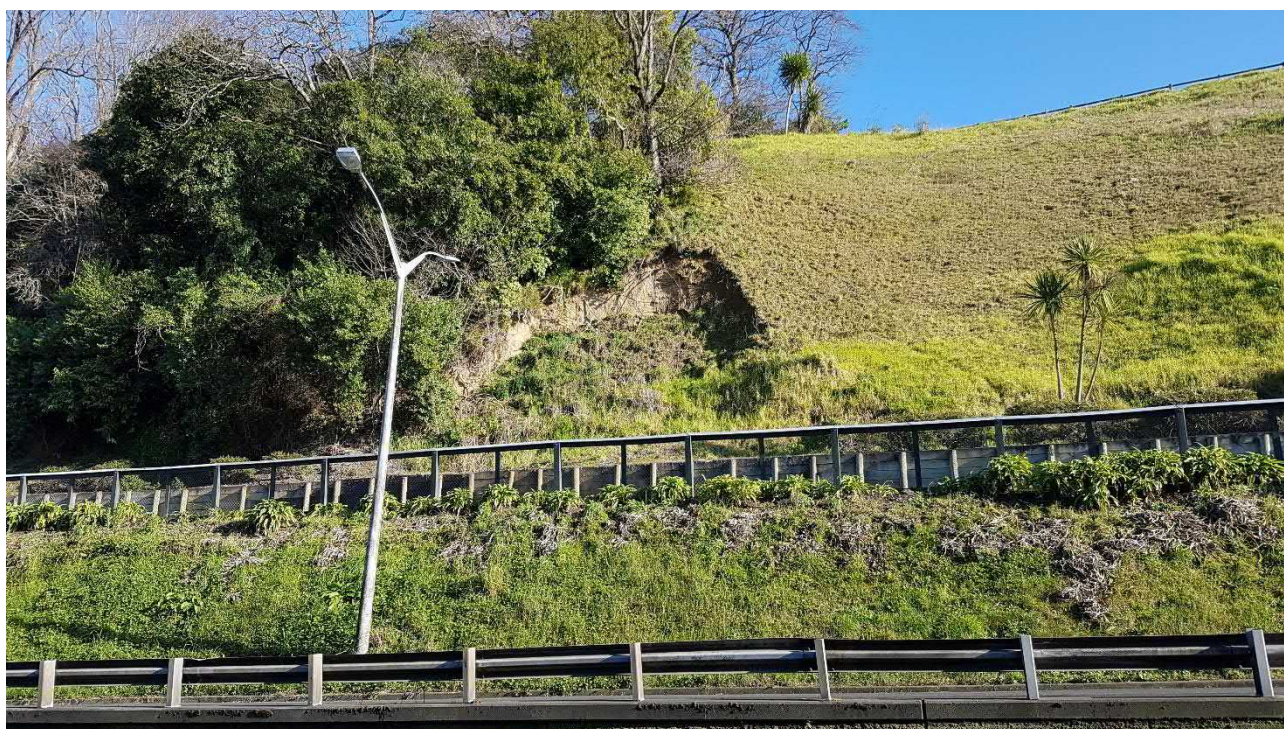
*Illustration 5-3 : Landslide on steep slope*

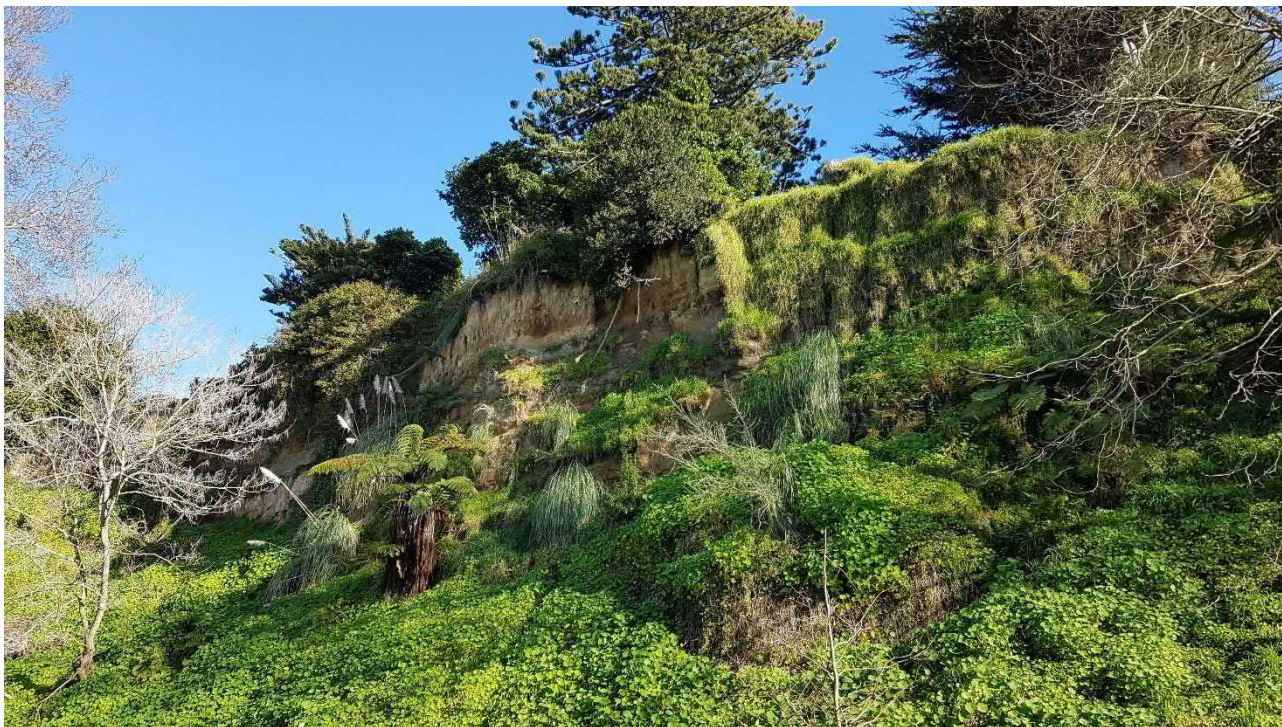
*Illustration 5-4 : Slump of siltstone at crest of steep bluff*
