Whanganui Land Stability Assessment Areas

Stage 4

Risk Study Report

Reference: GER 2018-53

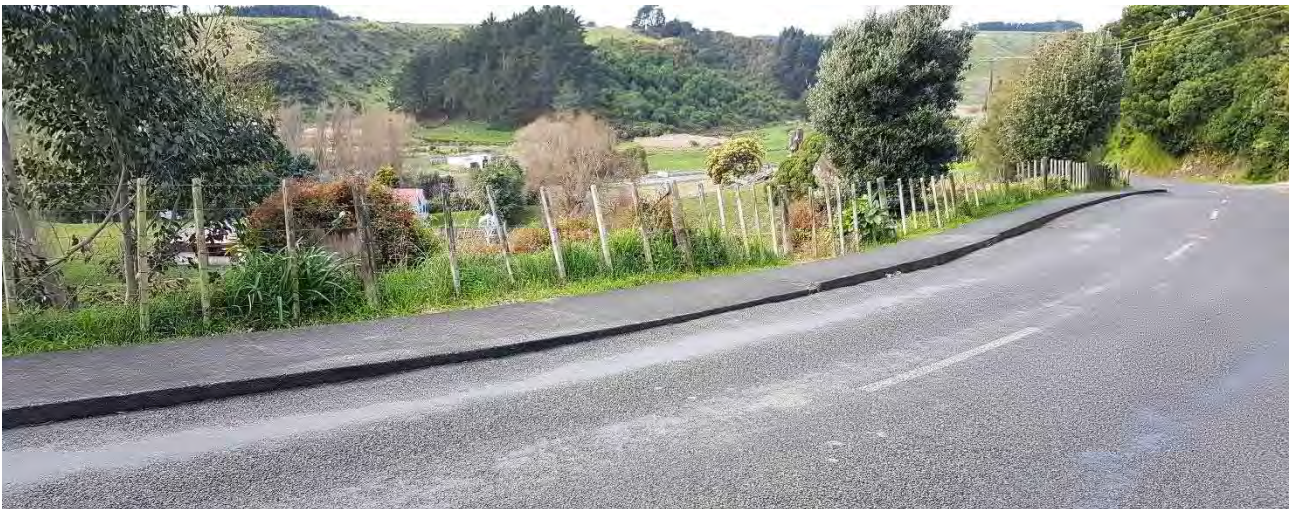
Excavation into natural slopes may cause instability by over-steepening of the slope, particularly if the excavation is into the toe of a slope. The formation of fill embankments may also contribute to landsliding, due to the increased load on slopes. Evidence of minor deformation of the road/footpath pavement due to downslope movement of the soil at the crest of the slope was observed at Marybank Road in Marybank (Illustration 5-1).

Illustration 5-1 : Minor deformation of pavement on Marybank Road

- Creep failures of soil, leading to cracking and rotation of road pavements at slope crests (e.g. Illustration 5-1);
- Topsoil and regolith slides (e.g. Illustration 5-2);
- Shallow seated slumps and slides on steep slopes (e.g. Illustration 5-3 and Illustration 5-4).

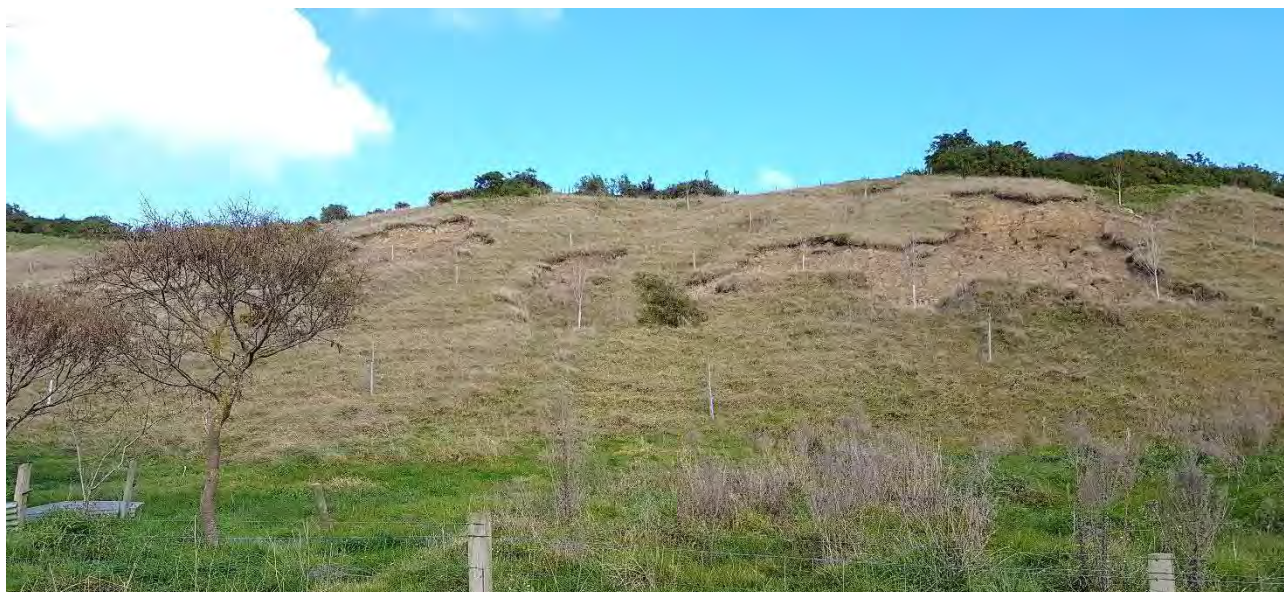
Illustration 5-2 : Shallow landslides in surficial topsoil/regolith

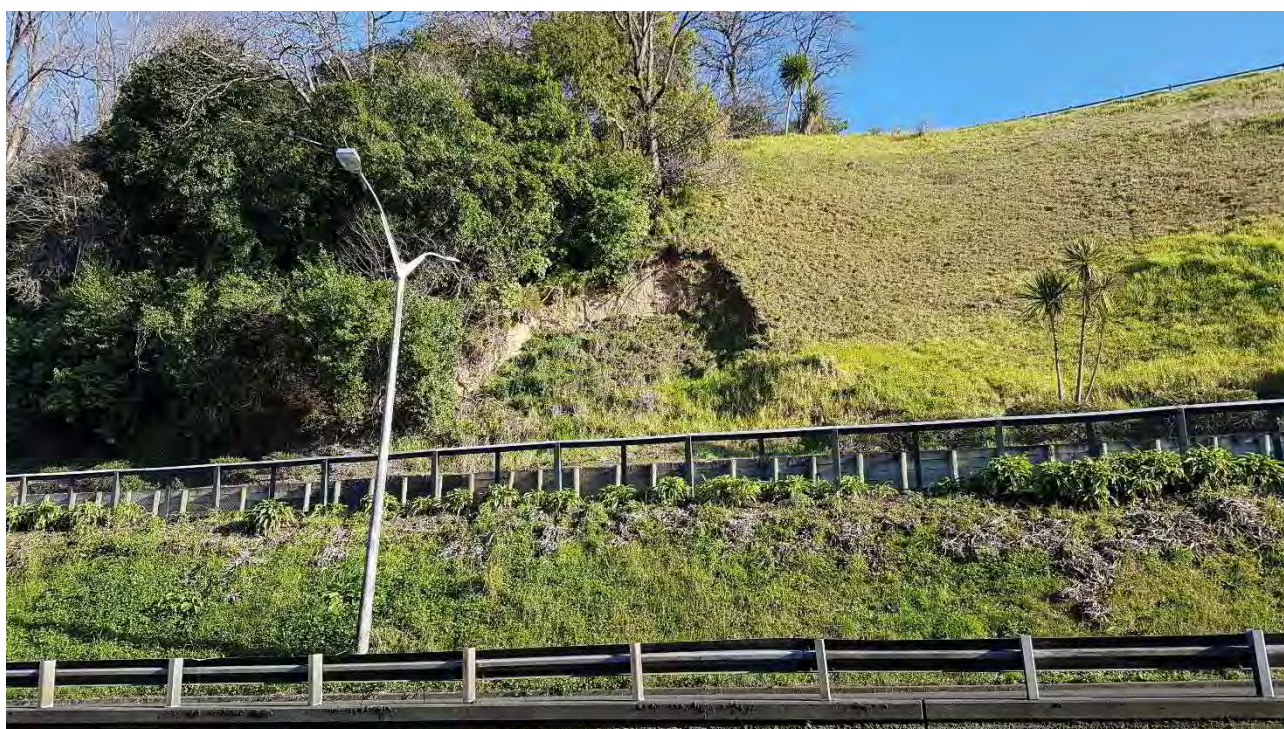
Illustration 5-3 : Landslide on steep slope

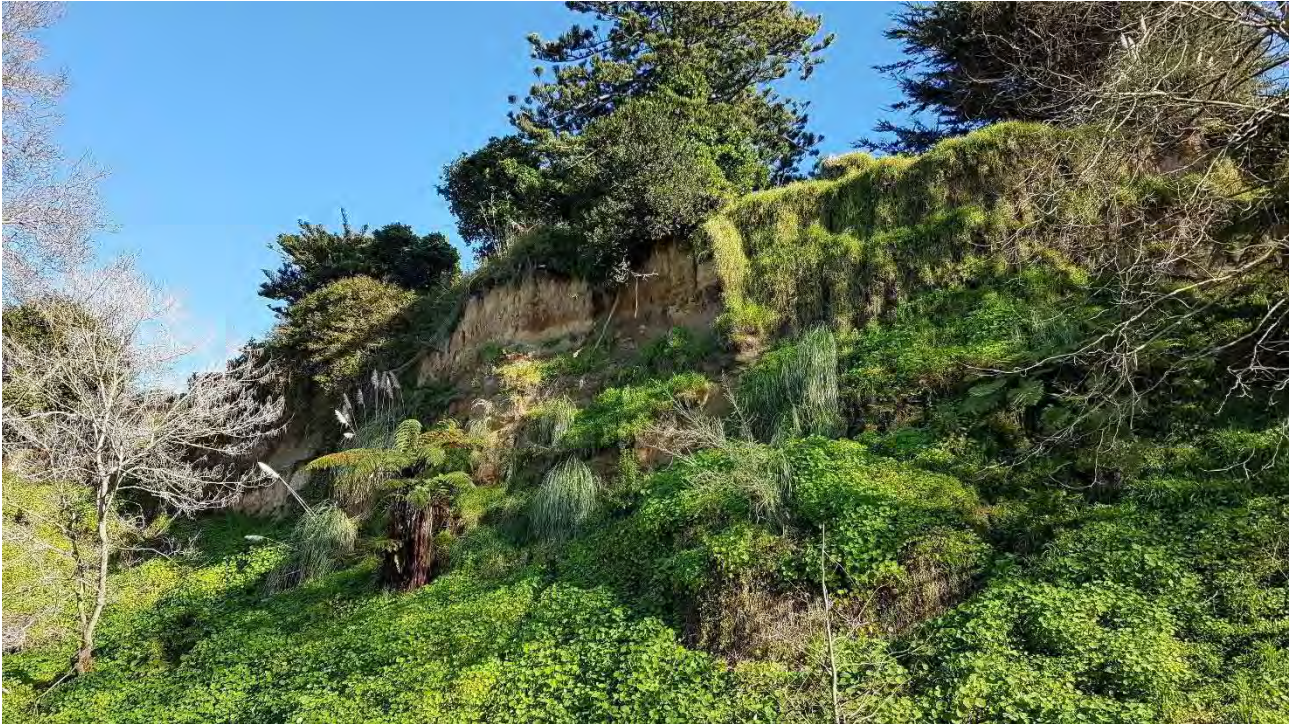
Illustration 5-4 : Slump of siltstone at crest of steep bluff
