Project Number: 5-W1100.15

Whanganui District Council Plan Change 58 Outer Castlecliff

25 February 2020

Preliminary Geotechnical Appraisal

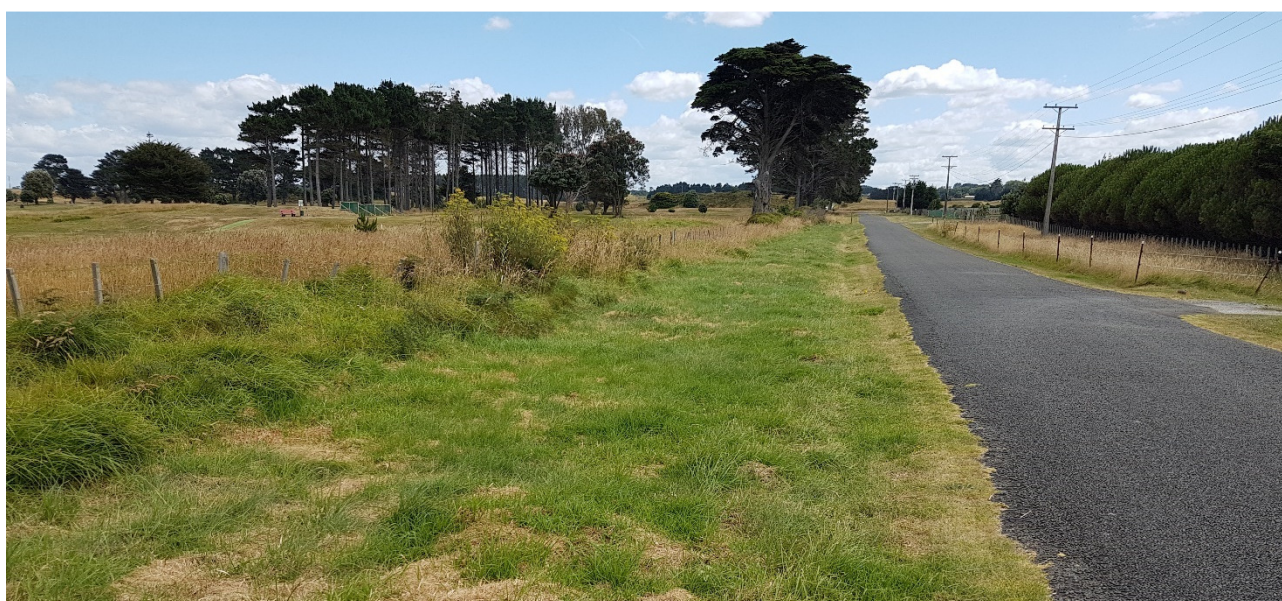
Area 1 comprises parts of the Castlecliff Golf Course. The area has a modified contour and is grass-covered. To the southwest side of the entrance road to the clubhouse are a series of shed used by greenkeepers for the storage of machinery and chemicals. Modification of the ground surface has occurred in the past to contour the tees, fairways and greens. Some areas of fill are likely to be present across Area 1.

Photograph 1 : From Waitai St, looking north, fairway on left of photo

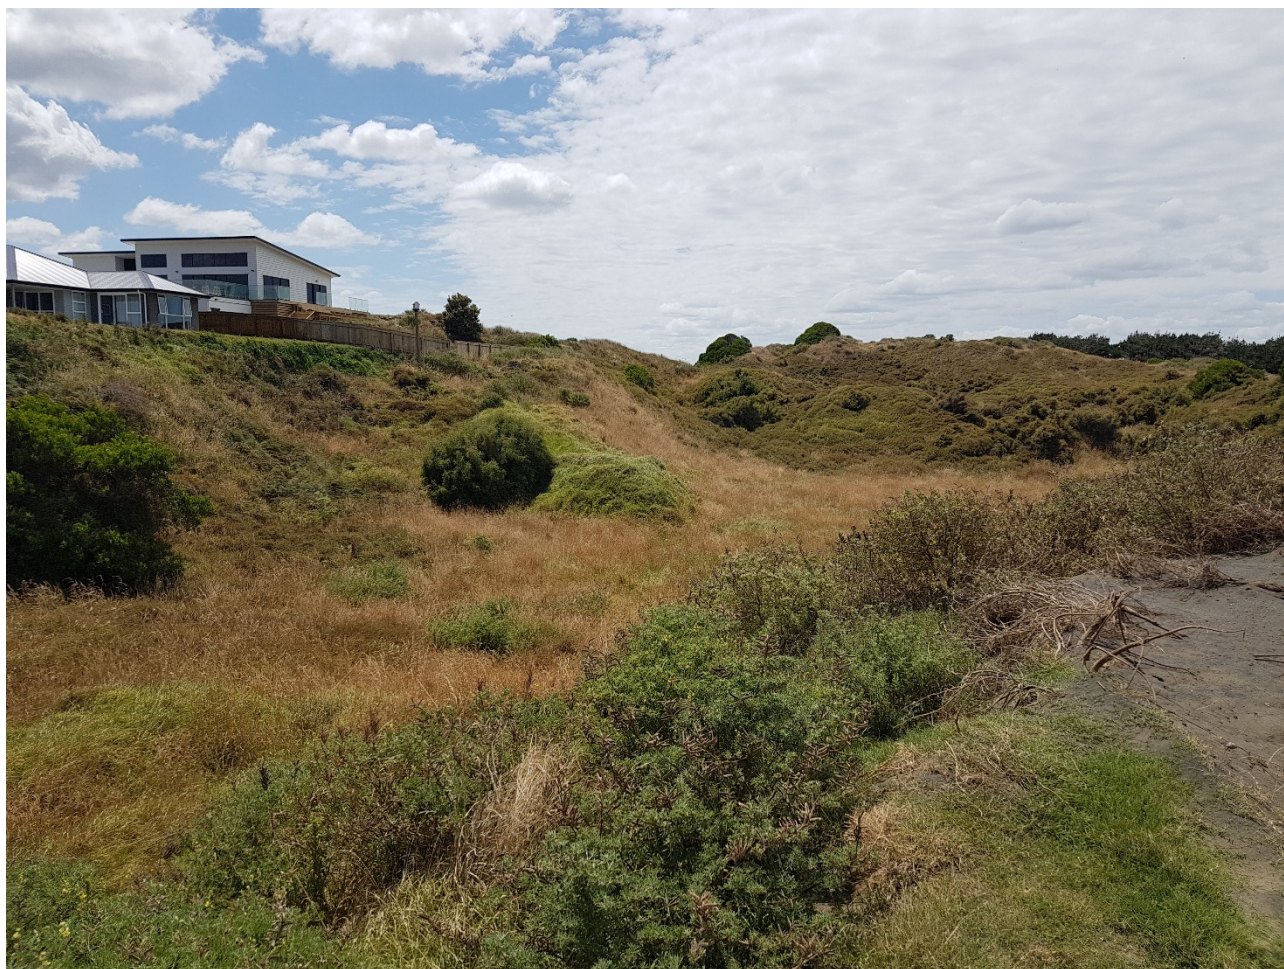
Photograph 2 : Area 2 from behind houses on Longbeach Drive, looking north. Houses shown accessed from end of Golf Vue. Note steep vegetated slopes below houses.

Area 2 and 3 contains slopes that are steep to very steep. There were no significant slope failures observed during the walkover, and no slope failures observed on aerial photographs. The slopes are inferred to comprise dune sand, and failures would therefore be expected to be shallow and involve most of the slope length. Existing slopes in Areas 2 and 3 are as steep as 36° , but more typically 30° - 33° . This slope would represent the angle of repose of loose windblown sand.

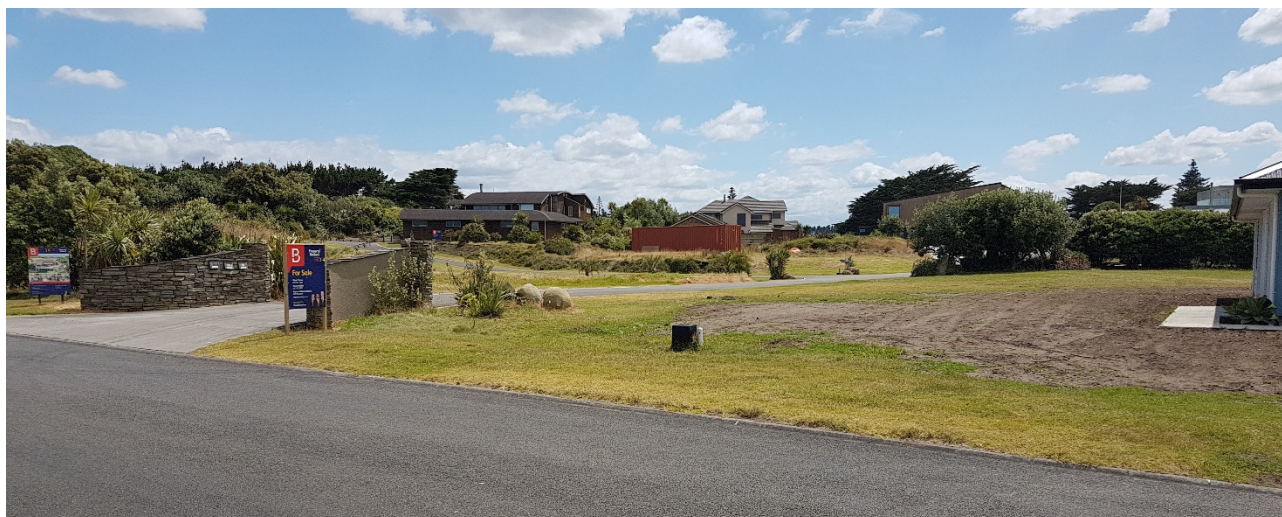
Area 4 is an area currently zoned Rural Lifestyle and has been almost fully developed under the current District Plan rules. The ground surface has previously been modified for building platforms and site contouring, smoothing out the dune landform. There may be areas of non-structural on properties formed during the previous development of the lots.

Photograph 3 : General view of Area 4, north side of Longbeach Drive.

Area 4 has a modified ground surface from previous development works and slopes are generally gentle to moderate. Slope instability is unlikely in this area, except for the southern side of Longbeach Drive, where properties back on to the eroded relict sea cliff. Parts of this old sea cliff exhibits some instability, and further investigation would be required to confirm the stability of this area.

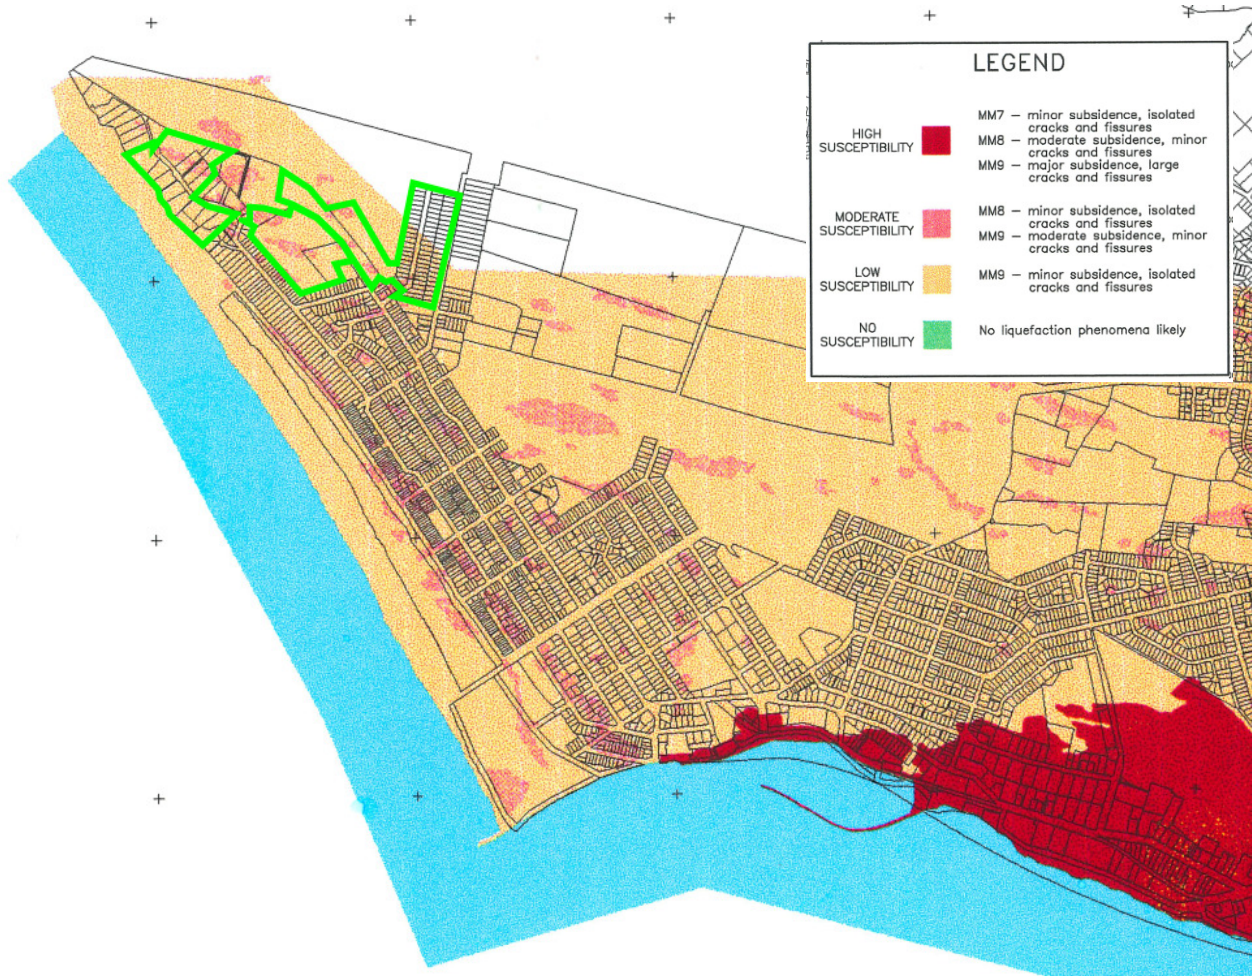
The GNS Science report (Dellow, et al 2016), which updated hazard information for the Horizons area produced regional-scale liquefaction maps. This liquefaction hazard map indicated a low risk of liquefaction in the study area.

Figure 3 : Liquefaction Susceptibility - study areas highlighted in green (from Beetham et al. 1998)

The report describes the sand dune susceptibility as follows “At the coast the modern beach and dune belt is up to 500 m wide. The modern beach is unlikely to be susceptible to liquefaction owing to the high energy of its environment of deposition. However, the modern dune belt behind the beach may contain isolated swampy areas that may be susceptible to liquefaction and the dunes themselves may undergo differential settlements during strong earthquake shaking.” (Beetham, Dellow, & Barker, 1998).

The report goes on to describe the sand dunes in Whanganui as “(a) loose, uniform sand that historical earthquakes show is not prone to ground damage at MM8 intensity, and tends to “protect” buildings from damage.”

Further investigations during subdivision stage should be undertaken to investigate whether the susceptibility of the area is greater than low.

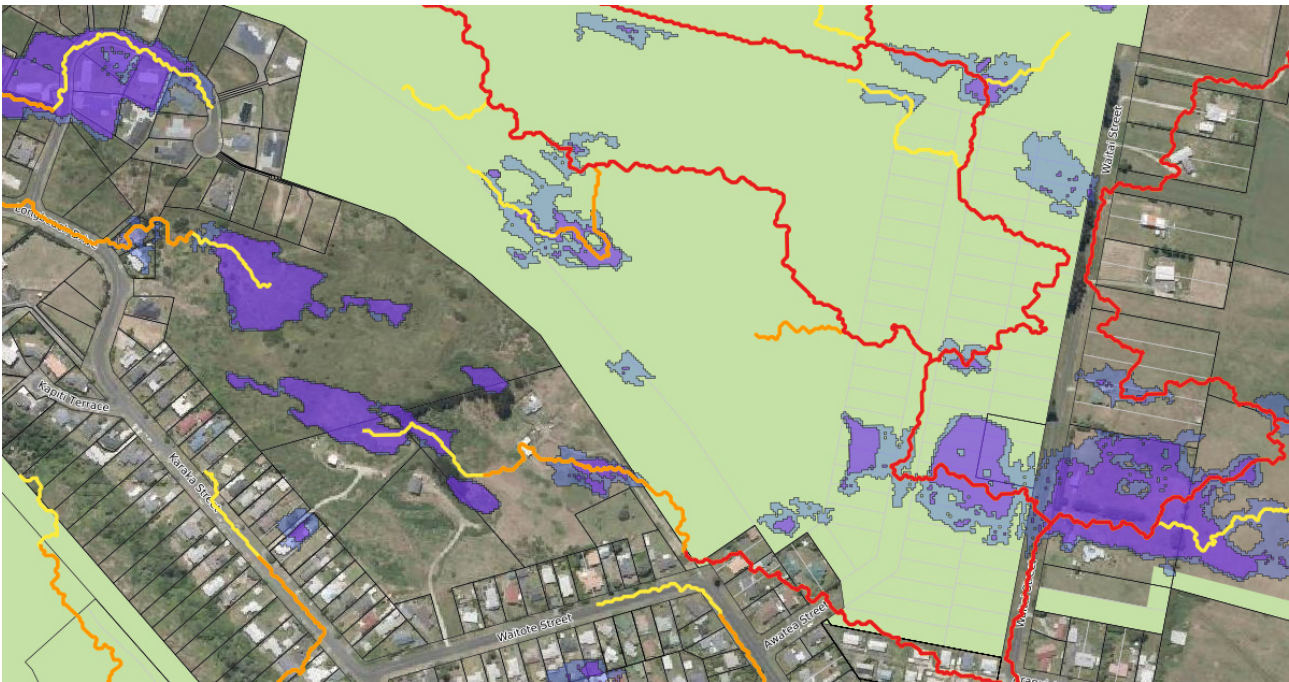
Overland flow paths and areas of ponding are shown on Whanganui District Council's GIS on-line mapping. We understand this ground surface model has been generated from LIDAR surface data and computer modelling. The modelling shows overland flow paths and areas of ponding. This is based on the ground contours and may or may not represent areas of actual ponding during a heavy rainfall event. The permeable nature of the dune sand may result in soakage into the ground, avoiding ponding to the extent shown.

Figure 4 : Overland Flow Paths - Area 1, 2, & 3 (from <https://data.whanganui.govt.nz/mapstore2-whanganuidc/#/viewer/openlayers/346>)

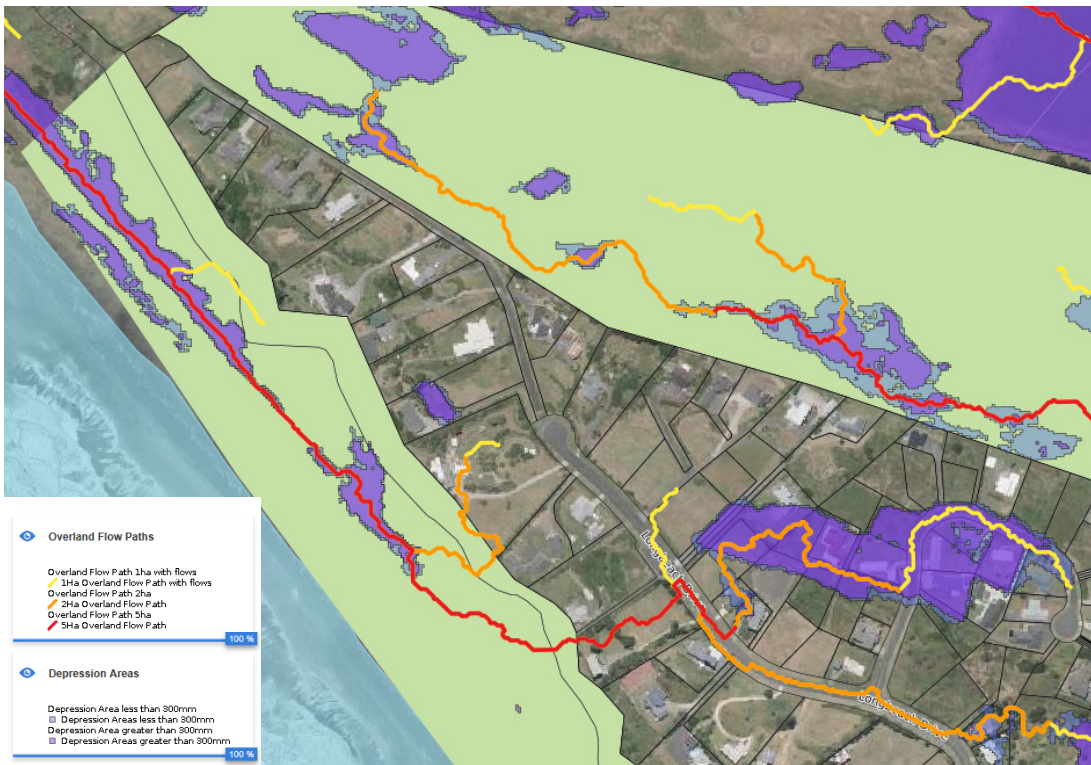
Figure 5 : Overland Flow Paths - Area 4 (from <https://data.whanganui.govt.nz/mapstore2-whanganuidc/#/viewer/openlayers/346>)

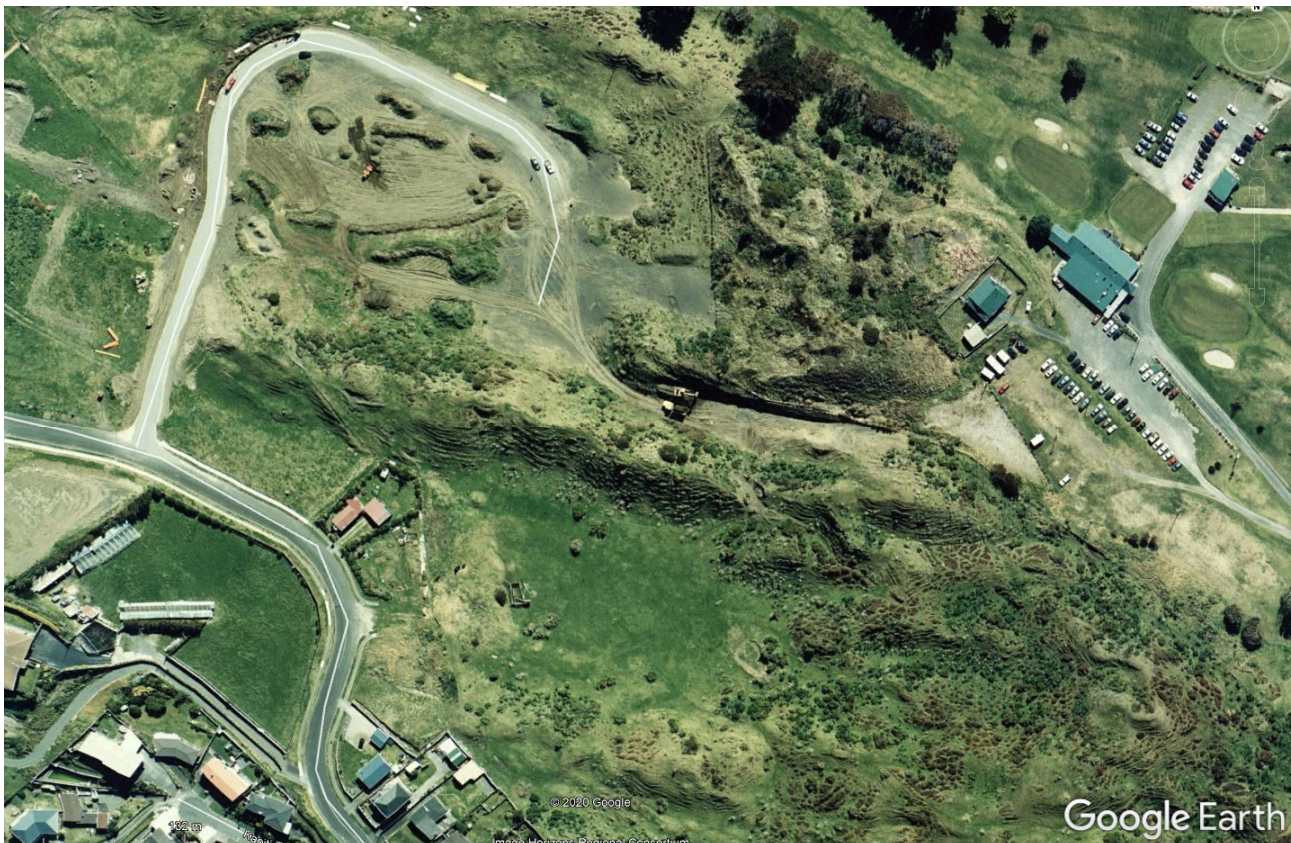
Modification of the landform of some areas may have occurred, included formation of fills, with no intention of them being used in the future for residential buildings. During subdivision stage detailed analysis of historical aerial photographs should be undertaken to identify any areas of significant filling (greater than 0.6m), and an investigation programme planned around their location.

Photograph 4 : Aerial view from 2005 during construction of Golf Vue development. (from Google Earth)

There was evidence of construction debris and possible placing of fill within Area 2. Further investigations will be required at subdivision consent stage to determine the extent and quality of this material.

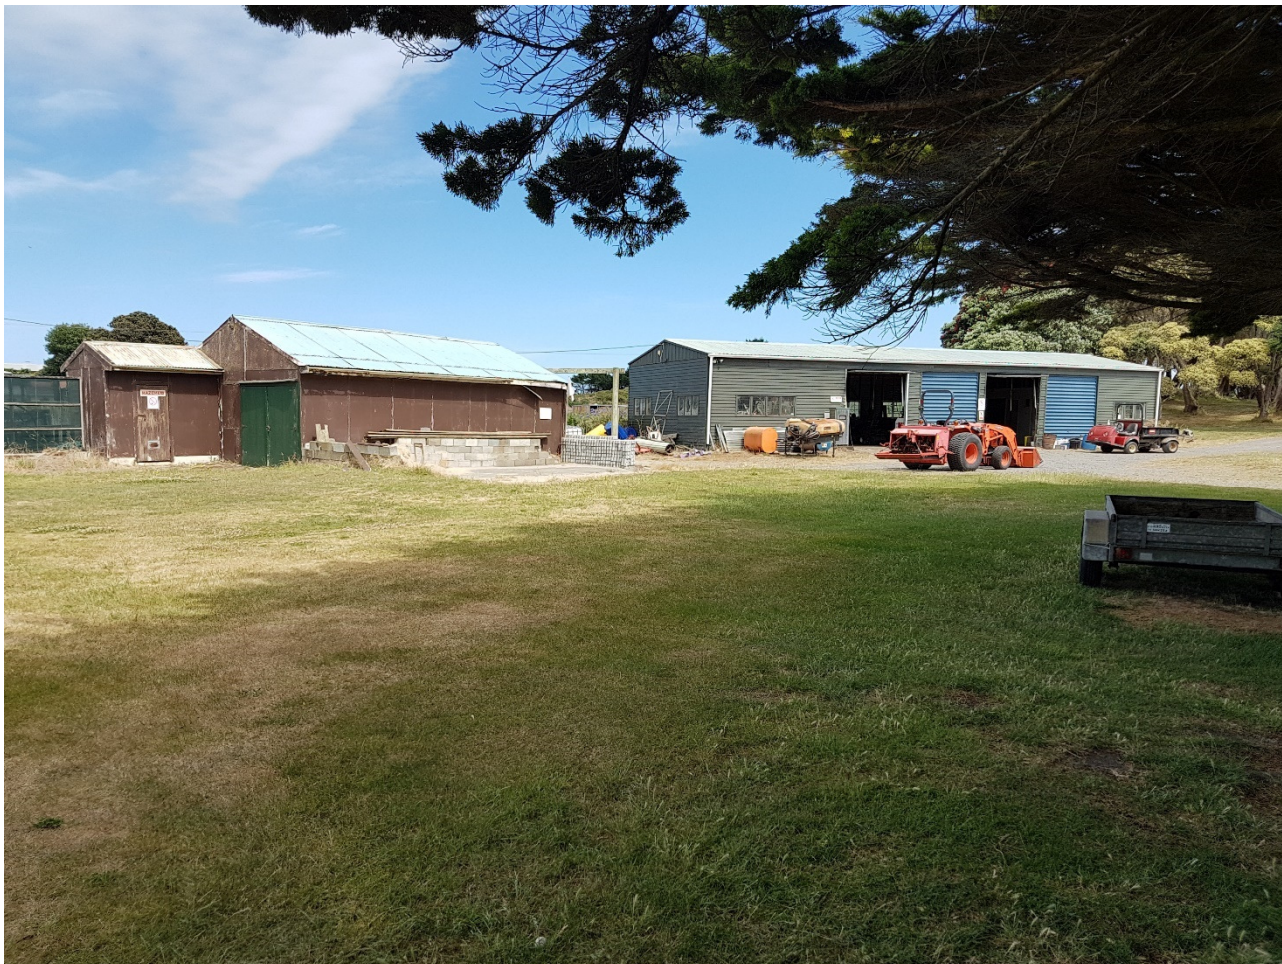
Storage of chemicals has also occurred within Area 1 and this area should be further investigated.

An assessment of contaminated soils within the study area is beyond the scope of this report. As previously discussed, the use of areas as a golf course for a long period of time would suggest that there is a history of chemical application and storage that should be investigated further should the area be subdivided.

Figure 6 : Storage sheds and Hazchem storage - Castlecliff Golf Club
