#### Current Condition of the Stagehouse – Health and Safety

# What is a flying system & stage house?

Royal Whanganui Opera House

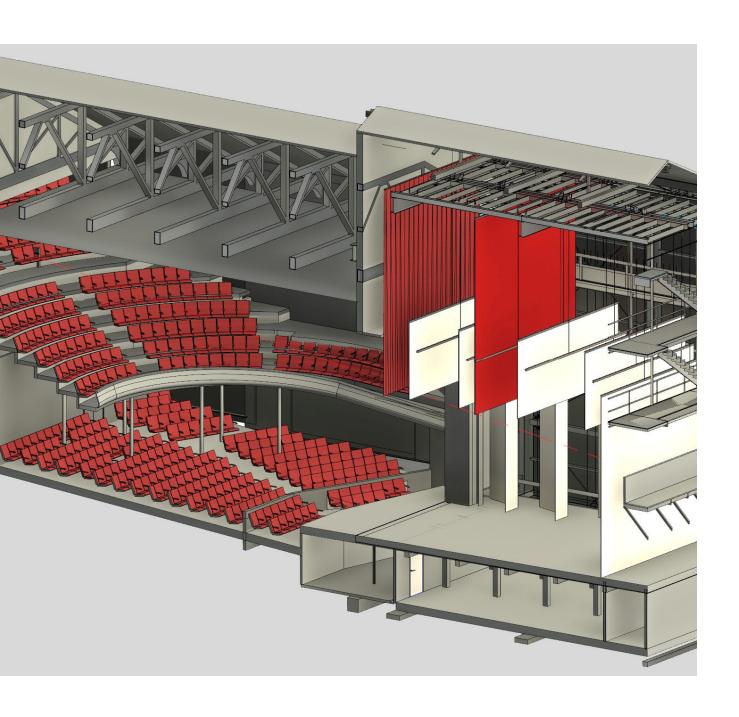
From left to right: Dressing rooms open direct on to stage / Stage wing space (both prompt & opposite prompt) / Comms / Stage Managers position

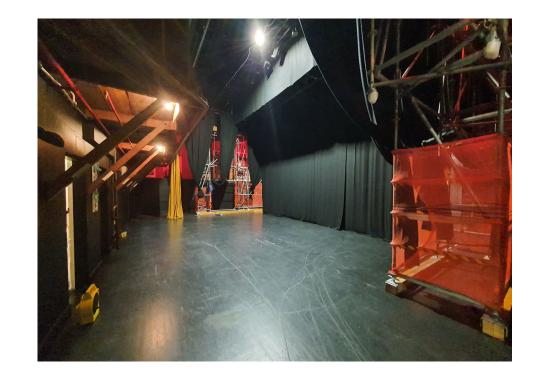
#### Option 1 – Retaining the Status Quo

#### This options retains the current situation:

- This option retains the existing scaffold structure
- Completes work on health and safety issues identified.
- The venue will not provide the level of facility required by promoters, national companies and some local productions.
- Lack of flying system will limit types of shows that can come to Whanganui
- Not a viable option for a heritage lyric theatre looking to attract productions into Whanganui.

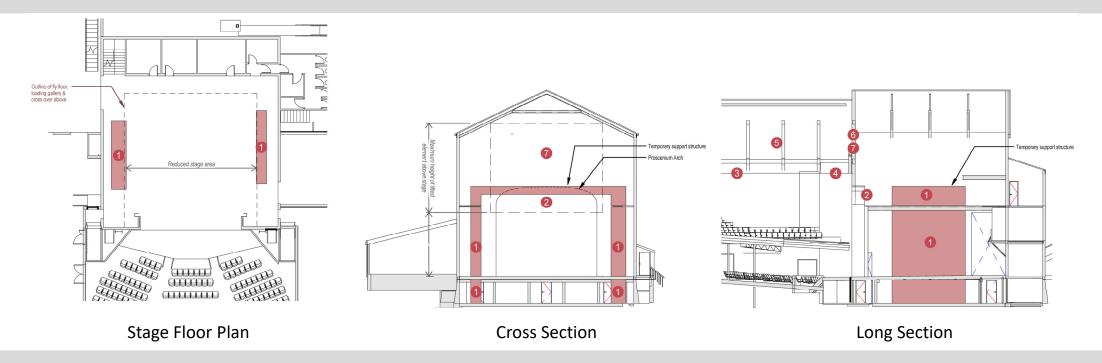
- Illustrates extent of scaffold/ truss structure.
- 2. Replacement of the house curtain, house curtain pelmet rigging and installation of smoke stop curtain.
- 3. Replacement and upgrade of rigging and support of the moving light bar FOH.
- 4. Replacement and upgrade of the rigging and support of the suspended speakers adjacent to the proscenium arch.
- 5. Providing safe access to the four FOH lighting positions.

- 6. Removal or encapsulation of what appears to be asbestos cement sheet on the proscenium arch wall between the stagehouse and auditorium ceiling space.
- 7. Addressing the compliance of the access door between the stagehouse and auditorium ceiling space to achieve smoke control.

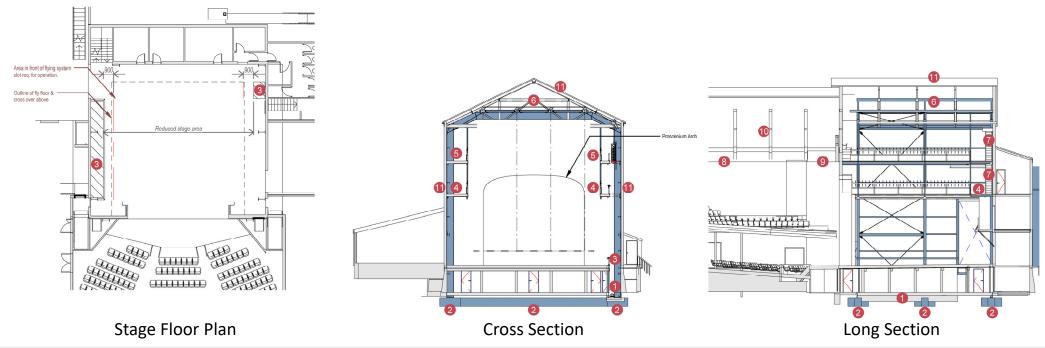
#### Option 2 - New counterweight flying system Installed within the existing building envelope

- 1. Creation of trough for flying system idler pulleys to be housed and provide the required travel distance for the counterweight cradles.
- New foundation pads & tie beams below the existing basement slab level for new structure to support Flying system
- 3. Line sets on Prompt & Opposite Prompt (OP) sides of the stage
- 4. Replacement of the existing fly floors on both Prompt and OP will need to be made to incorporate the theatrical flying system and support the load of stored counterweights.
- 5. New loading gallery is required above the fly floors on both Prompt and OP. Linked with a crossover

- 6. New walk-on grid structure that is wider and provides the ability to fit the grid blocks onto.
- 7. New staircase fly floor, loading gallery and the grid is to be installed.
- 8. Upgrade of rigging and support of the moving light bar FOH.
- 9. Upgrade of the rigging and support of the suspended speakers adjacent to the proscenium arch.
- 10. Providing safe access to the four FOH lighting positions.
- 11. Provision of vapour barriers, insulation, and wall linings to the stagehouse walls and roof.

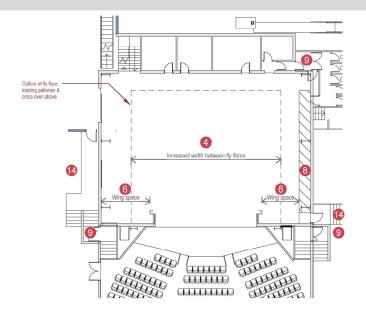
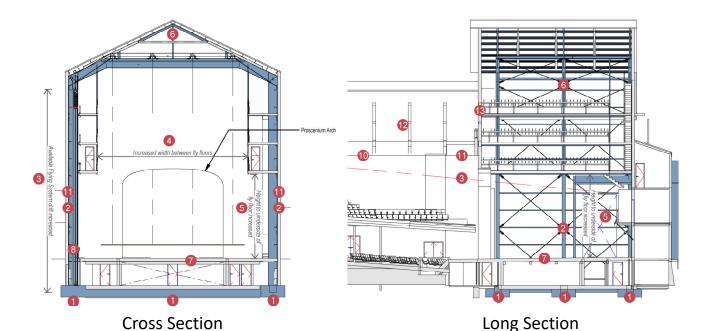
### Option 3 – New Stagehouse and Flying System

- 1. New foundations the existing slab used as a dry slab for waterproofing.
- New stagehouse structure minimises dead spots and enables better coverage of the flying system with the stagehouse.
- Available Flying System drift increased, enhances sightlines.
- Width between fly floors increased.
- 5. Height between stage and underside of fly floor increased.
- 6. Available wing space increased.
- 7. Flat floor provided in lieu of raked (including trappable portion of floor).

- 8. Flying system operation to one side of the stage.
- 9. Fire Egress Compliance from stagehouse addressed.
- 10. Replacement and upgrade of rigging and support of the moving light bar FOH.
- 11. Replacement and upgrade of the rigging and support of the suspended speakers adjacent to the proscenium arch.
- 12. Safe access to the four FOH lighting positions.
- 13. Removal or encapsulation of what appears to be asbestos cement sheet, on the proscenium arch wall between the stagehouse and auditorium ceiling space.
- 14. Addressing accessibility and accessible facilities to the stagehouse.
