# Assessment of Ecological Effects

Stormwater Discharge Points, Castlecliff Whanganui

Date: 13 August 2019  
Reference: FINAL  
Status: 5-WDO31.00

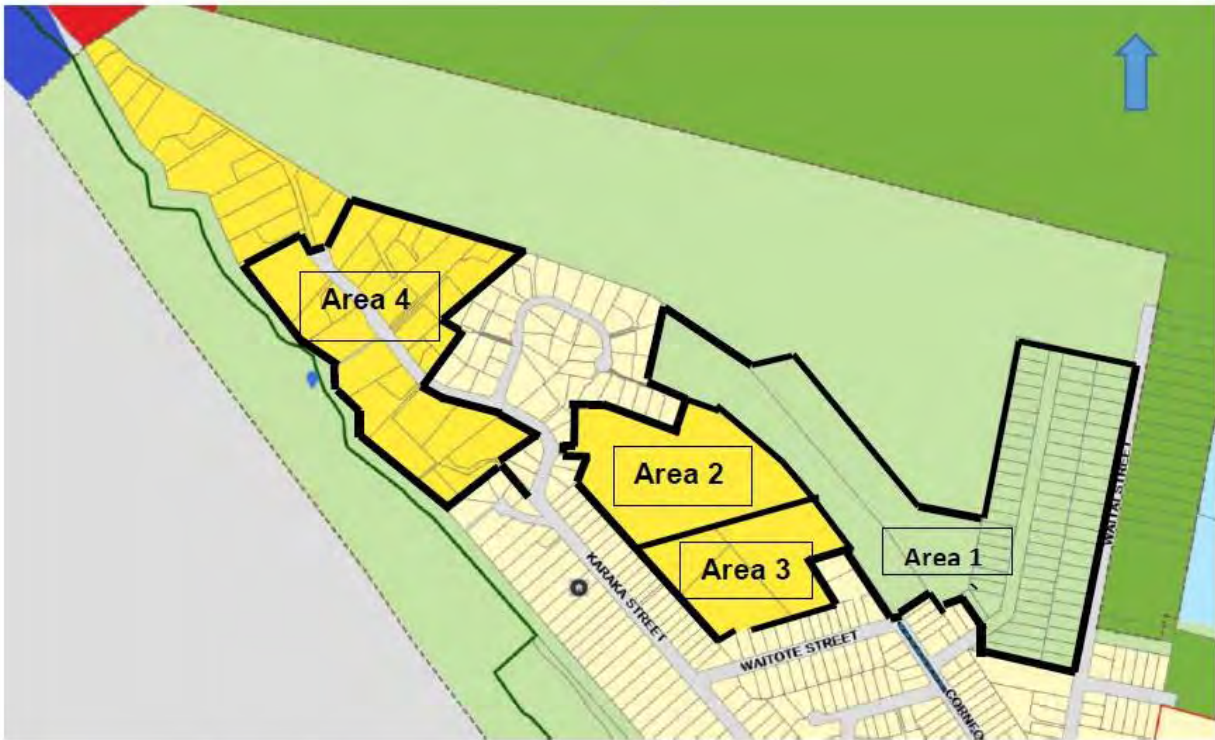
Figure 2: Outer Castlecliff area proposed to be rezoned. (Map retrieved from the Whanganui District Council Plan Change 58).

The total area of the proposed residential area can be seen in Figure 2 below. The outer Castlecliff area is currently zoned Rural Lifestyle under the Whanganui District Plan.

Figure 1 outer Castlecliff Area Proposed to be rezoned Residential

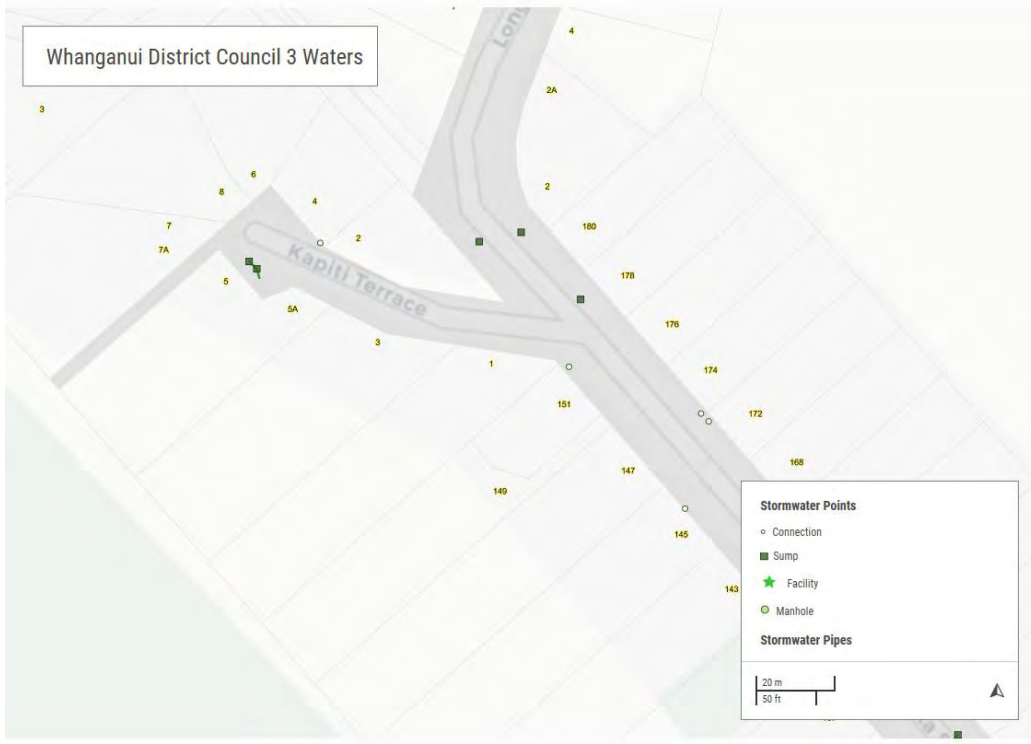
Figure 3a-c: Location of existing stormwater infrastructure to be upgraded in relation to the streetscape of outer Castlecliff.

A. Location of existing stormwater discharge into Karaka Wetland, this is proposed to receive a greater discharge following the rezoning of the outer Castlecliff area.

B. Location of existing stormwater sumps and pipes at the Kapiti Terrace end of Karaka Wetland. These are also proposed to be upgraded.

C. Location of existing stormwater discharge point at Longbeach Drive, this is proposed to be upgraded as per the above description.

and Seafront Road by utilising the nearby open unnamed stream that discharges directly to the sea (Figure 3a). The upgrades described below are upstream of this point (Figure 3b&c).

The Taupata Street (Figure 3a) outfall is also to be upgraded and an engineered swale is proposed on council owned land to attenuate/treat the stormwater before it enters Karaka Wetland. The existing flow rate for a 1 in 10 ARI is nil and the post-development peak flow will increase to 1.786m<sup>3</sup>/s.

Upgrades are also proposed on Longbeach Drive include: an upgrade from 300mm to 535mm diameter gravity main (309m long) and upgrades from 375mm to 525m diameter gravity main (133m long). The outfall is also to be upgraded. The existing pre-development flow is 0.784m<sup>3</sup>/s and the post development peak flow will be 1.152m<sup>3</sup>/s (Figure 3c).

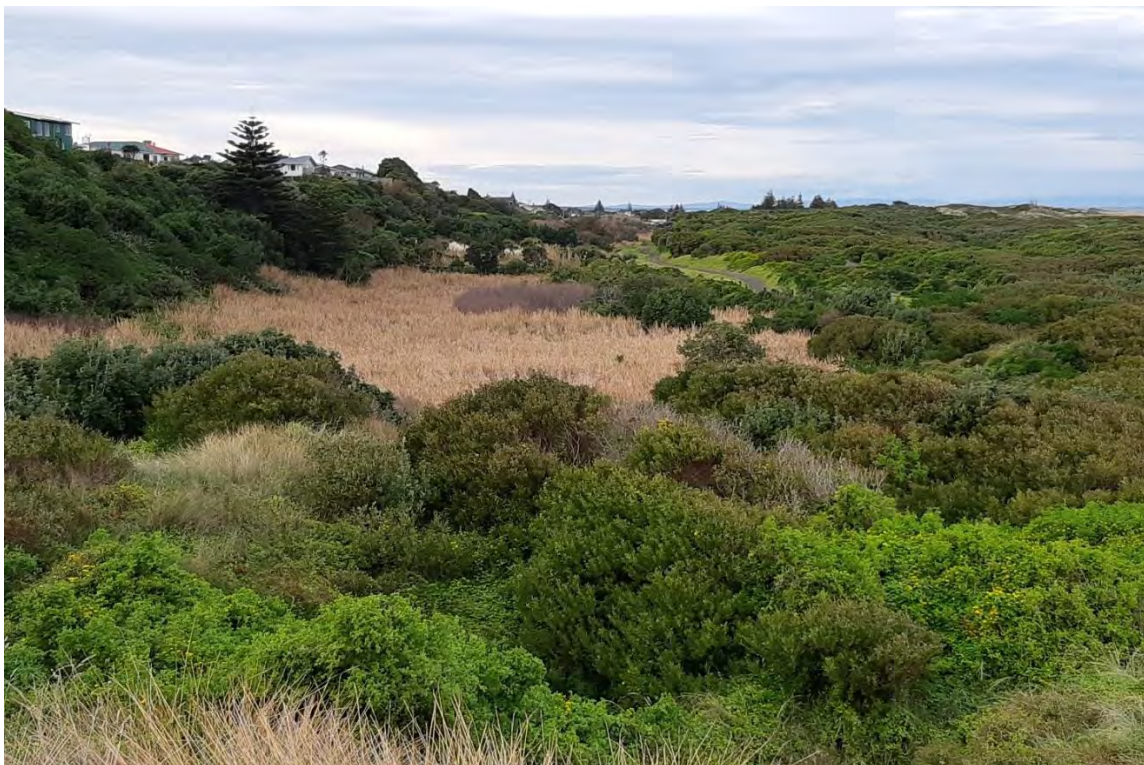
Figure 4: looking down on Karaka Wetland from Kapiti Terrace. The different vegetation types can be clearly seen in this figure. The canopy vegetation is seen on the escarpment, the raupo reedland is the central component of the wetland and the unnamed stream runs between the raupo reedland and the adjacent sand dunes.

Following the recent site visits Karaka Wetland has been identified to contain three distinct plant communities (Figure 4 & 7). Karaka Wetland consist of an area of canopy vegetation which is located on the dune below the houses on Karaka Street and Kapiti Terrace, this area of vegetation is dominated by exotic species with many planted residential garden plants intermingled with native species (Figure 6 A-F).

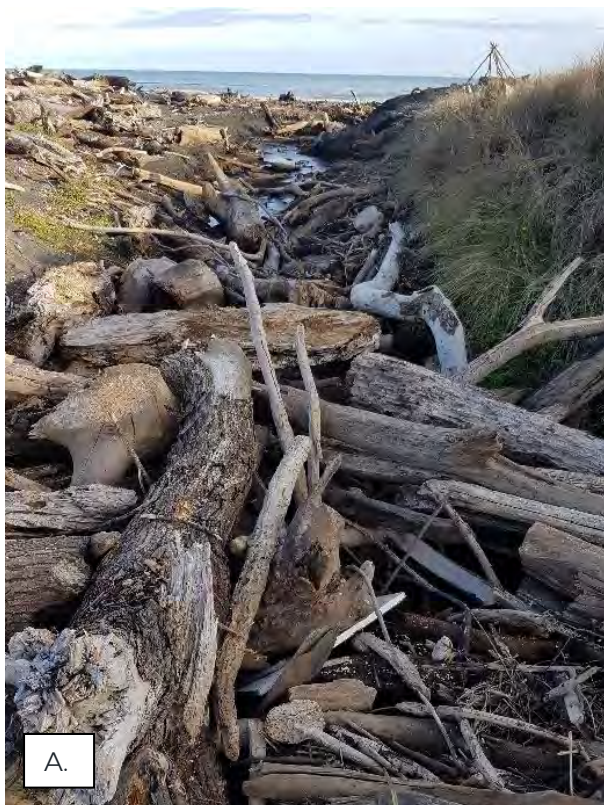
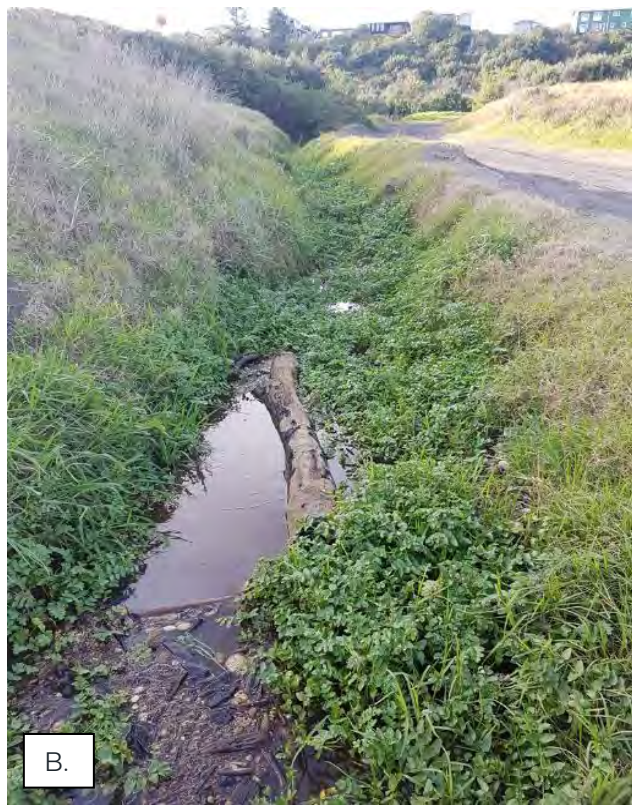
Figure 5: A) Karaka Wetland outlet to the sea. B) the open stream that runs adjacent to the dunes and Karaka Wetland.

Karaka Wetland is a naturally formed dune slack wetland, located between a residential environment and the coast. An access track (predominantly for beach access and emergency vehicles runs adjacent to the unnamed stream along the margin of the wetland (Figure 5b and 6a).

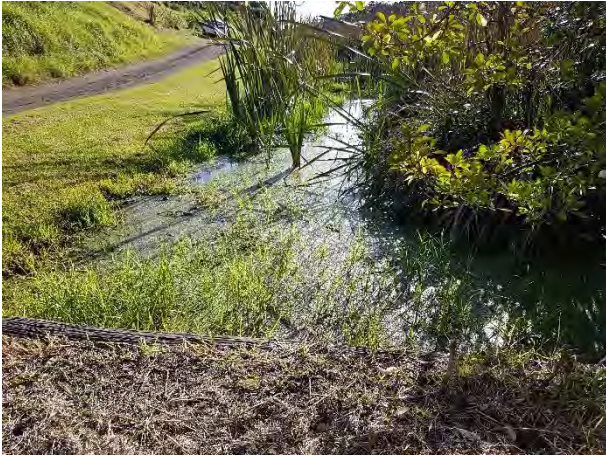
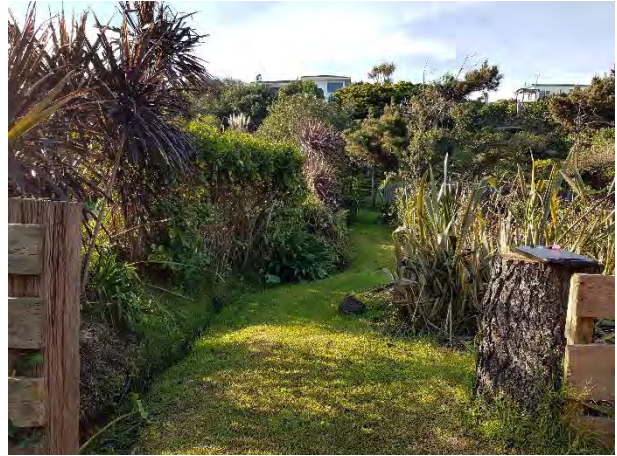
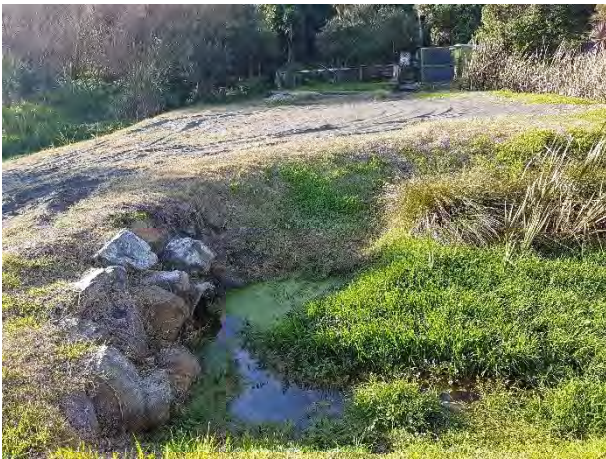
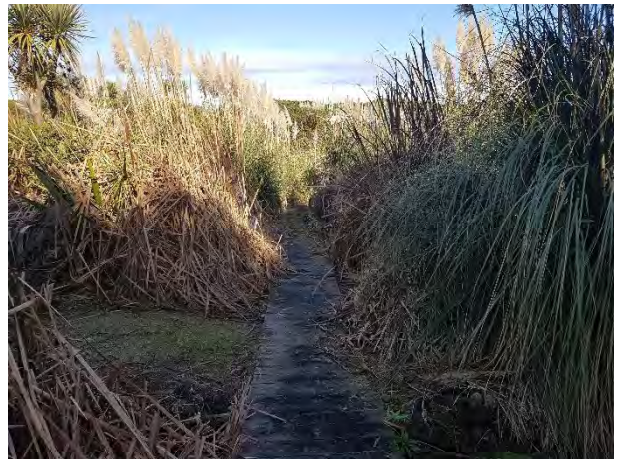
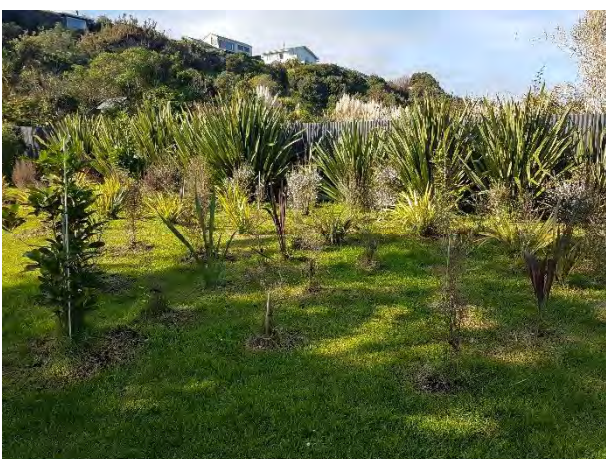
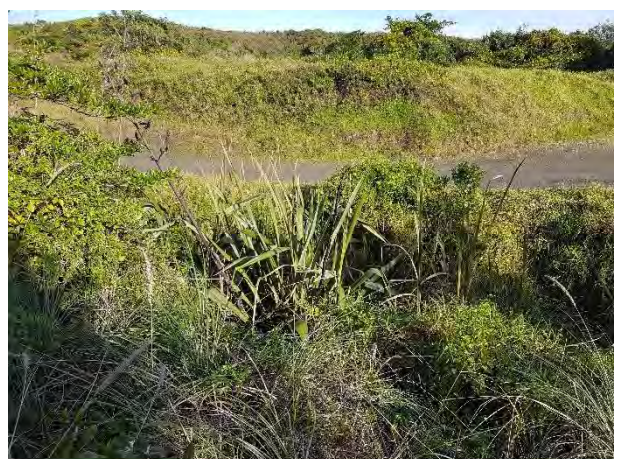
Figure 6: A-F different private uses and access ways located throughout Karaka Wetland.

A. Photo taken from one of the private accessways looking NW of Karaka Wetland.

B. Private accessway across Karaka Wetland and landscaped area.

C: One of the many existing culverts conveying the unnamed stream under private accessways.

D: Private accessway through the raupo reedland habitat zone.

E: Landscape planting zone - located on a private accessway within Karaka Wetland.

F: The location of the beach access in relation to Karaka Wetland.

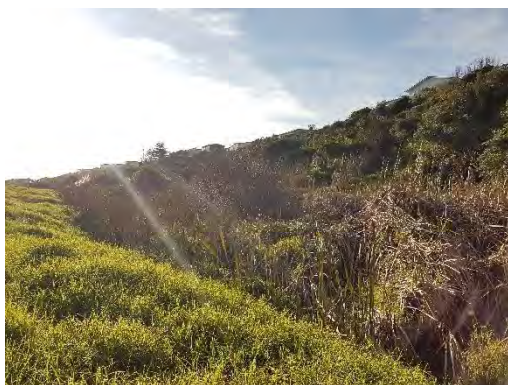
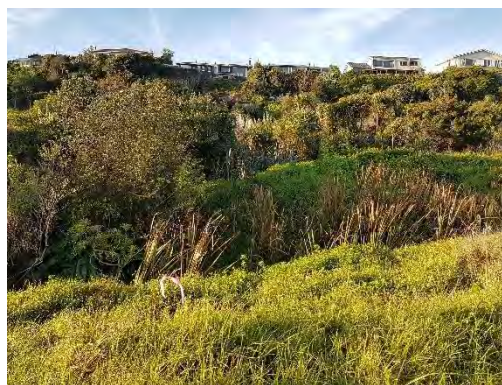
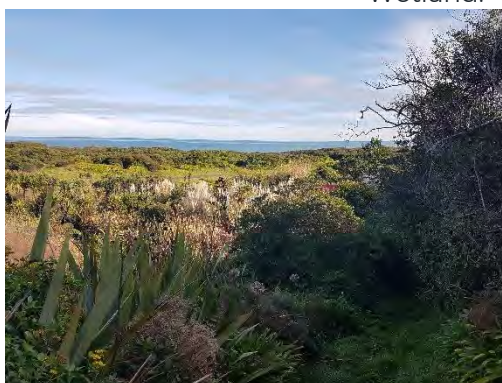
Figure 8: plant composition of each habitat zone.

A. Raupo Reedland habitat zone.

B. Reedland and canopy zones of Karaka Wetland.

C. Looking from the canopy zone across the reedland and out to the sea.

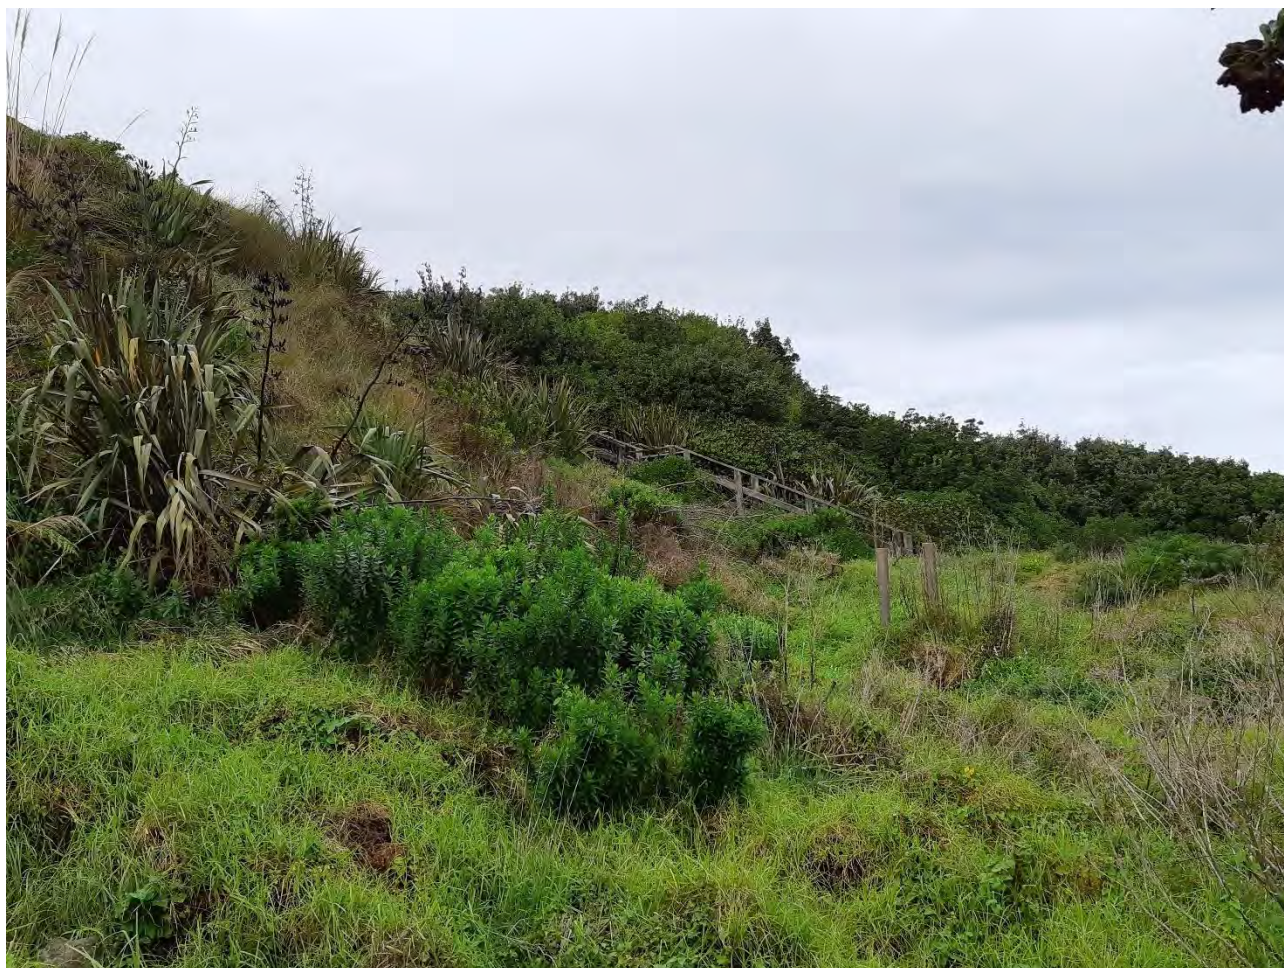
*Figure 9: Longbeach Drive stormwater discharge point, the stairs in the background show the location of the access track from Longbeach Drive.*

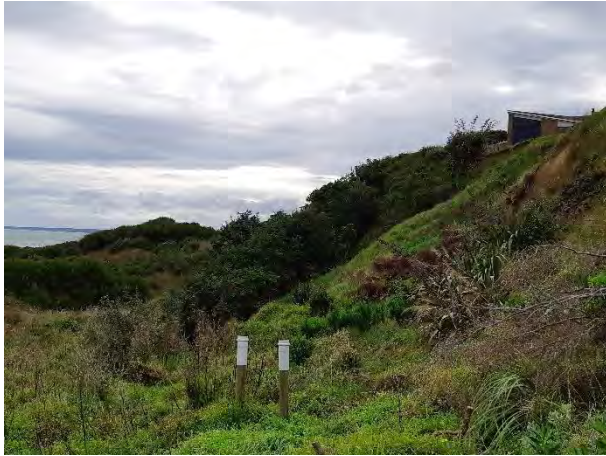
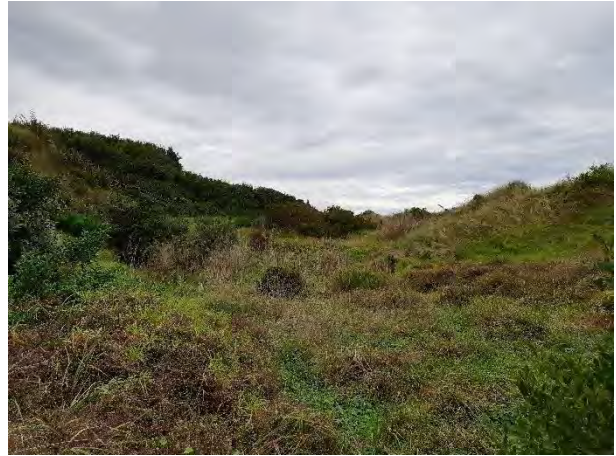
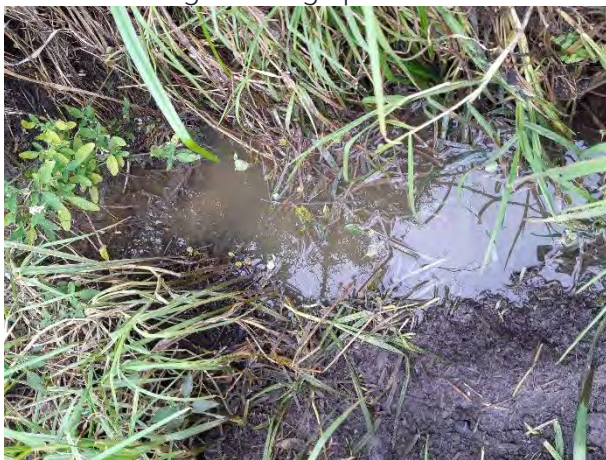
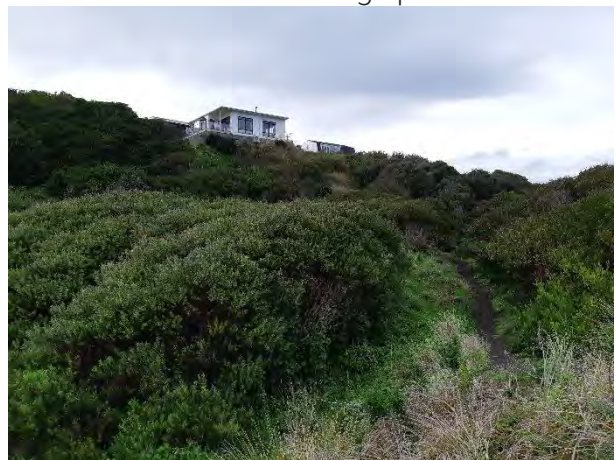
Figure 10: Longbeach Drive Stormwater Discharge point.

A. The poles mark the location of the existing discharge point.

B. Existing habitat at secondary stormwater discharge point.

C. Existing area of open water found at this site.

D. Marginal edge zone of this area, dominated by coastal wattle.

The existing stormwater discharge point had a small area of ponded water approximately  $<0.5\text{m}^2$  (Figure 10c). It appears that the existing stormwater discharge is readily absorbed into the existing environment.
