# Mowhanau Cliff Line Retreat Review

Version	Date	Status	Approved By:
V. 1	27 June 2012	Final Draft	STM

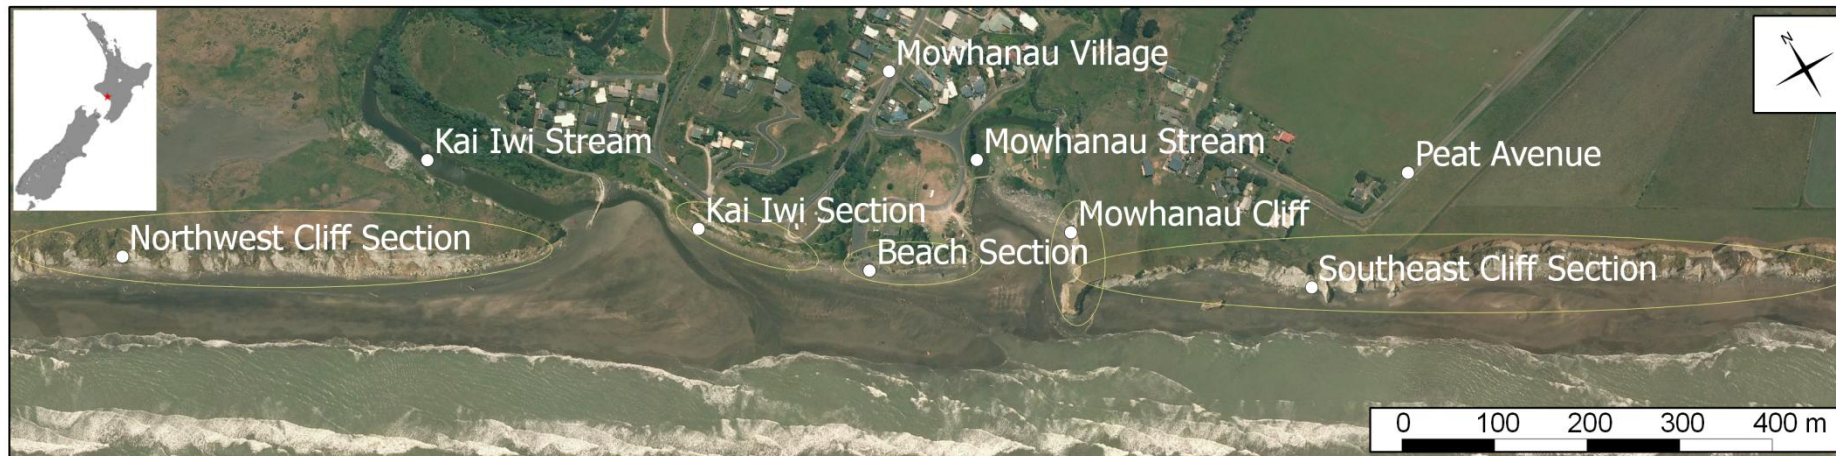
Figure 1.1. Ortho-rectified 2011 image of Mowhanau Village with prominent features and cliff line sections annotated; Inset showing study site national location.

Mowhanau is located on the North Island of New Zealand in the district of Wanganui (Figure 1.1). To the north west of Mowhanau Village is the Kai Iwi Stream, to the south east is Mowhanau Stream. Both water courses terminate on the beach adjacent to Mowhanau Village. The streams effectively delineate the wide Mowhanau Beach area, where north west and south east of the Kai Iwi and Mowhanau Streams the cliff line runs, broken only by small streams, to the district boundary and Castlecliff, respectively. Figure 1.2 is a 2011 ortho-rectified image showing Mowhanau Village and an overlay of the current CHZ established by Gibb in 1999. There are several dwellings located within the H-MRZ, particularly in the Peat Avenue area.

The XY data for the available years was sub-sectioned in to 5 areas: Northwest Cliff; Kai Iwi; Beach; Mowhanau; and Southeast Cliff, as shown in Figure 1.1. The cross shore differences between data sets were calculated at 50 m intervals (30 m for the Mowhanau Section) by interpolating along the XY arrays, creating 39 potential nodes for comparisons of the cliff top (Figure 3.1) and 31 nodes for the cliff toe (Figure 3.2). This is achieved by converting the XY arrays to polar coordinates and rotating by 29°, the exception to this is the Mowhanau section which is rotated 137.5°, extracting the XY value and calculating the difference at the interpolated nodes. The steps are then reversed to revert the node XY arrays back to the Cartesian coordinate system (NZMG). Subsequently erosion rates are calculated from the cross shore differences by dividing by the number of years elapsed between XY array data. From these data, geospatial vector format files are constructed to be incorporated into the GIS database.

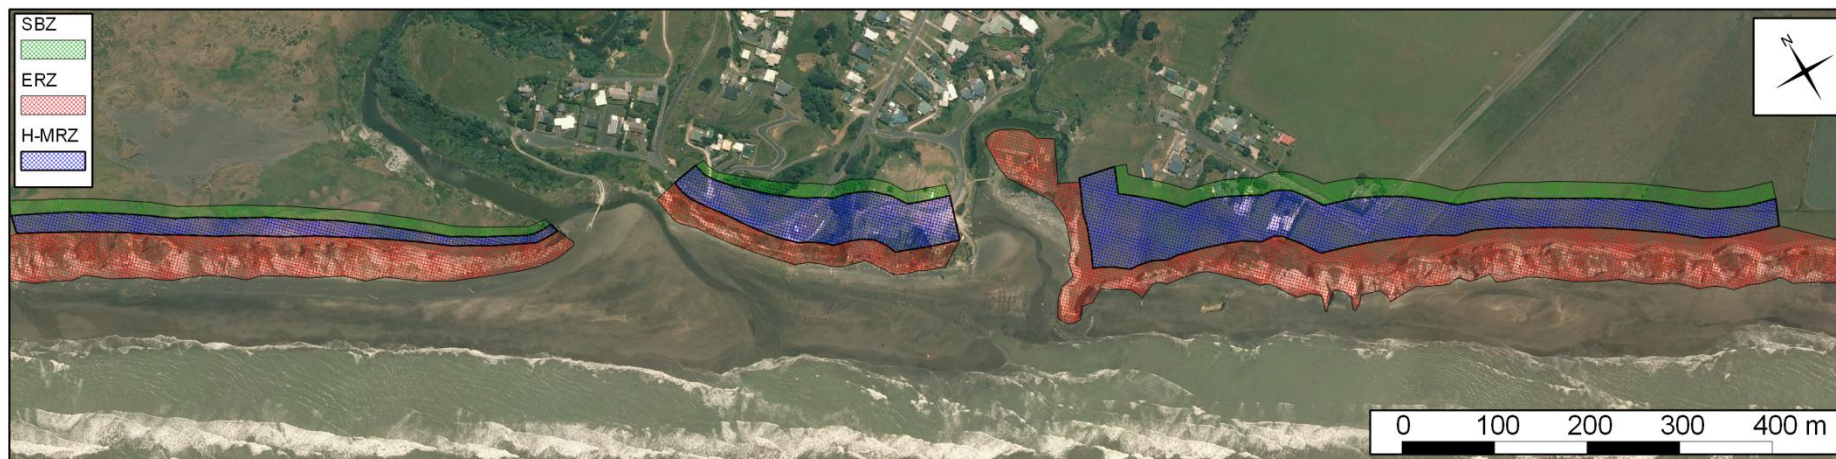
Figure 1.2. Ortho-rectified 2011 image of the study site with the current Coastal Hazard Zones, as established by Gibb (1999).

Coastal hazard zones (CHZs) describe the present and potential future coastal hazard for a particular area of the coast. In 1999 coastal hazard zones were defined for a 2300 m stretch of coast line centred on the settlement of Mowhanau (Gibb, 1999) (Figure 1.1 and Figure 1.2). The major coastal hazard at Mowhanau is erosion and landslip. Gibb (1999) split the CHZ in to three zones: Extreme Risk Zone (ERZ), High-Moderate Risk zone (H-MRZ) and a Safety Buffer Zone (SBZ).

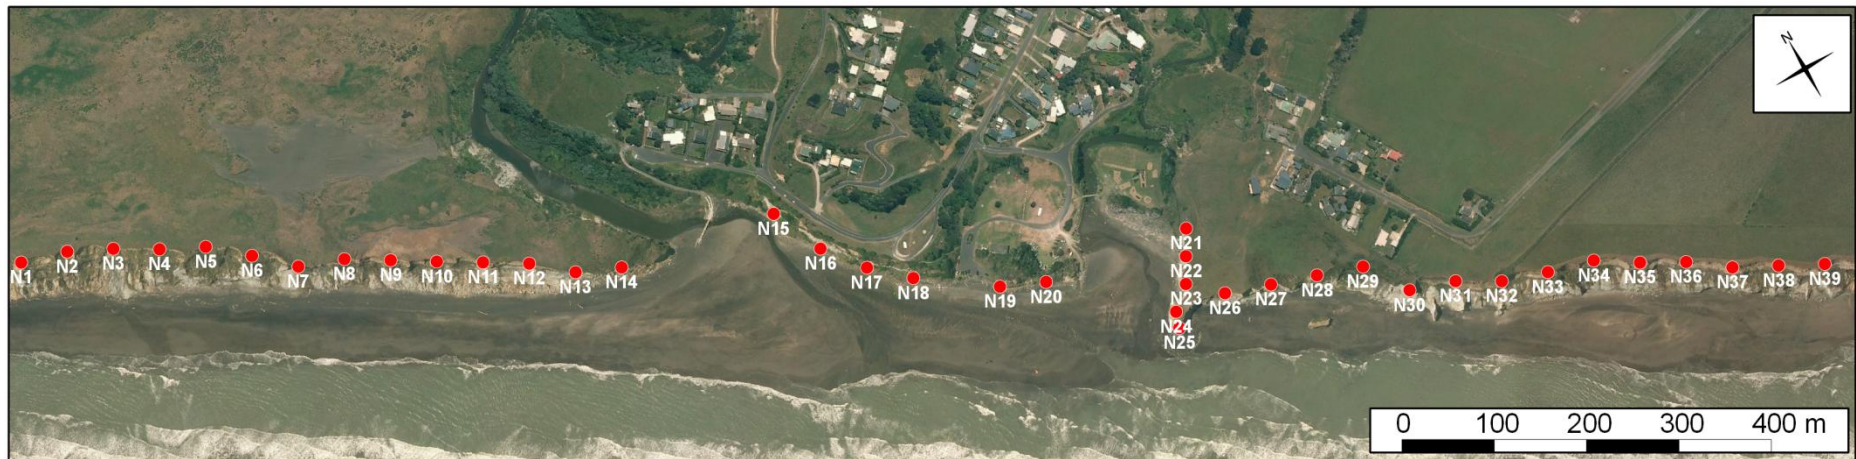
Figure 3.1. Locations of interpolated nodes for the cliff top.

2013 periods at each transect location along the coast (Figure 3.1). At more than 66% of the comparable nodes the erosion rate has increased. The greatest increases occur at the southern end of the northwest cliff section and for much of the southeast cliff section, including the Mowhanau Stream section. A paired t-test shows that there is a significant difference between the erosion rates at the 95% confidence level ( $p = 0.001$ ). The average increase is 0.3 m/yr.

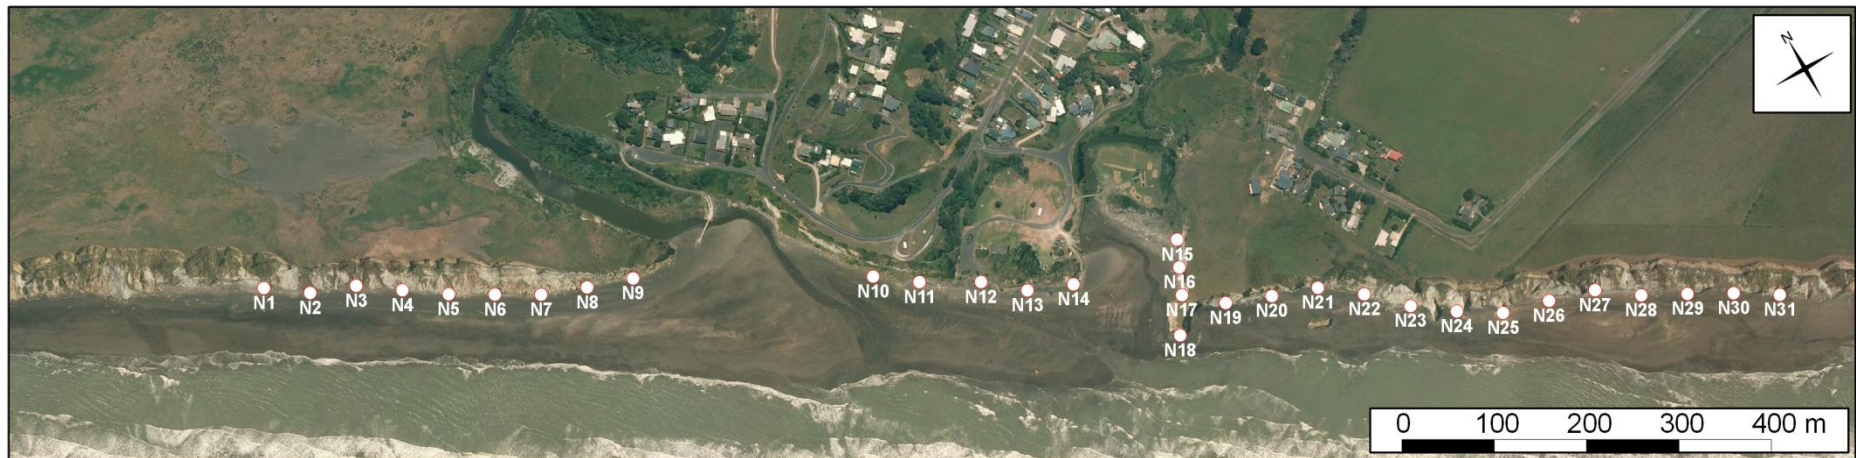
Figure 3.2. Locations of interpolated nodes for the cliff toe

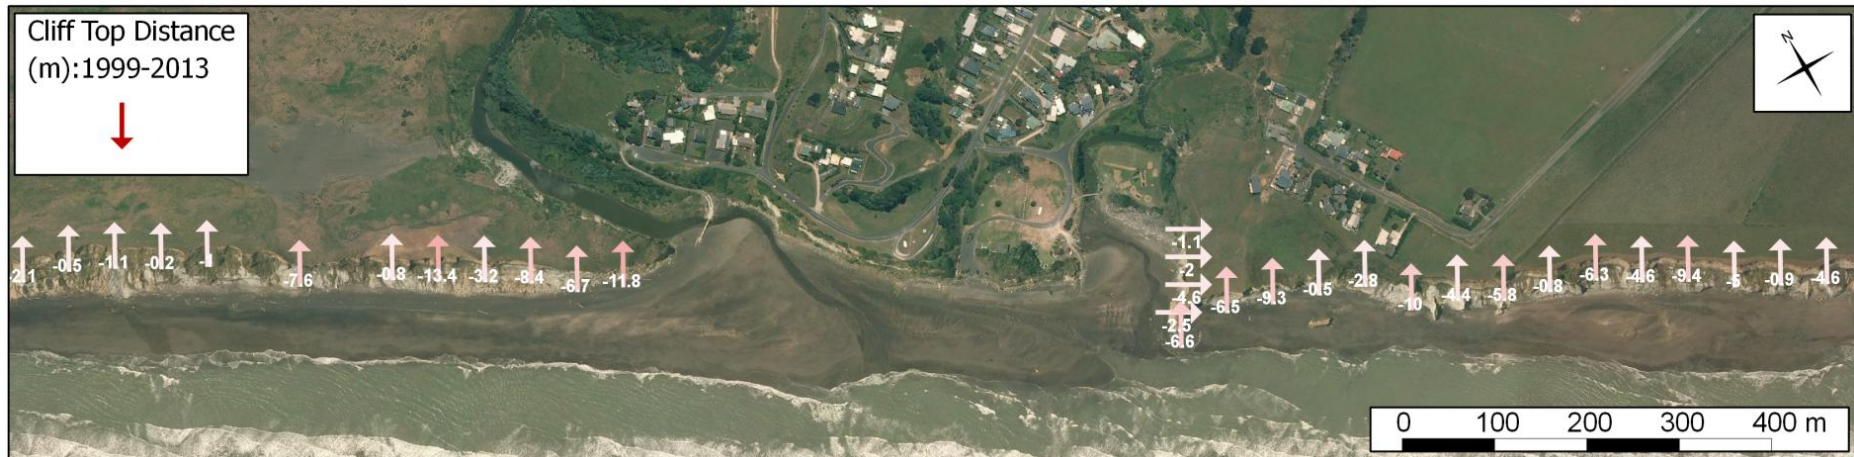
Figure 4.1. Cliff top erosion rates for the 1999 to 2013 period.

Figure 4.1 and Figure 4.2 show that between 1999 and 2013, the exposed cliff line at Mowhanau continued to erode landward, and the Mowhanau Cliff section continued to erode to the south east. Erosion distances of the cliff top at the west end of the Northwest Cliff Section are less than at the eastern end where the cliff top has eroded an average of 8.7 m from nodes 10 to 14. In the Mowhanau Cliff section (nodes 21 to 24), the average erosion distance is 2.6 m toward the southeast. The average erosion distance in the Southeast Cliff Section is 5.1 m. The west end of this section, from nodes 25 to 30 averages a retreat of 6 m. This average value is reduced by nodes 28 and 29 where the cliff retreated by 0.5 m and 2.8 m, respectively. This area is in the lee of the remaining stack, and the nodes directly adjacent have much higher retreat distances (2.8-10 m). The dwelling closest to the cliff line on Peat Avenue is <25 m from the 2013 cliff top position

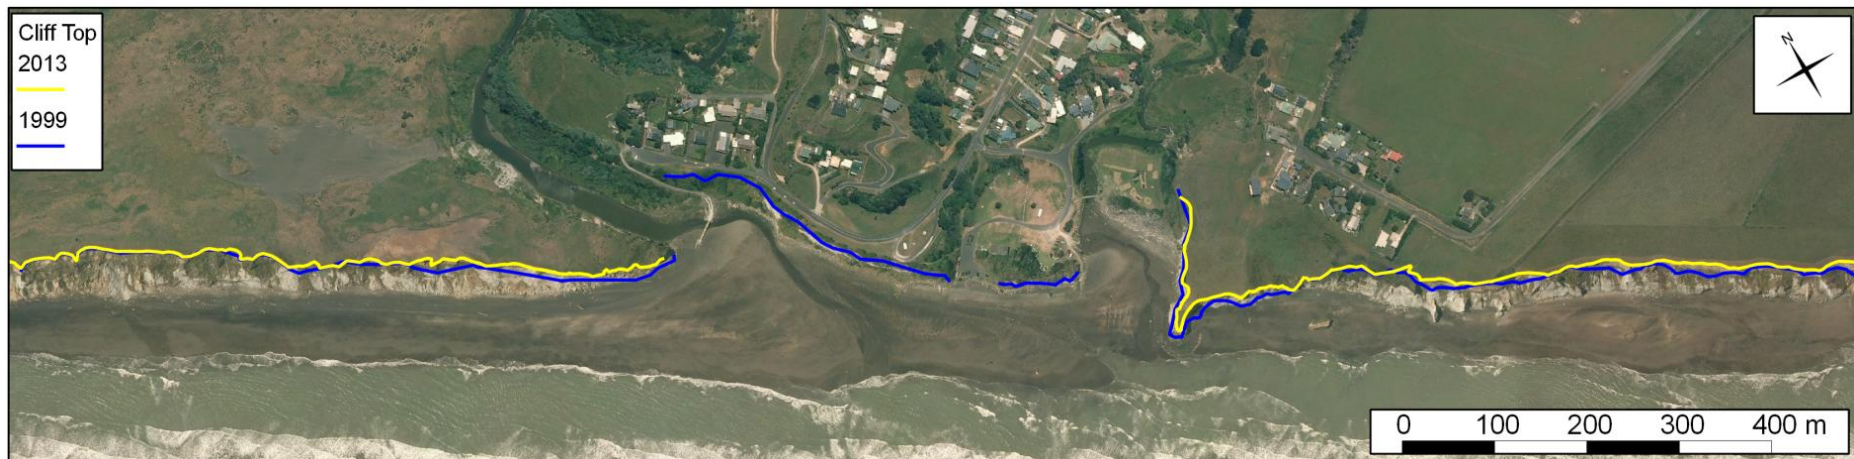
Figure 4.2. The 1999 and 2013 cliff top location lines.

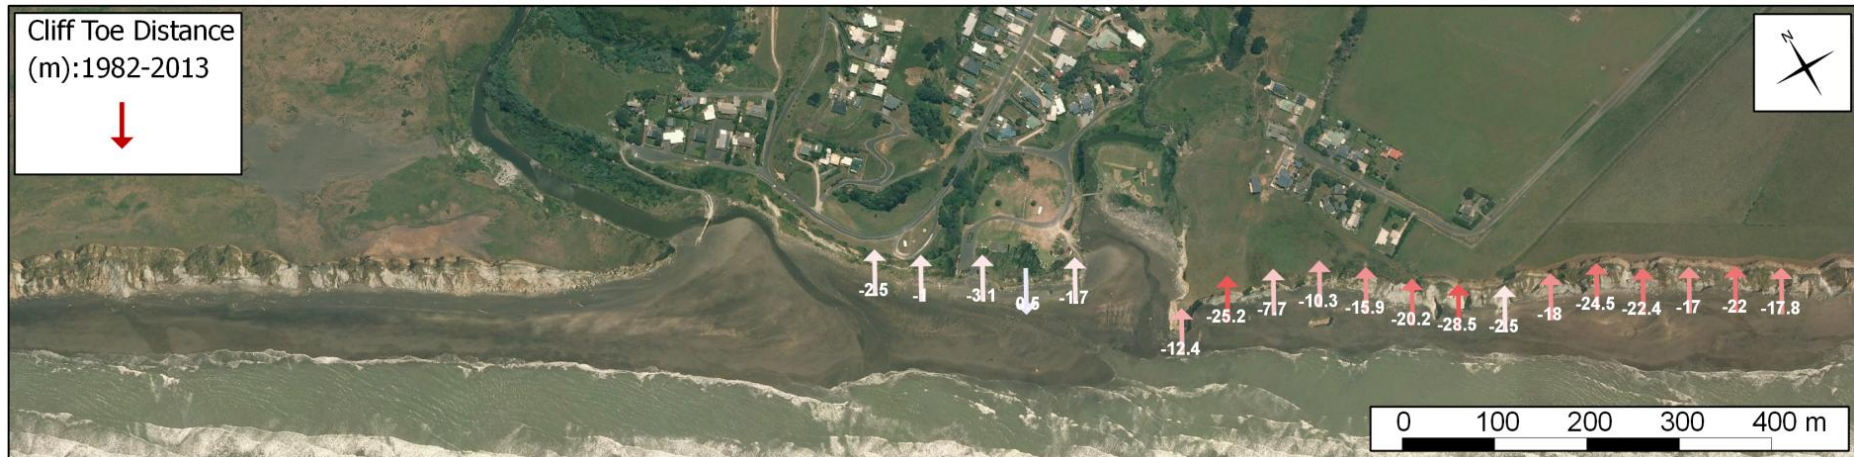
Figure 4.3. Cliff toe erosion rates for the 1982 to 2013 period.

Figure 4.3 and Figure 4.4 shows the cliff toe position in 1982 and 2013, the 2013 toe line includes the toe of the riprap armour adjacent to Mowhanau Village. The position of the toe has moved a maximum of 3.1 m at node 12. In places (e.g. node 13) the toe of the riprap is equal to or in advance of the 1982 position, suggesting that the erosion control system is effective. However, a comparison of the 2013 riprap toe line and with the original toe line after installation is not possible, but would provide an insight in to the durability of the system and if there is potential for a failure in the future.

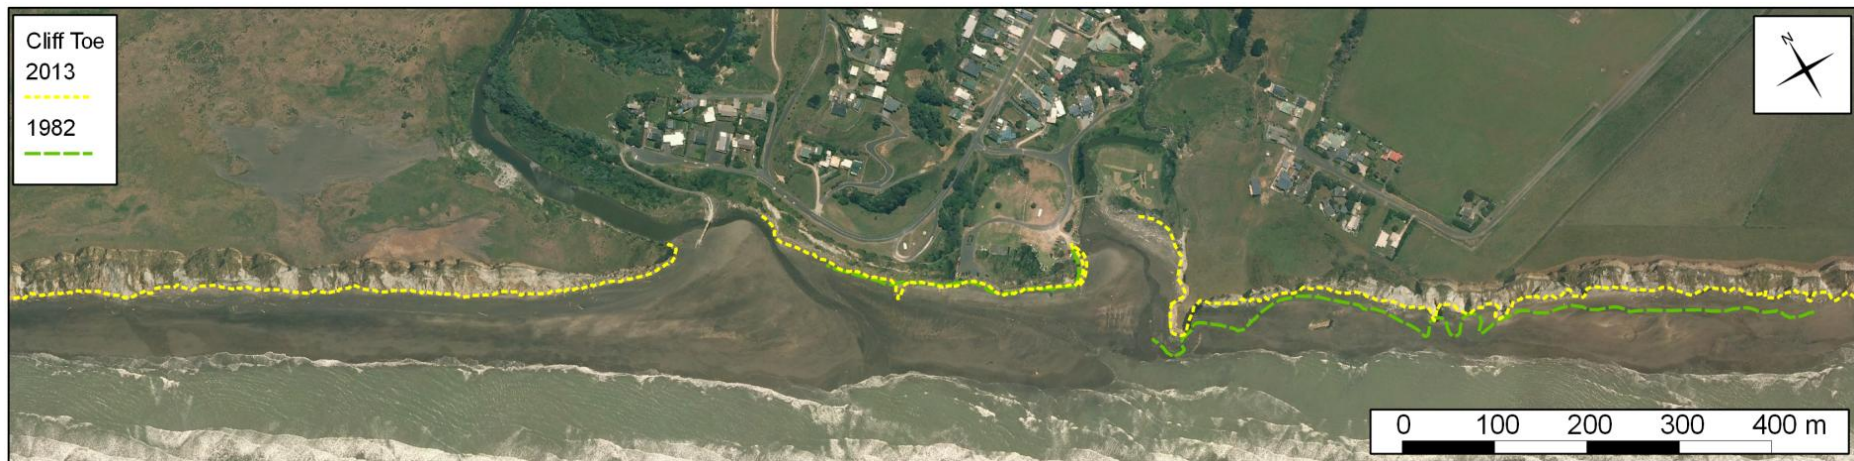
Figure 4.4. The 1982 and 2013 cliff toe location lines.

The toe of the riprap armour in 2013 is equal to or in advance of the 1982 position suggesting that the erosion control system is effective. Again, repeat surveys and/or inspections of defences would provide more details as to whether the system is being undermined and has the potential to fail.

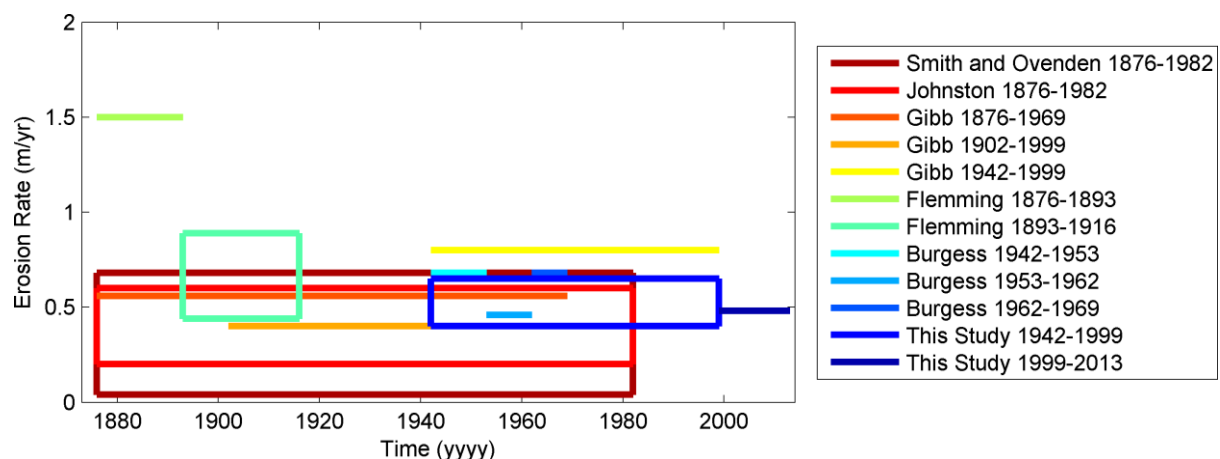
Figure 5.1. Compilation of historic and contemporary erosion rates.

Figure 5.1 presents the historic estimations of erosion rates detailed above and cliff top erosion rates calculated in this study for the exposed cliff just southeast of where the Mowhanau Stream terminates. No clear trend can be discerned from the plot, this in part may be due to the large ranges by which erosion rates are cited to by previous investigators. In addition there is some ambiguity regarding the alongshore location each investigator is referring to. The plot does however show that the latest estimations of erosion rates are not in excess of previously estimated rates.

Latest estimations in this report are directly comparable. Minimum and maximum values are extracted from nodes 25 and 26. The minimum value in the 1999-2013 period (node 25) is higher by 0.8 m/yr, indicating an increase in erosion rate. In light of this observation, Figure 5.2 has been constructed to compare the cliff top erosion rates for the 1942-1999 and 1999-

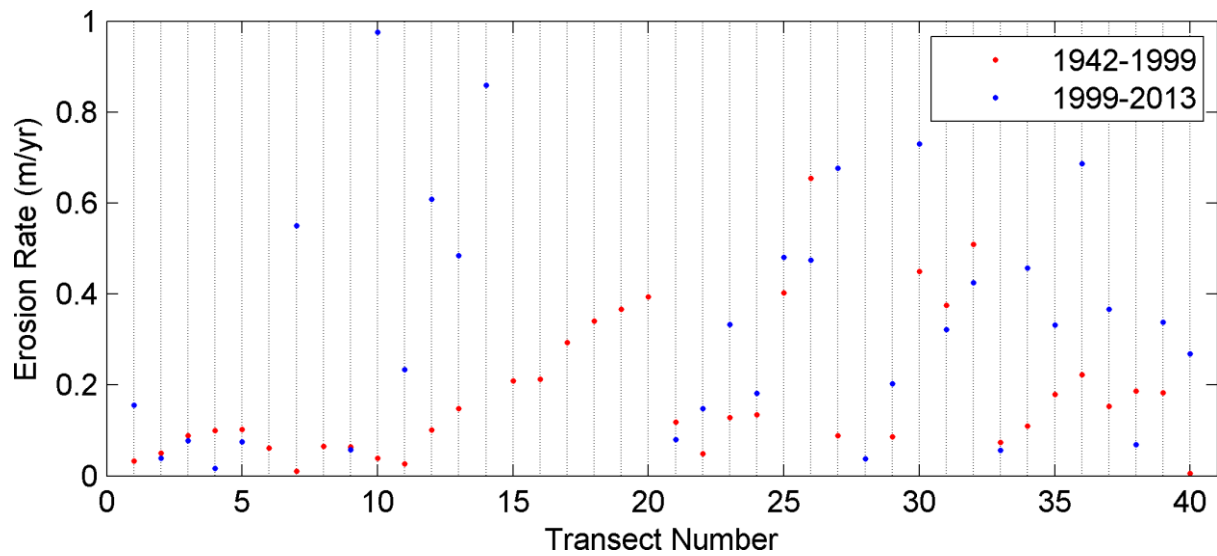
Figure 5.2. A comparison between the 1942 to 1999 and 1999 to 2013 erosion rates.
