Appendix D - Groundwater Desktop Report

Whanganui District Council

Mill Road Manufacturing Zone Structure Plan Groundwater Desktop Review

October 2017

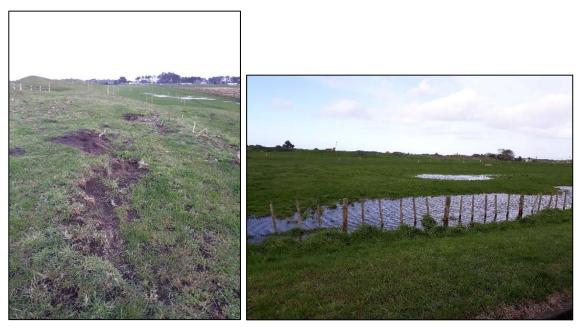
Plate 1 (left): View to west along ridge of E-W dune

(Location 10 with a view to Location 11). Ponded water visible (far right) in the topographic low north of the dune.

Plate 2 (right): Ponded water in a topographic low south of Mill Road

(Location 1)

- Evidence of small-scale slope instability was noted within the sand dunes (**Plate 1**).
- Standing water was observed in low points between dunes in several locations (Plate 2).

Plate 1 and Plate 2 above shows observations of ponded water in low-lying areas in the Study Area.
