IWIK TRUST
SOIL CONTAMINATION PRELIMINARY & DETAILED SITE INVESTIGATION REPORT
OF 21A MANUKA STREET, CASTLECLIFF, WANGANUI.

Project Reference: 15383
28 February 2019

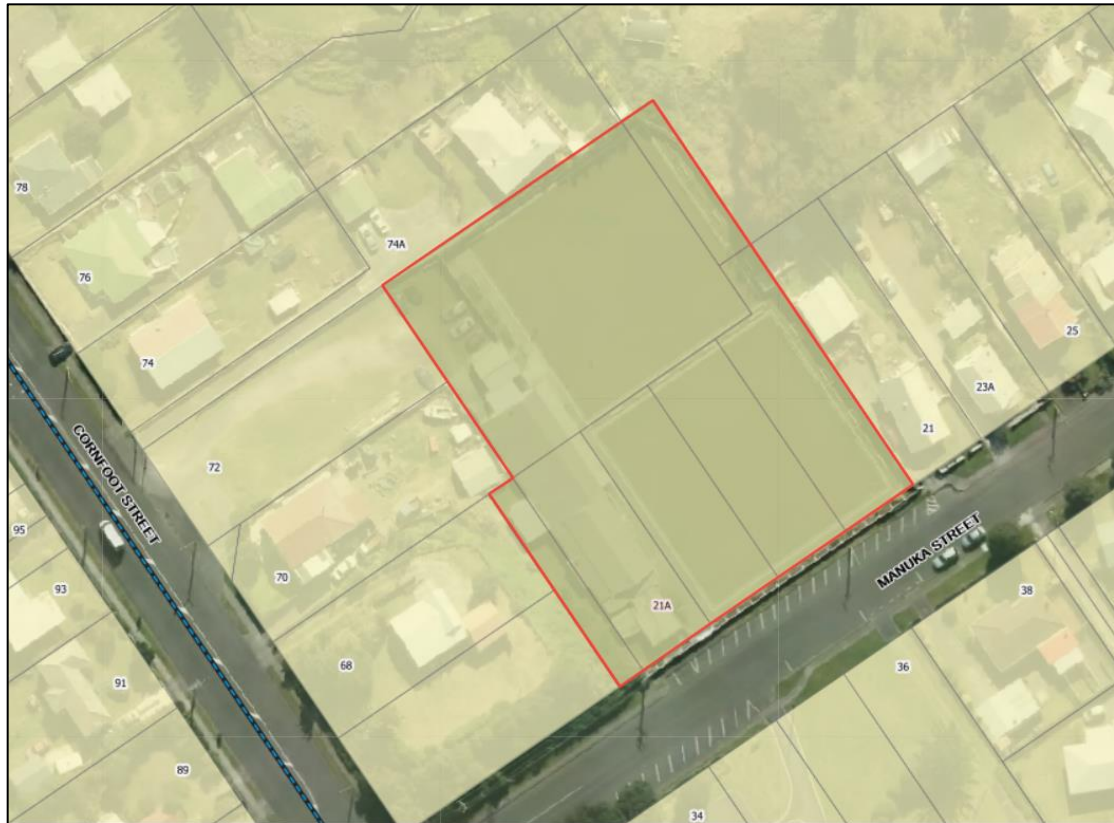
Figure 2: Site location shown by the red border. Source WDC GIS District Plan (annotated image).

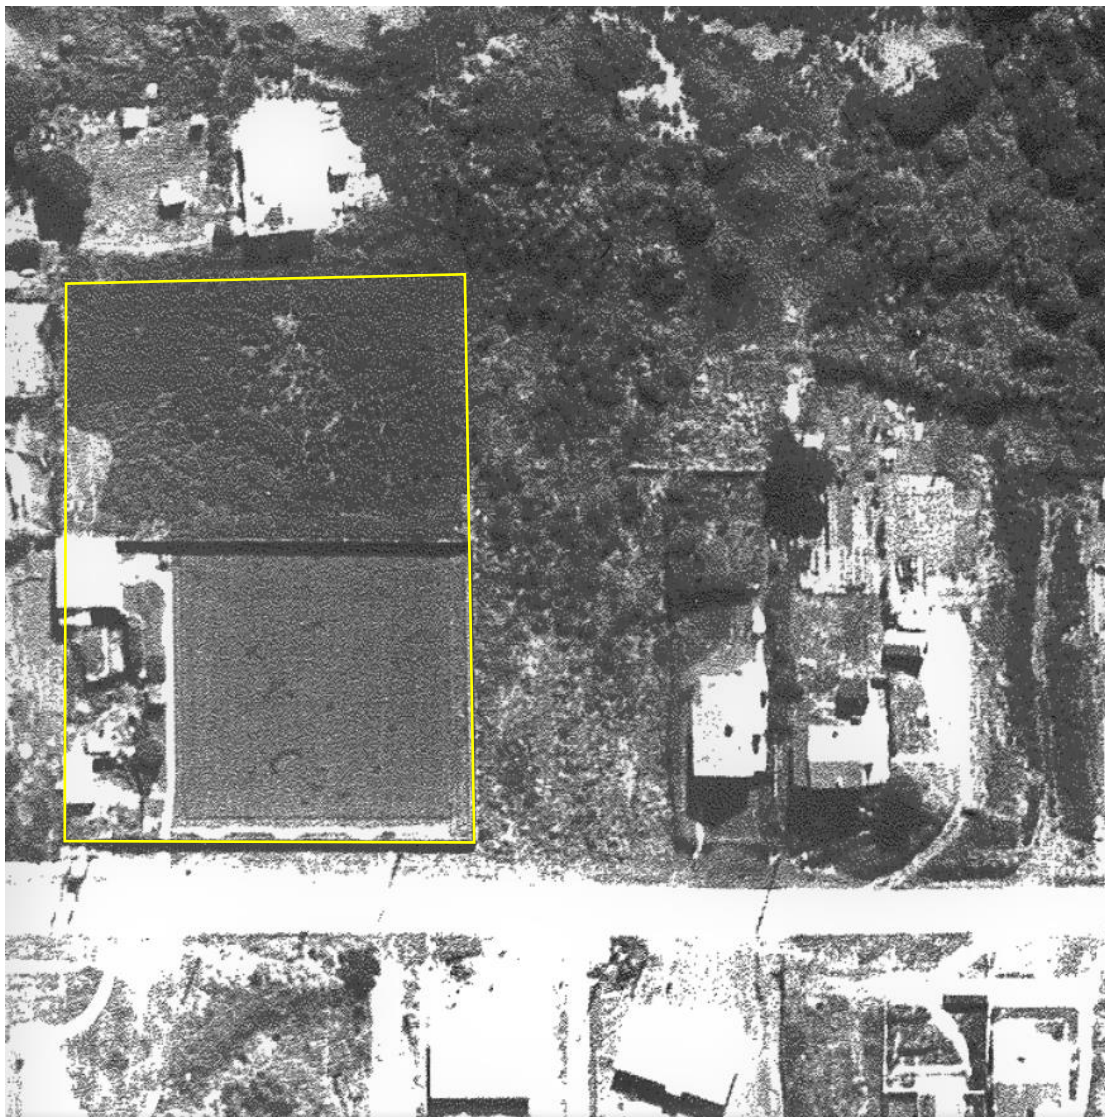
1960 Photograph: This is the earliest available image of the site which shows one of the greens in place with part of the current clubhouse also present. The remainder of the site is vacant comprising vegetation.

Figure 3: 1960 aerial photograph [source: Whanganui District Council]

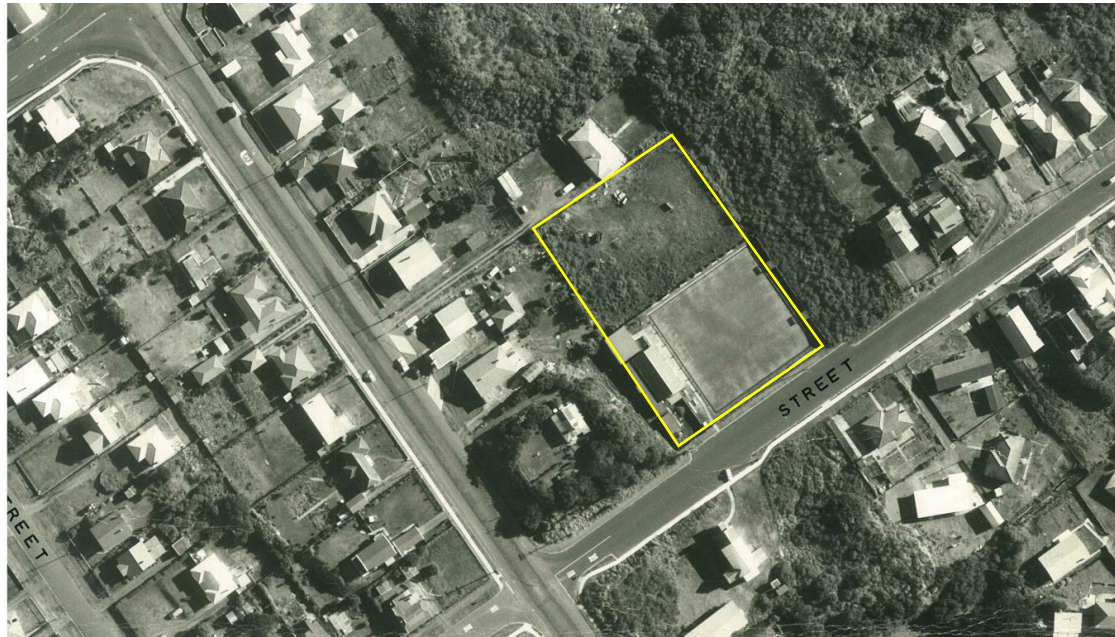
1968 Photograph: This is the earliest available image of the site which shows one of the greens in place with part of the current clubhouse also present at the south of the site. The remainder of the site is vacant.

Figure 4: 1968 aerial photograph (source: Whanganui District Council)

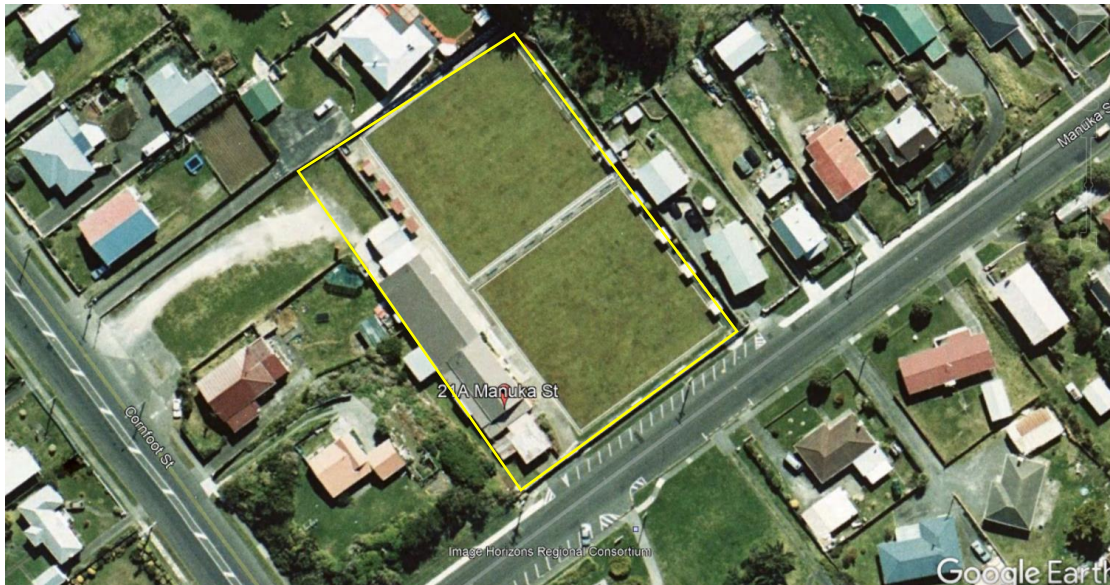
2005, Photograph: Both greens are present, and the clubhouse is in the present day state as well the addition of the groundsman and implement shed.

Figure 5: 2005 aerial photograph (source: Google Earth)

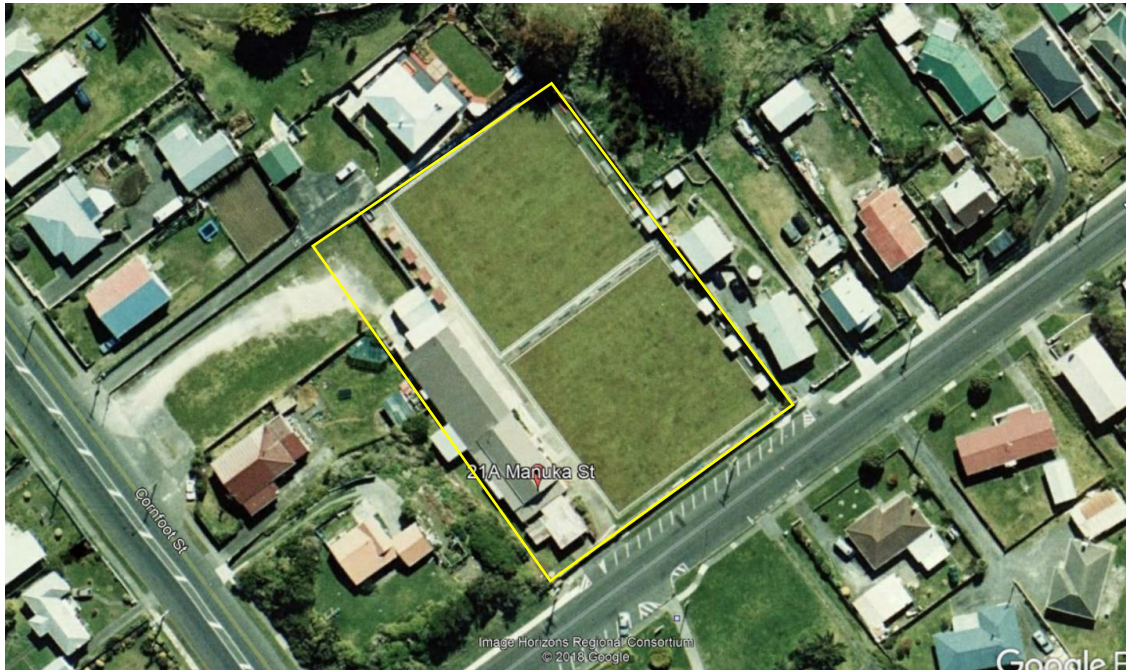
2017 Photograph: No changes identified.

Figure 6: 2018 aerial photograph (source: Google Earth)

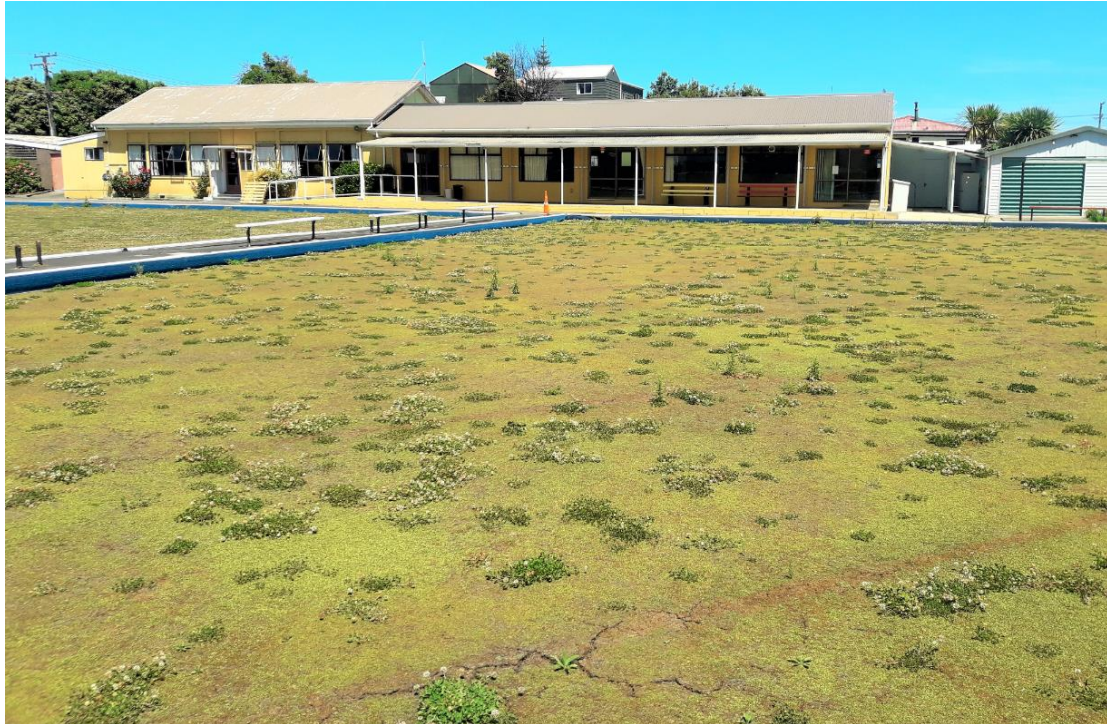
All sheds including the Groundsman's shed are situated on concrete slabs (not bare earth). We understand that historically, while the site was used as a bowling club, sprays used in the upkeep of the greens would have been stored here.

Figure 7: Photograph taken facing southwest across the greens towards the clubhouse and groundsman shed (right).

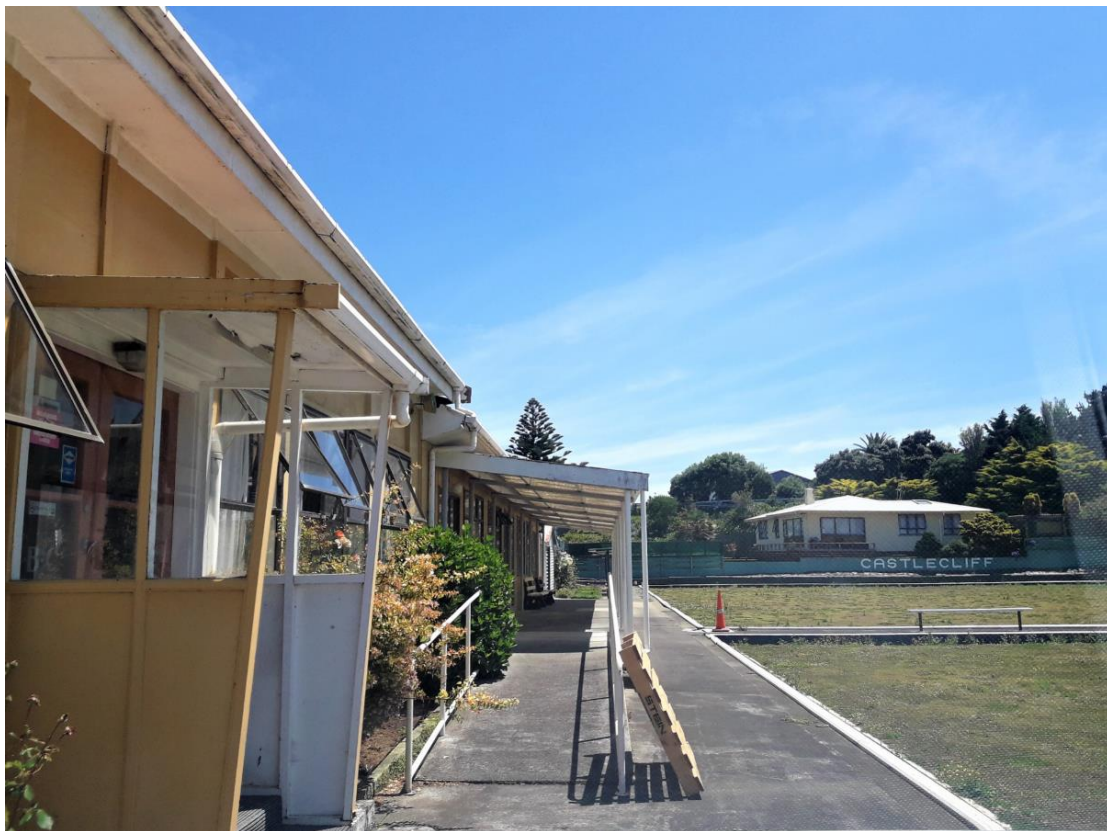
Figure 8: Photograph showing the clubhouse and greens to the right.

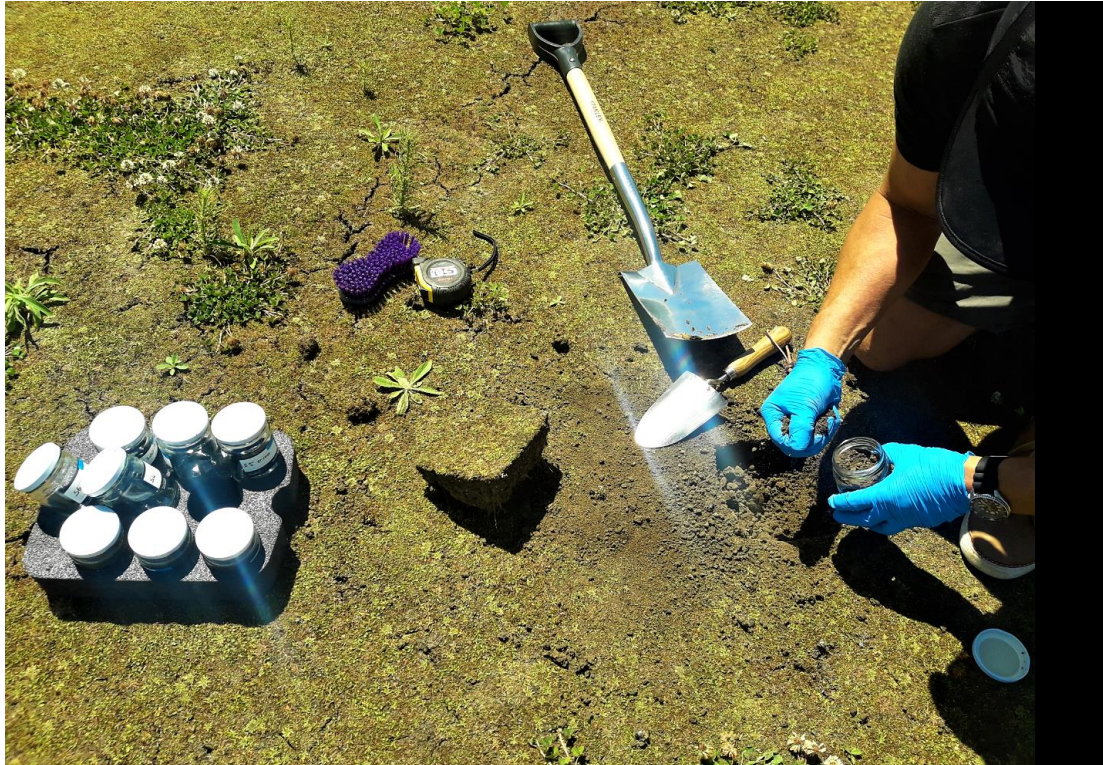
Figure 9: Soil sampling of the greens.

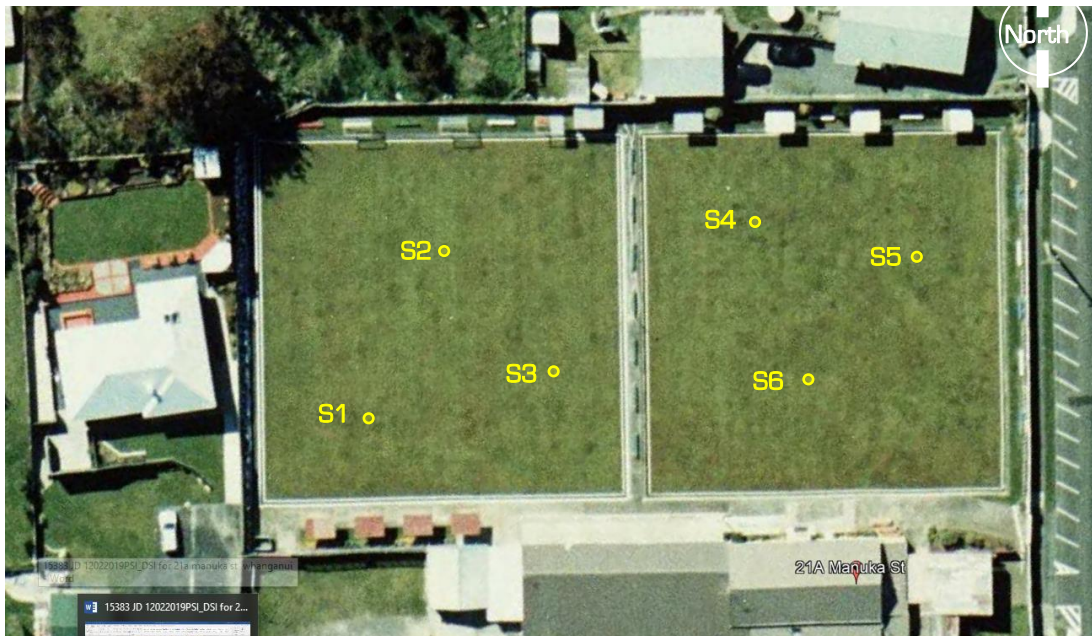
The sample locations were selected to represent the contaminant status of the two greens including the different soil strata at depth. Discrete surface samples (S1 0-100 – S6 0-100) were collected at depths of 0 to 0.1m below ground level (bgl) representing the topsoil layer, subsurface sample (S5 100-200) was collected at depths of 0.1m to 0.2m bgl representing

the orange clay layer, and subsurface sample (S6 200-300) was collected 0.2 to 0.3m bgl representing the underlying natural sand layer (see sampling plan Figure 11)

Figure 11: Soil sampling site plan. Approximate soil sample locations shown in yellow.
