**Kai Iwi Beach – Technical  
Assessment of Community  
Options**

**Prepared for**  
Whanganui District Council

**Prepared by**  
Tonkin & Taylor Ltd

**Date**  
November 2023

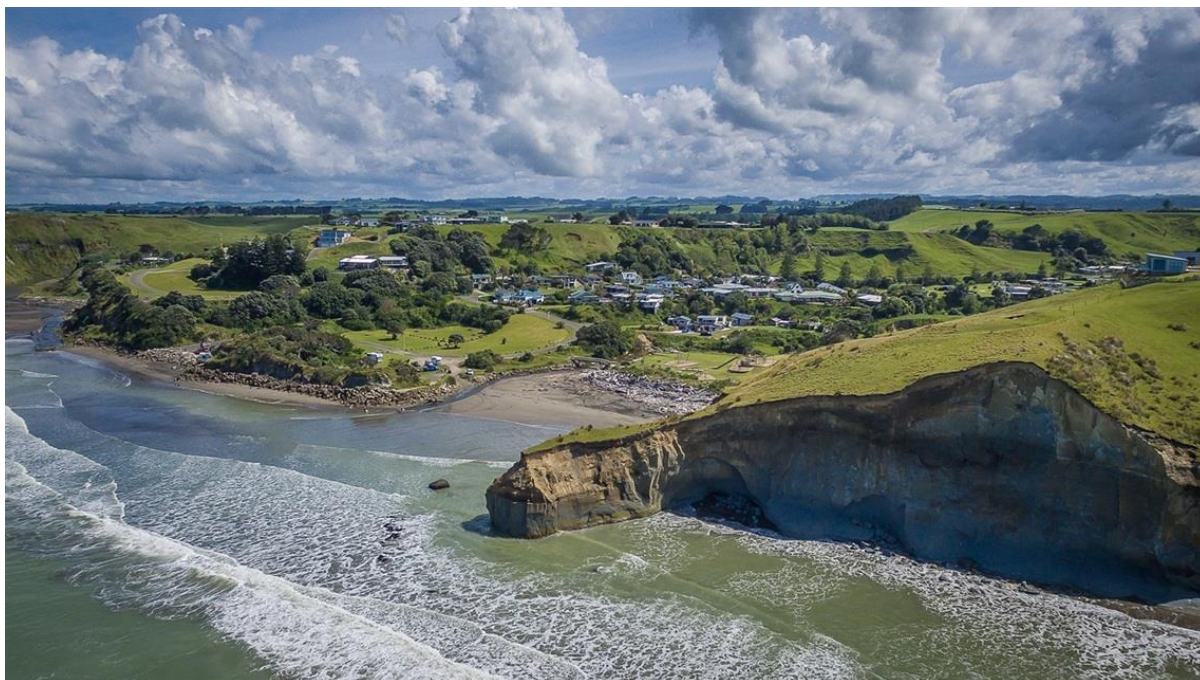
*Photograph 1.1: Aerial view of the Kai Iwi shoreline (Source: WDC, 2022)*

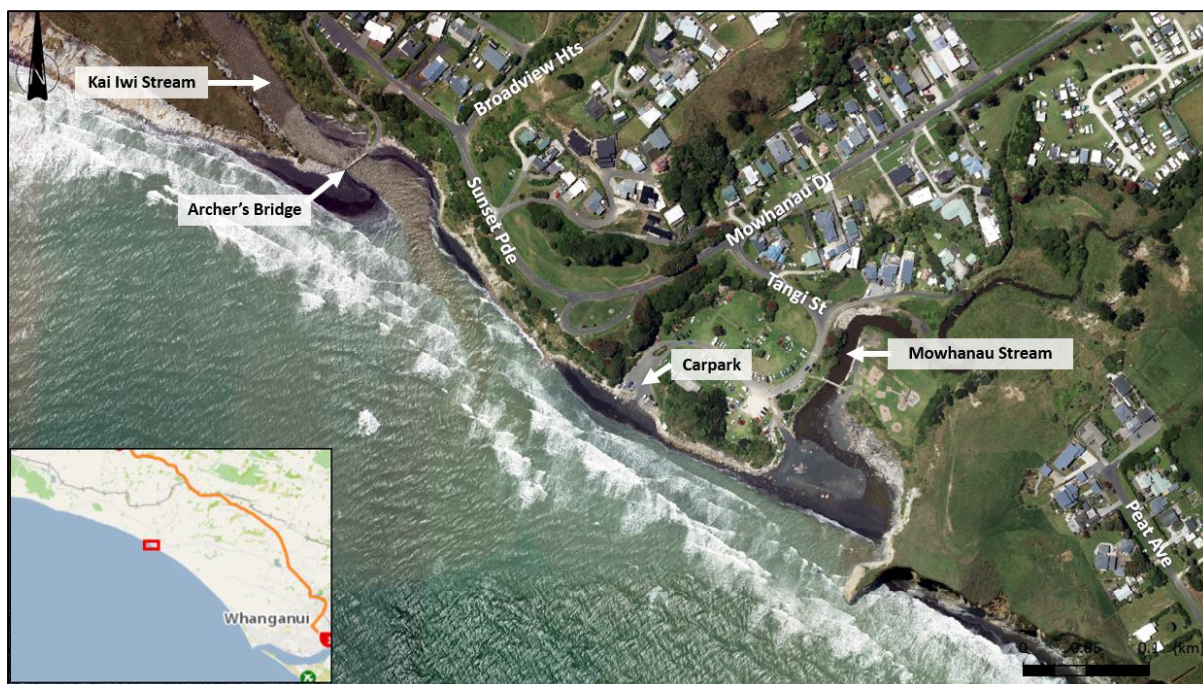
Figure 2.1: Overview of the site at Kai Iwi/Mowhanau Beach overlaid on the 2022 aerial photograph (sourced from LINZ)

At the northern end of the site the current cliff crest is at the seaward edge of Sunset Parade near the Broadview Heights intersection. Properties on the landward side of Sunset Parade are less than 20 m from the cliff edge. Further south, there is some buffer between the edge of the road and the cliff crest, with a grassed area approximately 7 to 10 m wide. However, the loop road and lookout are located at the edge of the current cliff crest. The cliffs transition down to a lower banked area where the beach carpark is located at the edge of the current shoreline.

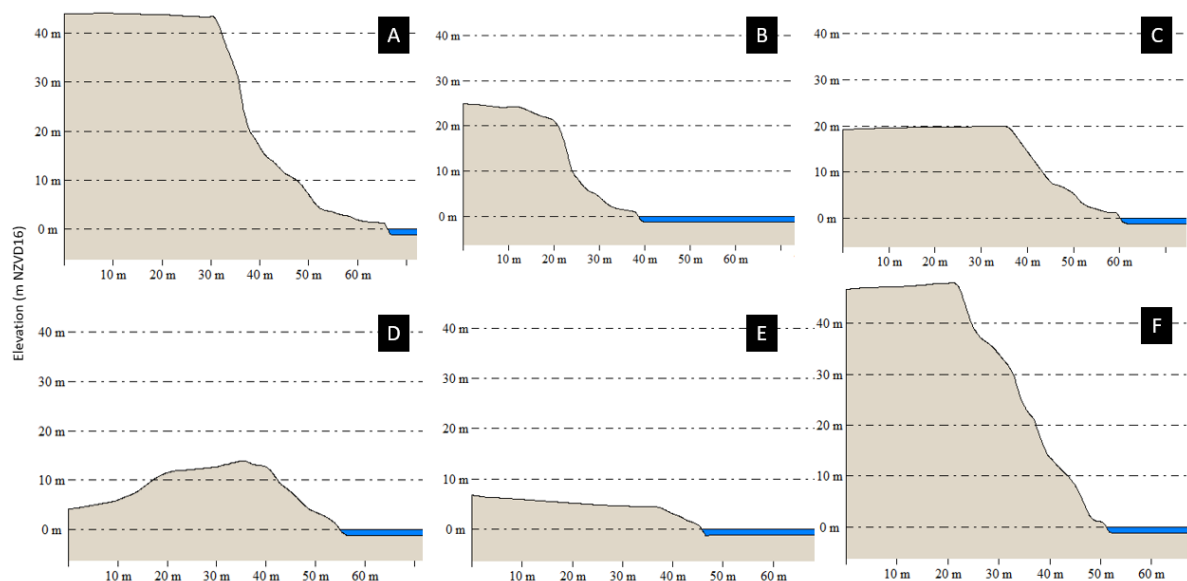
Figure 2.3: Example of cross-section along the Kai Iwi shoreline (locations shown on Figure 3.2)

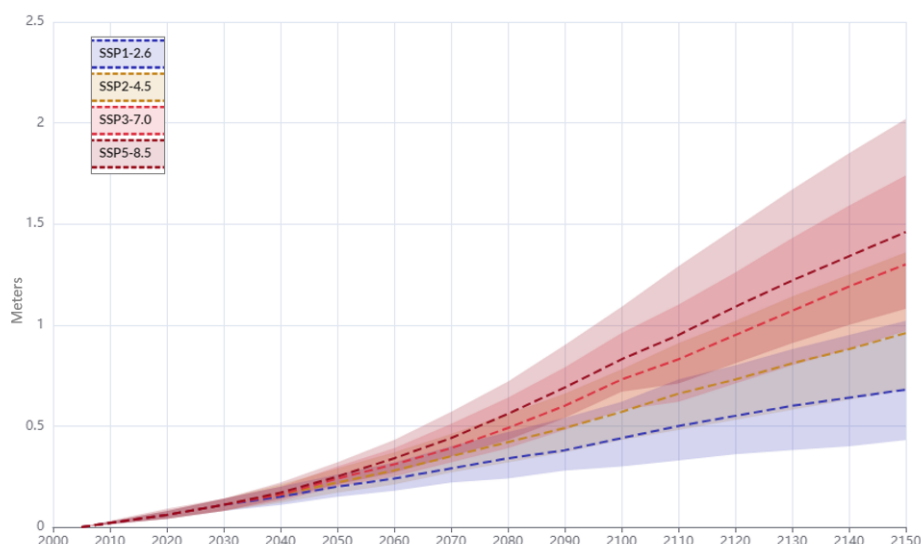
Figure 2.4: Four scenarios of sea-level rise projection for Kai Iwi coast as stipulated by the the MfE 2022 guidance (modified from NZ SeaRise 2023)

Historic sea level rise in New Zealand has averaged  $1.7 \pm 0.1$  mm/year (Hannah and Bell, 2012). Climate change is predicted to accelerate the rate of SLR. The Ministry for the Environment interim SLR guidance recommends using a range of “medium confidence” SLR scenarios to cover a range of predicted future sea levels that reflect the inherent uncertainty. The scenarios are based on the most recent IPCC Assessment Report 6 (IPCC, 2022) (Figure 2.4).

- Low emission scenario (SSP2 - 2.6 median projection).
- Moderate emissions scenario (SSP2 - 4.5 median projection).
- High emissions scenario (SSP3 -7.0 median projection).
- Very high emissions scenario (SSP5 - 8.5 median projection).
- Very high emissions scenario (stress test), based on the (SSP5 -8.5 83<sup>rd</sup> percentile projection).

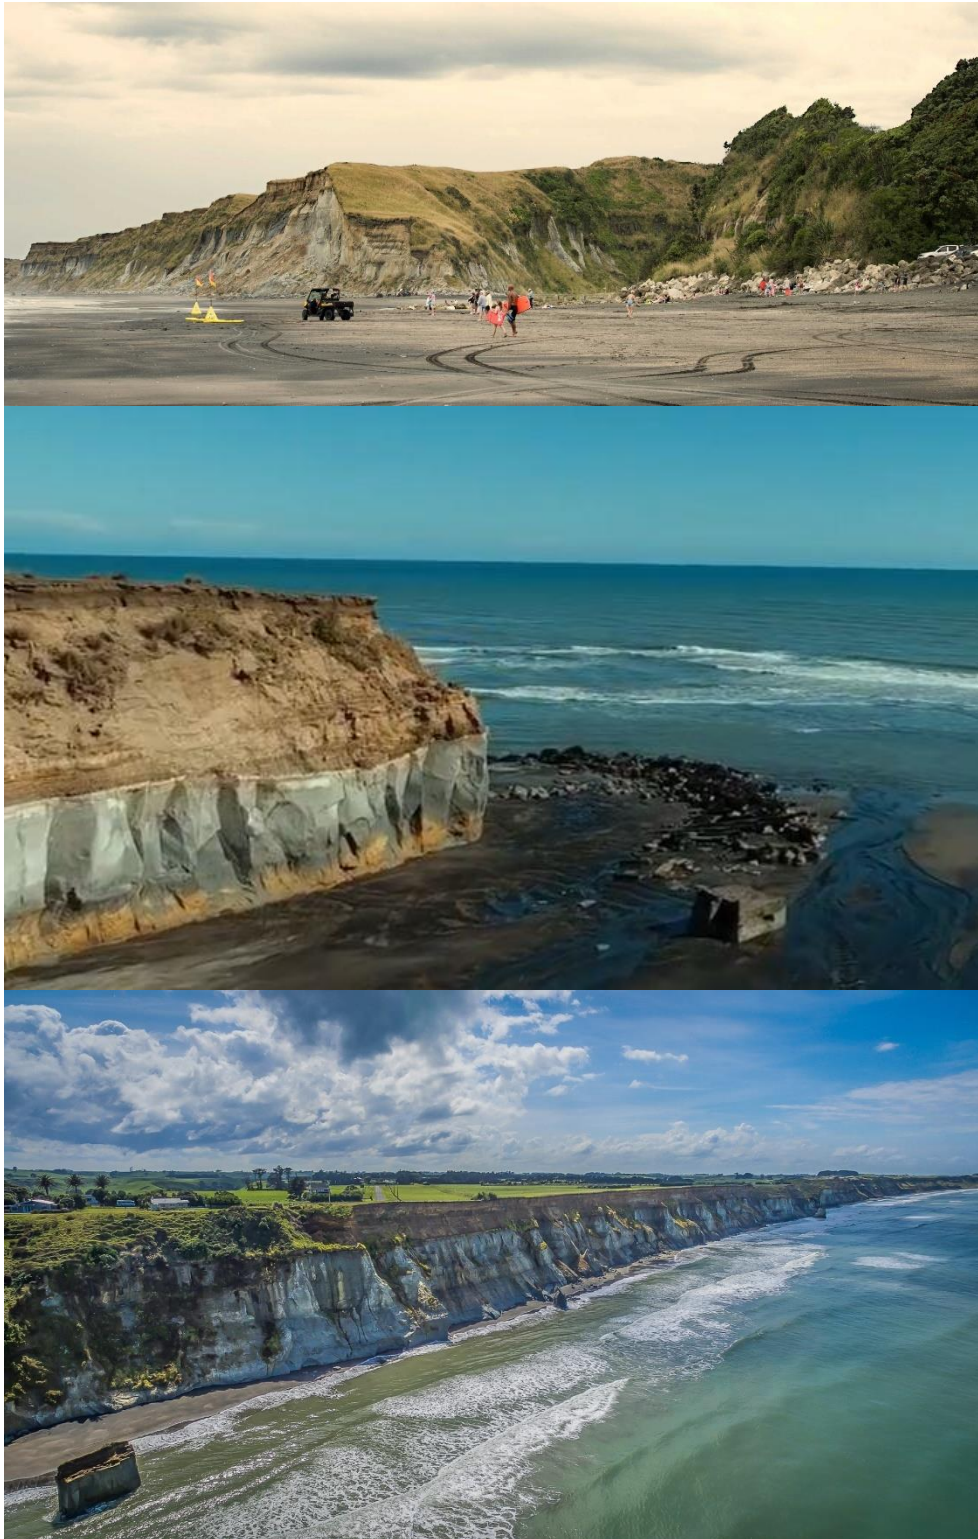
*Photograph 2.2: Cliffs to the north (top), and south (middle and bottom) of Kai Iwi/Mowhanau beach (sourced from NZJane.com and WDC, 2022)*

As described in Atkin et al. (2021), the cliffs at Kai Iwi beach are relatively weak sedimentary cliffs comprising Kaimatira Pumice Sand, overlain by Lower Kai Iwi Siltstone, Lower and Upper Westmere Siltstone, inter dispersed with thin sand and shellbed layers; then the Rapanui Formation, followed by modern sand dunes (Photograph 2.2).

The cliffs along majority of the Whanganui coast, including the Kai Iwi cliffs, tend to be oversteepened with minimal high tide beaches. Local observations indicate sand levels along the beach can fluctuate significantly (Atkin et al. 2021). Gibb (1999) estimated the stable equilibrium slope of the cliffs to be 40°. Most recent LiDAR shows most of the cliffs are sitting at steeper angles (50° to 90°) and are subsequently vulnerable to failure.

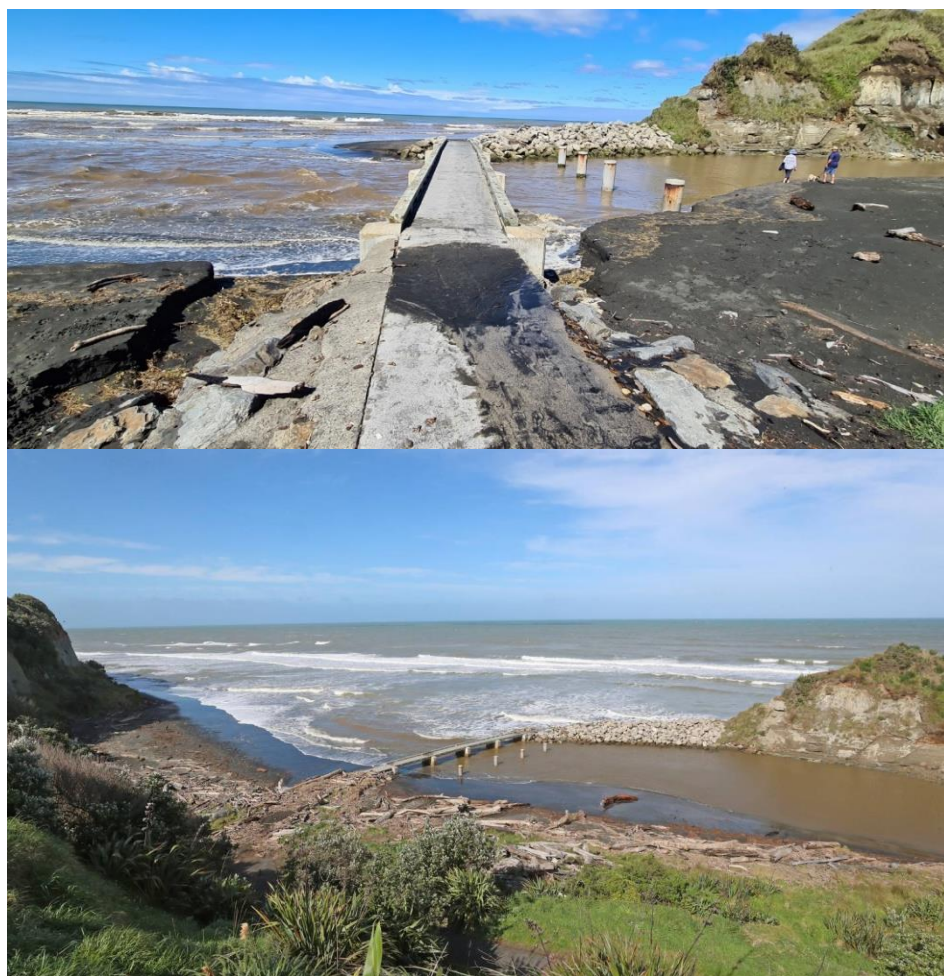
*Photograph 2.3: Archers Bridiget crossing the Kai Iwi Stream mouth with a small rock abutment on the landward side and a low rock breakwater linking the seaward end of the bridge with the cliff (source: Top - WDC, 2022, Lower – Whanganui Chronicle Dec 2021)*

Archer's Bridge crosses the Kai Iwi Stream mouth at the northern end of the site (Photograph 2.3). The bridge has been damaged in the past during storm events. In 2016 rock was placed along the seaward side forming a training wall or breakwater to link the bridge to the eroding headland and avoid outflanking by the river or sea. The intent of this appears to have been to enable pedestrians to reach the beach north of the Kai Iwi Stream.

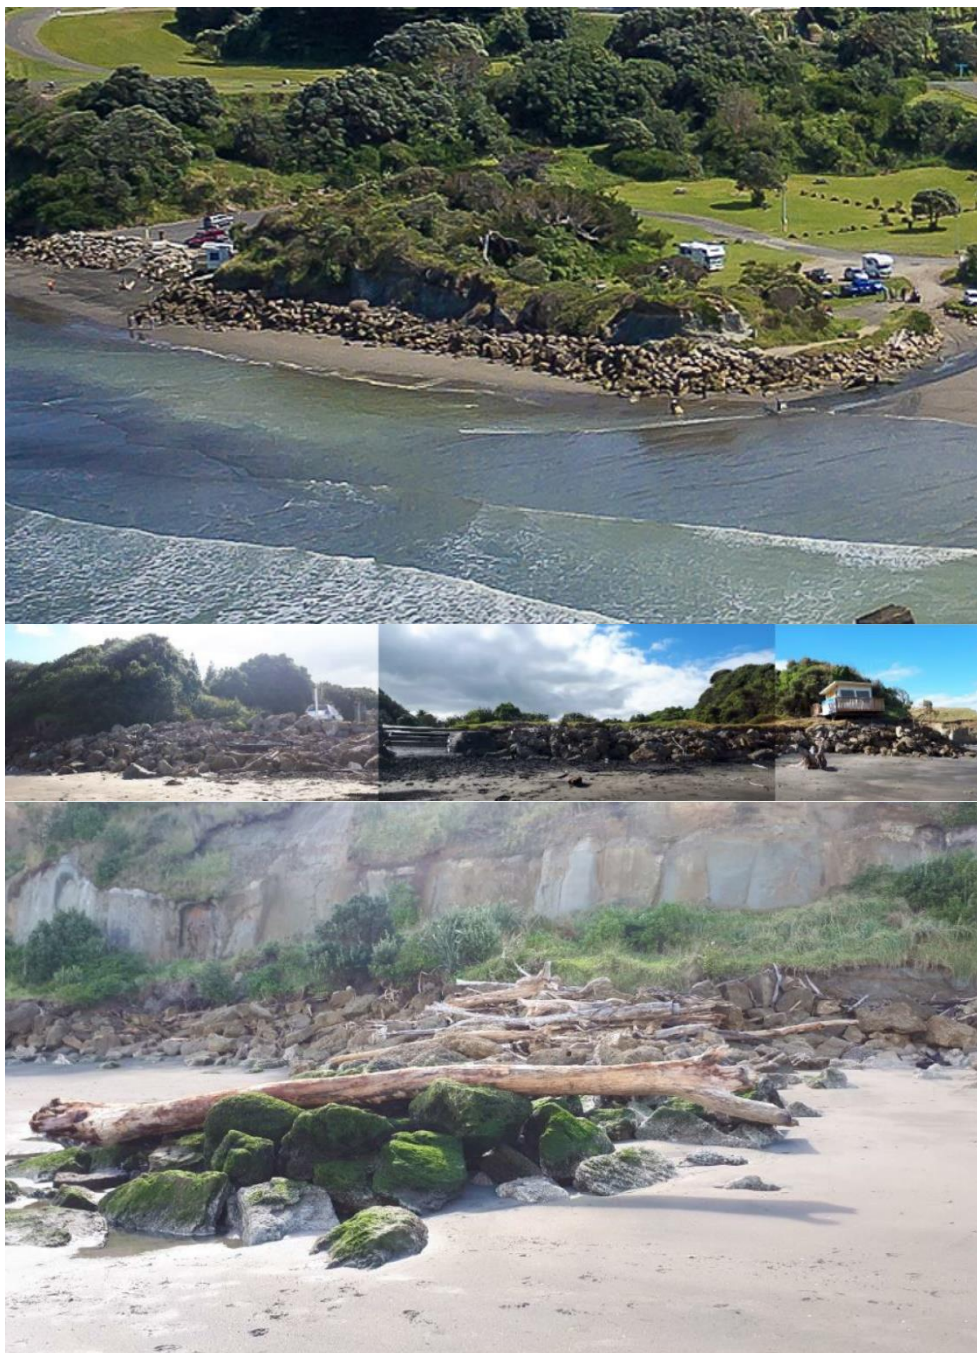
*Photograph 2.4: Existing 'shellrock' revetment running along the toe of the cliff at Kai Iwi Beach and smaller groyne within the revetment (source: Top – WDC, 2022, Middle and Lower – eCoast, 2020)*

Between the Kai Iwi Stream to the north and the Mowhanau Stream to the south, a rock revetment has been constructed along the cliff toe (Photograph 2.4). The initial construction date of this wall was reportedly in the 1980s with semi-annual repairs and top ups (Atkin et al., 2021). The revetment protects the toe of the cliff and lower backshore fronting the car park and surf club from coastal erosion but also from both the Kai Iwi and Mowhanau Streams when they flow along the base of the cliff. A small groyne is located some 220m south of Archer’s Bridge, reportedly to divert flows from the Kai Iwi Stream (Atkin et al., 2021). The revetment wraps around towards the Mowhanau Stream with a slipway that ran from the road to the sand reportedly collapsing in 2017/18 with an emergency repair now covered in sand (Atkin et al., 2021). A bridge crosses Mowhanau Stream some 50 m upstream linking the carpark to the playground.

The revetments have been constructed using local 'shellrock'. This sedimentary rock is formed by consolidation of shells and finer sediments and is well distributed around the Whanganui District, particularly in the Nukumarū and Kaiwhaiki regions. The rock varies in hardness and density depending on its source, but is generally lighter (2.4 - 2.5 t/m<sup>3</sup>) than volcanic rock that is typically used in coastal armouring (i.e. andesite or basalt at 2.6 to 2.8 t/m<sup>3</sup>) with higher water absorption and weathering characteristics. However, better shellrock can be resilient in the coastal environment with both the north and south Whanganui Moles being originally constructed of shellrock between 100 and 130 years ago.

The revetments do not show evidence of a geotextile layer, generally incorporated to prevent fine materials from migrating through the armour rock, or smaller underlayer materials used as a filter. It must therefore be concluded that the revetment is an informal structure placed and repaired as required using available rock. No information on toe depth is available with the LiDAR showing the beach level at the toe of the revetment to be around 1.2m RL (approximately MHWS). The beach level is reported to fluctuate so the toe likely extends 1-2m below this level. The crest level appears to be at around 4.5m RL based on LiDAR (around 3.5m above MHWS), though like varies along the structure. The slope of the structure is steep, around 1(H):1(V) based on LiDAR which likely contributes to instability and overtopping. Some damage to the backshore and loss of vegetation is apparently along the top of the revetment, particularly at its southern end indicating wave overtopping may occur reasonably frequently.

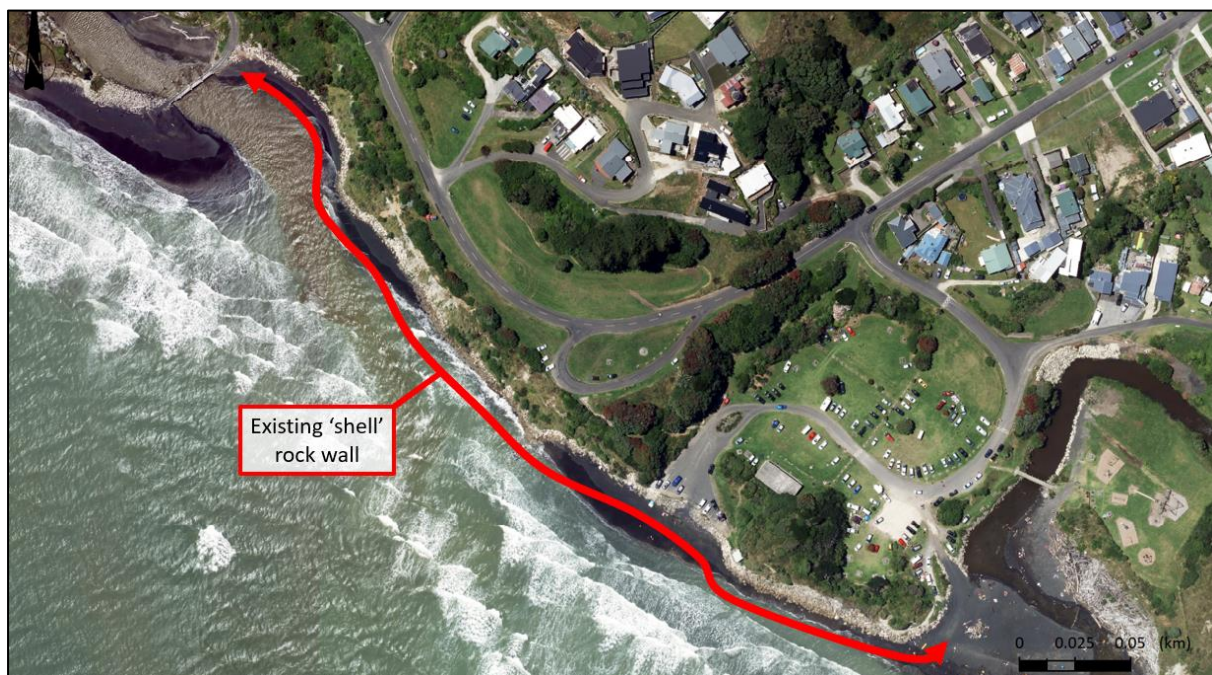
Figure 3.1: Extent of existing 'shell rock' revetment wall between the Kai Iwi and Mowhanau stream mouths

This option would remove part or all of the existing 'shell rock' revetment which extends along the cliff toe between the Kai Iwi Stream mouth and the Mowhanau Stream mouth. This would require mechanical plant to access the beach (likely from the Mowhanau Stream end) to remove rock and any other construction debris located beneath the rock from the coastal environment. This rock could be re-used elsewhere or disposed of at a clean fill site.

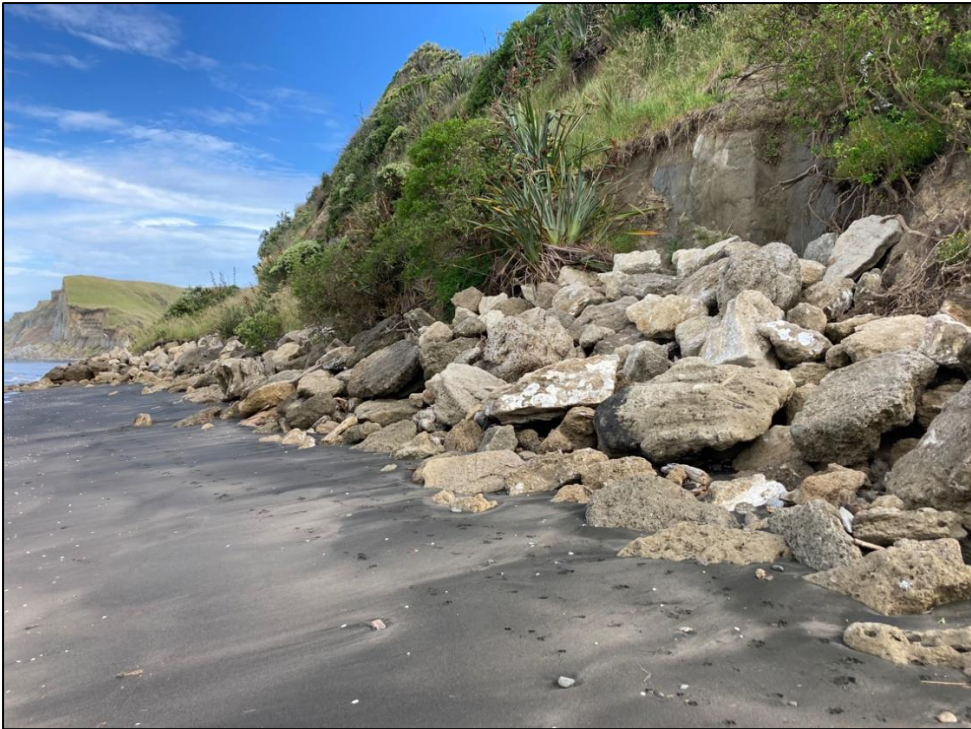
*Photograph 3.5: Existing 'shell rock' revetment between the Kai Iwi and Mowhanau stream mouths*

Maintenance of the existing 'shell rock' revetment would involve leaving the existing structure in place and adding rock as it is lost or abraded during wave events. There is also potential to increase the height of the rock wall over time, particularly if the cliff and backshore begin to be damaged by wave overtopping and to extend the length if the wall starts to become outflanked or increase rock sizing to limit damage. Note that placing rock on top of the existing structure will only be feasible for some locations where the existing profile accommodates this.

The existing 'shell' rock is relatively light and more susceptible to weathering and abrasion compared to commonly used armour rock materials (i.e., basalt, andesite or dolomite) and therefore is likely to be more easily moved and damaged by waves. Maintenance works replace these displaced rocks, though erosion can occur between when damage occurs, and maintenance is undertaken. Subsequently, this option is likely to only be effective for 15 – 30 years before water levels and wave climate increase to a point of causing damage to the structure more frequently than is feasible to repair. It must be acknowledged with this option, however, that major damage requiring a substantial re-build could occur at any time.

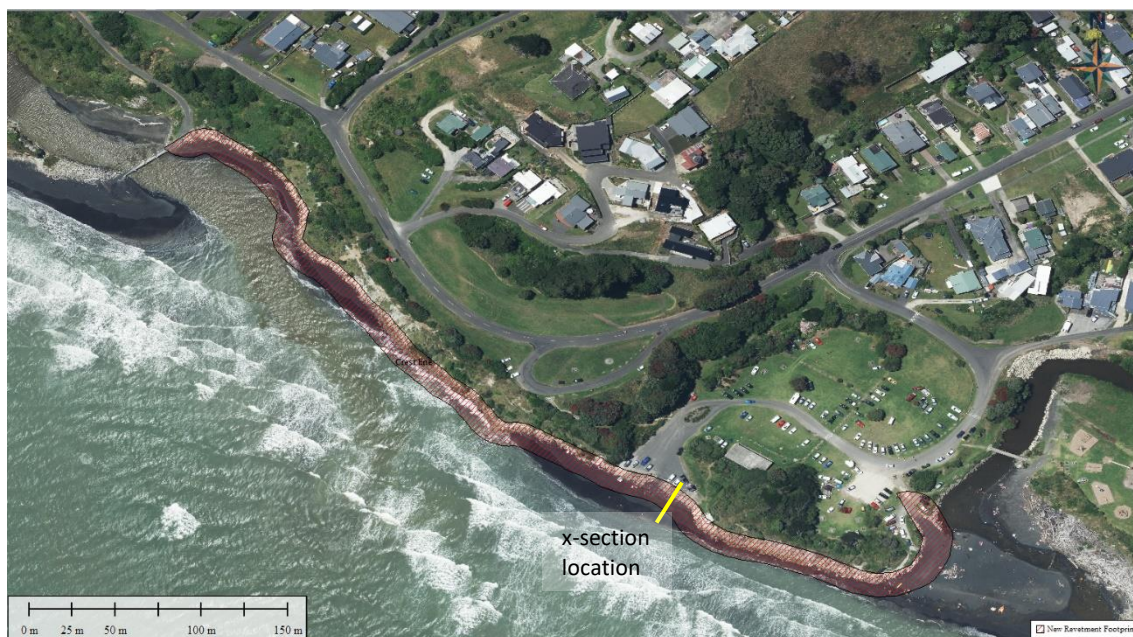
Figure 3.2: Indicative plan and cross section for new rock revetment

The existing structure could be removed and replaced with an engineered rock revetment. Rock revetments typically comprise a geotextile fabric to prevent the loss of finer sediments through the structure, an underlayer or secondary armour layer of smaller rock and a double layer of primary armour rock sized to withstand the local wave climate. The toe should be designed by below potential scour levels or able to accommodate scour and the crest should be sufficiently high to reduce overtopping to tolerable levels.

- Design life: 50 years.
- Design event: 1 % AEP (or 1 % likelihood of being exceeded in any one year).
- Sea level rise scenario: RCP8.5 (high end scenario).
- Damage:  $S = 2$  (start of damage).
- Tolerable overtopping (10 l/s/m – start of damage of unprotected slopes).
- Slope: 1(V):1.5(H).
- Rock density: 2700kg/m<sup>3</sup> (assuming andesite or similar rock).

Design based on these parameters and using methods set out in CIRIA (2007) and Eurotop (2018) results in a median primary armour rock size of 3T (range 1.2 – 7T), with a total structure height of 6 m and width of 12 m (Figure 3.2). These are relatively conservative design parameters resulting in a structure that is significantly larger (higher and wider) than currently existing. The design parameters and resultant structure geometry and sizing may be further refined during future design stages along with consideration of crest and toe detail to ensure damage due to wave overtopping and toe scour is managed.

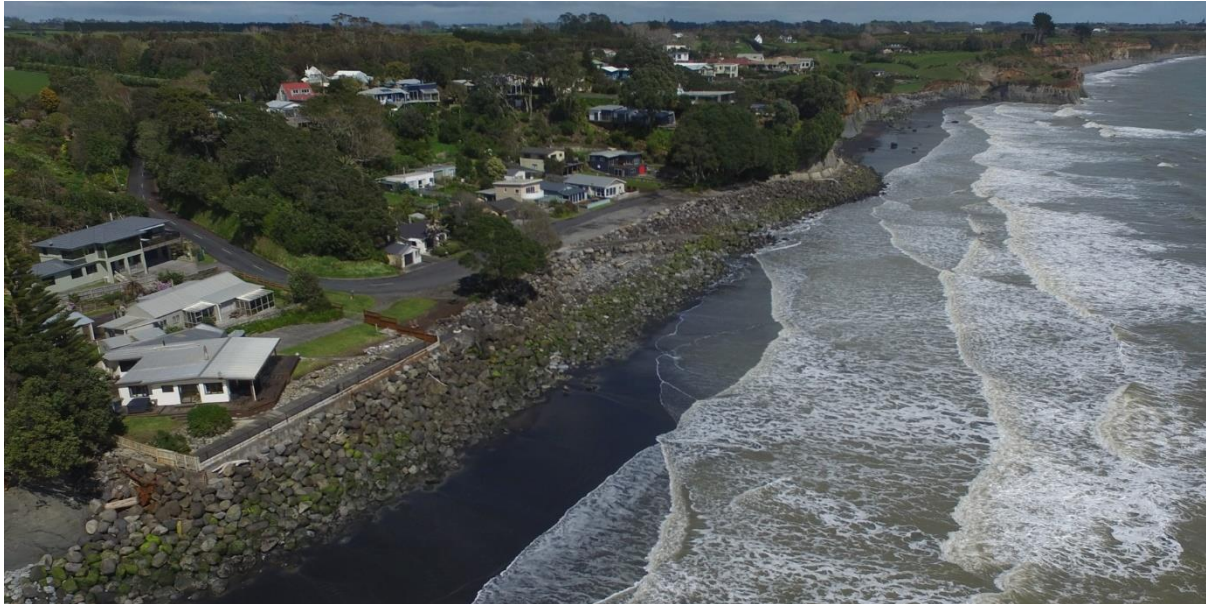
*Photograph 3.6: Example of a rock revetment along the cliff shoreline at Onaero, Taranaki protecting a low backshore and carpark in the foreground and cliff headland in the middle of the beach while the cliff adjacent to the wall (top of photo) continues to retreat*

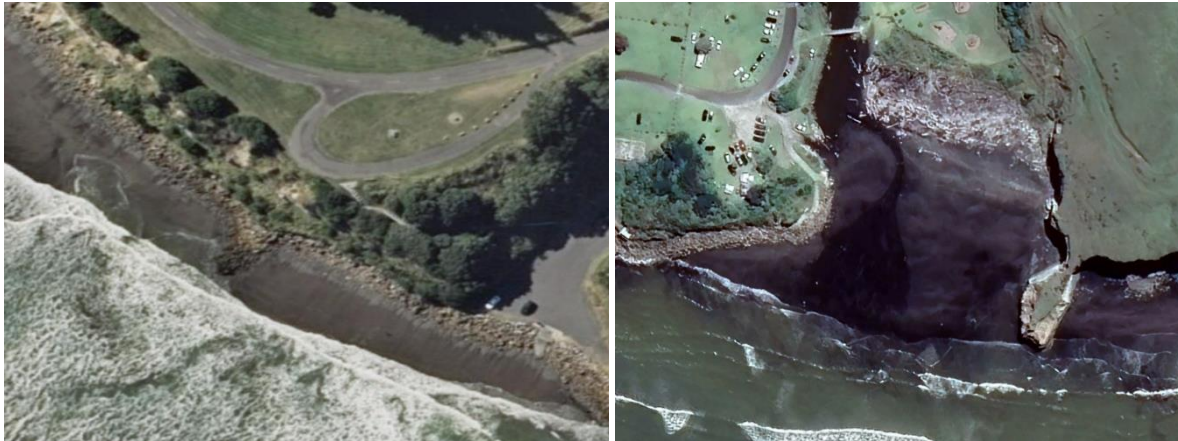
*Photograph 3.7: Examples of an existing manmade (left) groyne at Kai Iwi with no appreciable sand accumulation on the updrift (north) side evident and a pocket beach (Mowhanau Beach) adjacent to a natural headland (right)*

Short, upper beach groynes are not likely to be effective in trapping sand in this environment due to the very low beach slope with most alongshore sediment transport occurring in the nearshore bar and channel system rather than the upper beach (which essentially does not exist in this environment). This is evidenced by the existing groyne located in the middle of the existing revetment which shows no evidence of sediment accumulation on the updrift (northern) side (though it is noted that the intent of this groyne was to divert flows from the Kai Iwi Stream, Atkin et al., 2021).

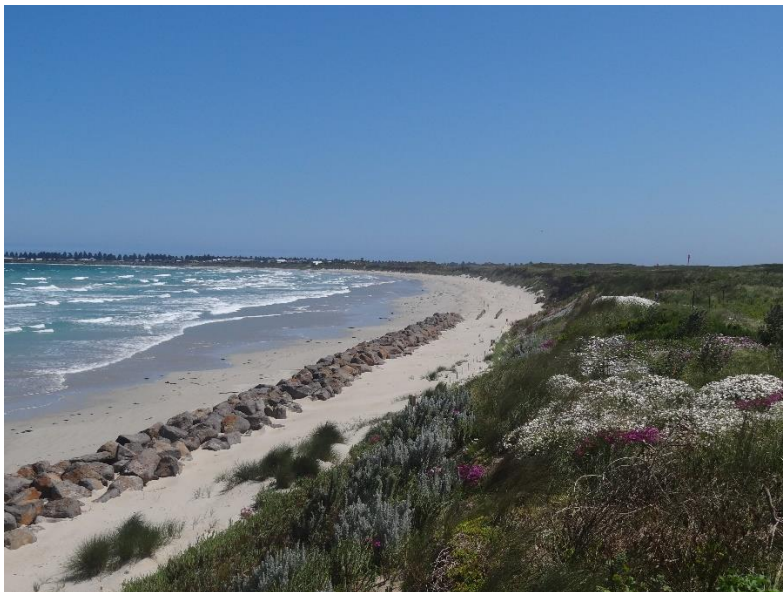
*Photograph 3.8: Example of a rock sill on an open coast beach at Port Fairy, Vic (source: T+T)*

A rock sill typically comprises a low-crested rock structure located along the foreshore with the intent of trapping sediment behind. It often is combined with vegetation to help bind the trapped sediment. Rock sills can be effective in sheltered estuarine or reef-top environments or where sediment volumes are high, and structures can be located high on the beach. However, it is unlikely to be effective along the Kai Iwi shoreline where the tidal range is large, there is moderate wave energy and sand levels are low. The rock sill would easily be overtopped by waves during high tides and sediment would likely to be washed out from behind the structure. A rock sill may potentially slow the rate of erosion through reducing the rate at which debris is lost after a landslide, however, it is not likely to make a notable difference to erosion in the long-term.
