GEOCIVIL
CONSULTING ENGINEERS LTD

Turoa Road Flood Mitigation Options

For Whanganui District Council

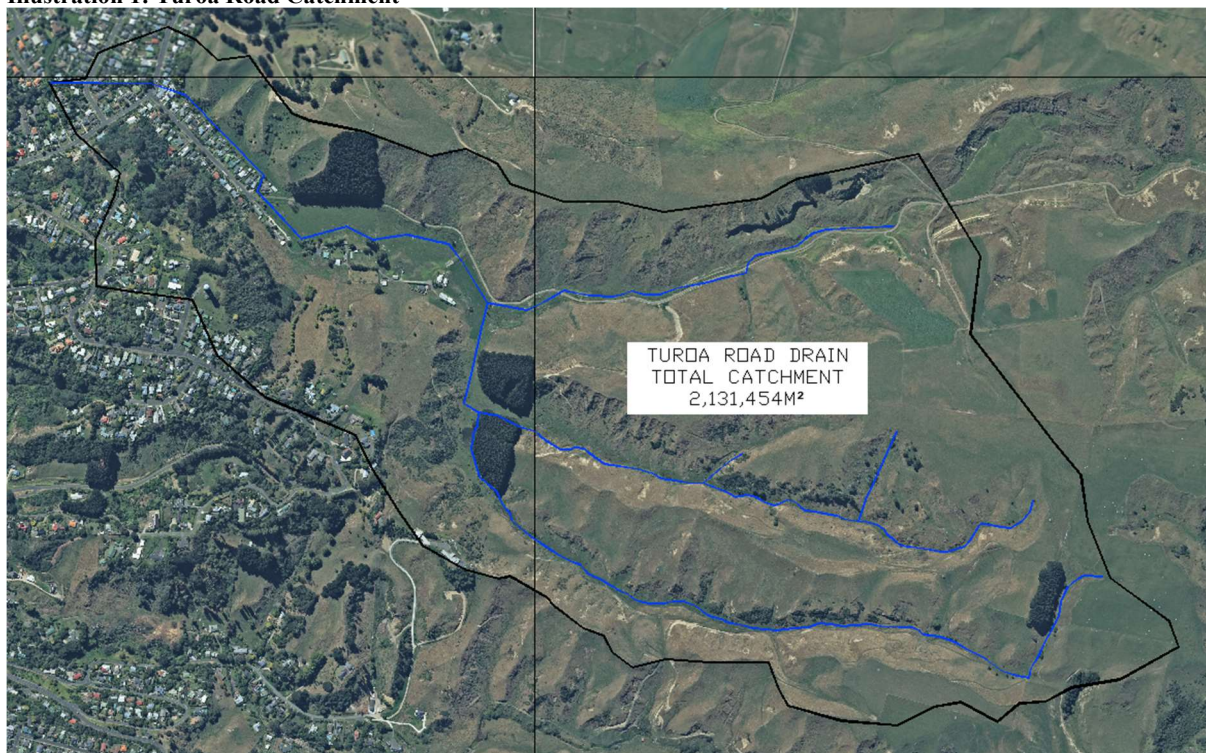
Illustration 1: Turoa Road Catchment

The Turoa Road Drain catchment covers an area of 2.1 km², the central and eastern side of the catchment is predominantly farm land. The western side of the catchment is predominantly urban and includes a small urban area of Bastia Hill bounded by Mount View Road and Bastia Avenue, Turoa Road and the southern end of Raine Street. Refer to Illustration 1 for the Turoa Road catchment.

The drain within the farm land now reduces in depth to 0.5 m. Approximately 500 m upstream from entering this farm land is an existing detention dam approximately 3 m high. The dams primary outflow is a 600 mm diameter pipe with headwalls and secondary outflow is a concrete spillway, both outflows are functional. Anecdotal evidence indicates the regional council at the time built the dam to reduce the risk of flooding along Turoa Road, Ikitara Road and Raine Street. The drain upstream further divides into three gullies that leads into the top of the Turoa Road Drain catchment as shown in Illustration 1.

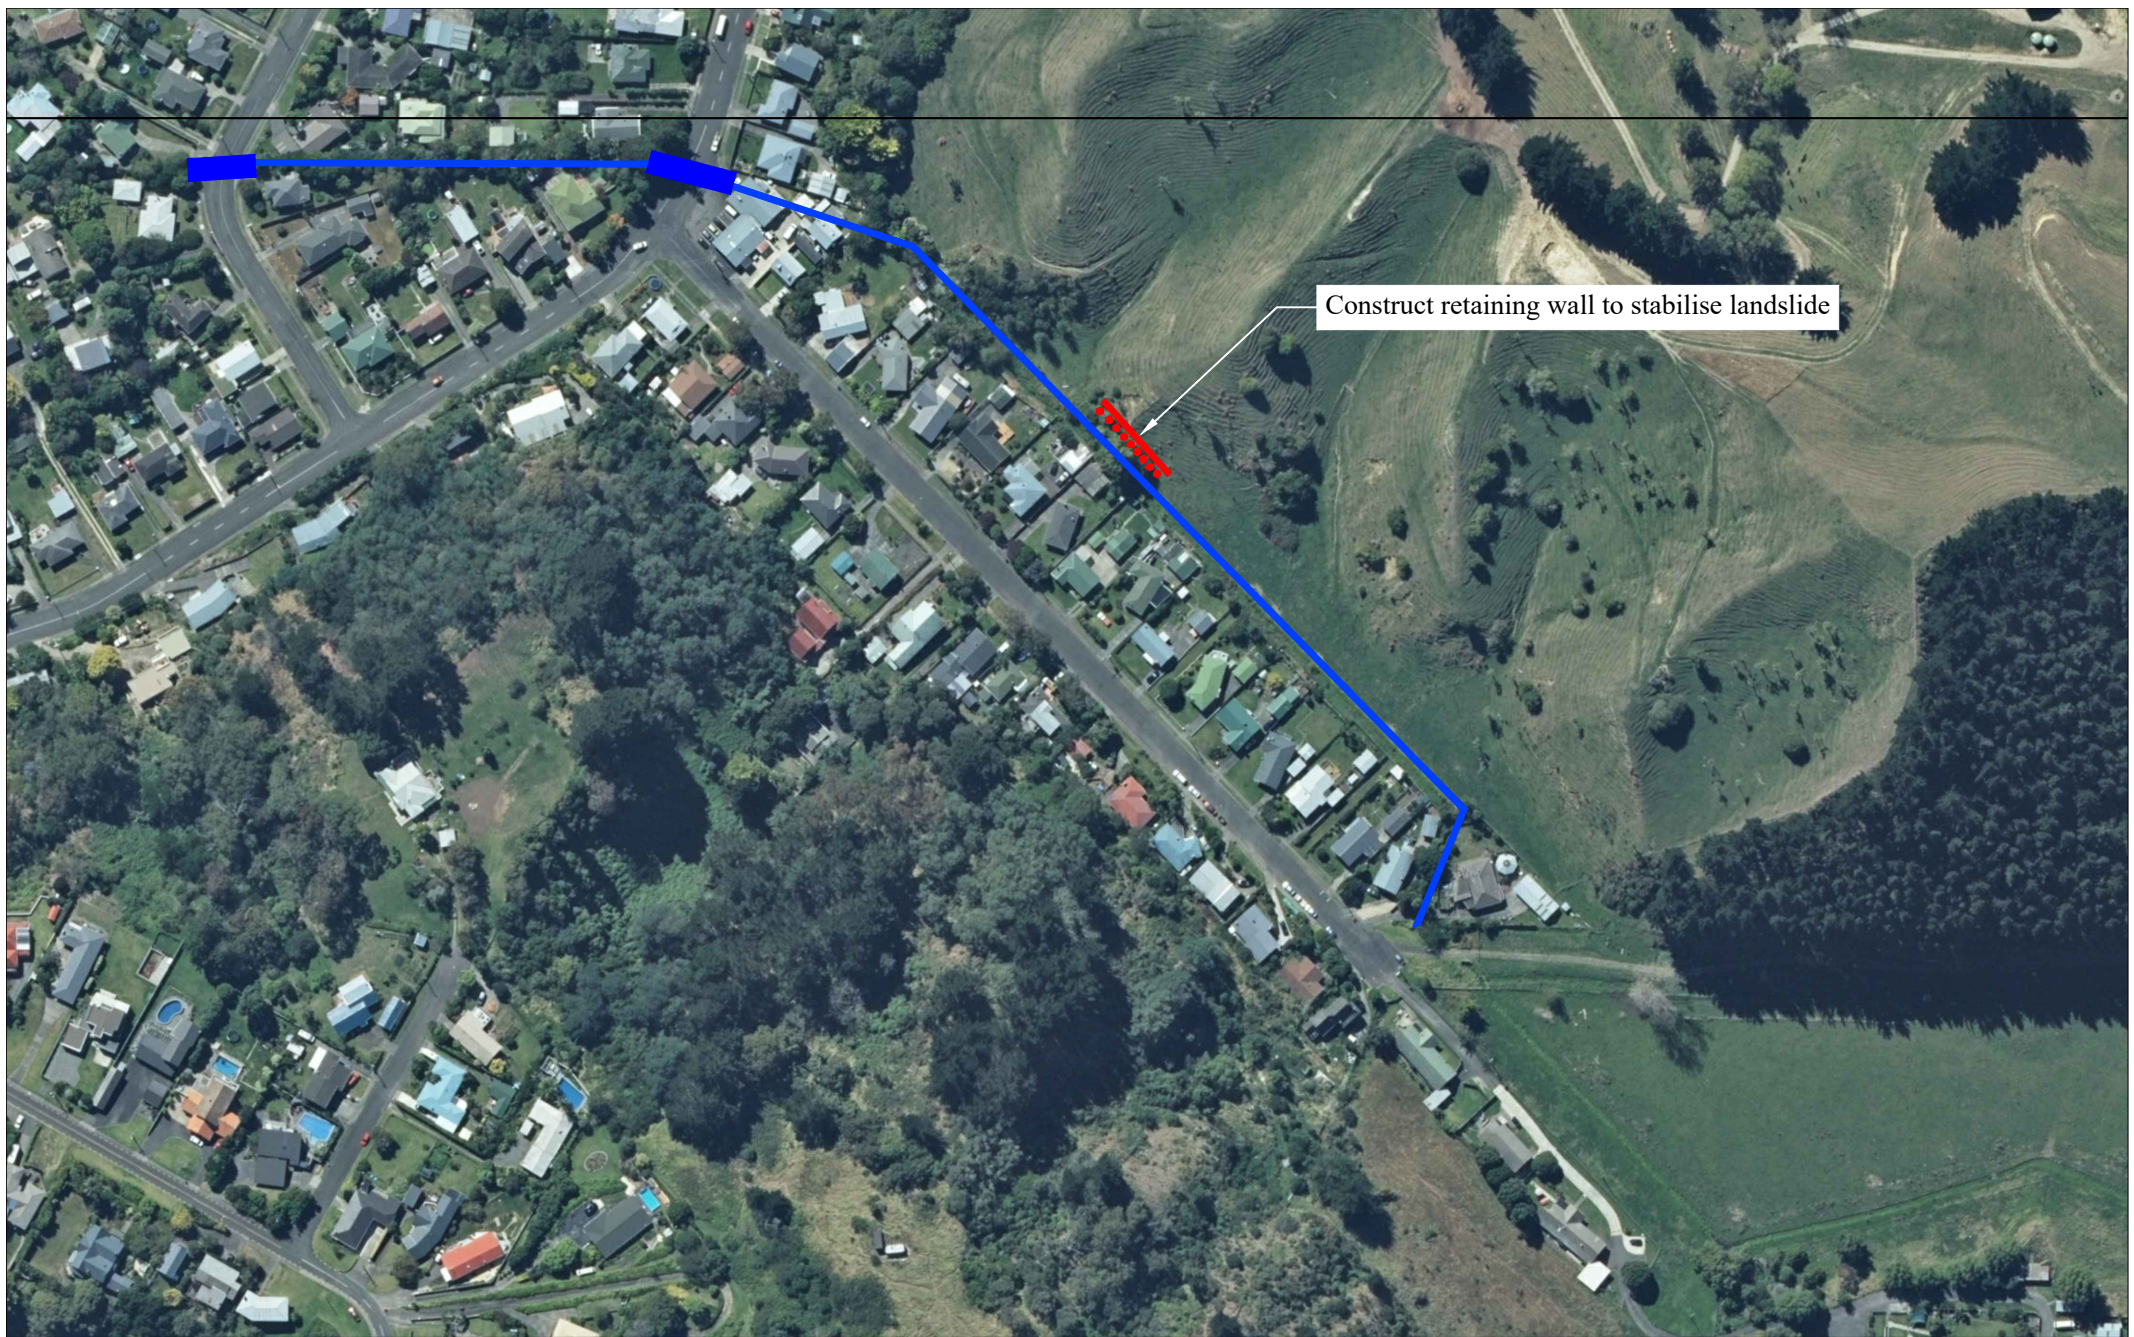
Figure 1
Project Number: 23-033

Option 1 - Construct Retaining Wall to Stabilise Slip
Scale 1:2500 (A4)

Option	Scope of Work	System Capacity	Advantages	Disadvantages	Estimate Costs (Excl GST)	Assumptions
1. Stabilise landslide adjacent 9 Turoa Road	<ul style="list-style-type: none"> Construct two retaining walls to stabilise slip Form access track through slip 	1 in 1 year storm event.	<ul style="list-style-type: none"> Landslide cannot block drain as in previous flood events. Retaining wall through landslide provides access track for future maintenance. 	<ul style="list-style-type: none"> Ongoing maintenance of retaining wall. 	\$200,000 – \$250,000	Access is over 21 Turoa Road
2. Clean drain out on 21 and 37 Turoa Road	<ul style="list-style-type: none"> Clear drain twice annually 	1 in 1 year storm event.	<ul style="list-style-type: none"> Cleared drain 		Initial clearance \$10,000 – 15,000 Ongoing annual cost \$4000 – \$6000	Can access private property

In the short term Option 1, to stabilise the landslide, is considered to have the greatest Level of Service on the drain by eliminating the risk of blockage. The second most effective option is a regular drain clearing program.

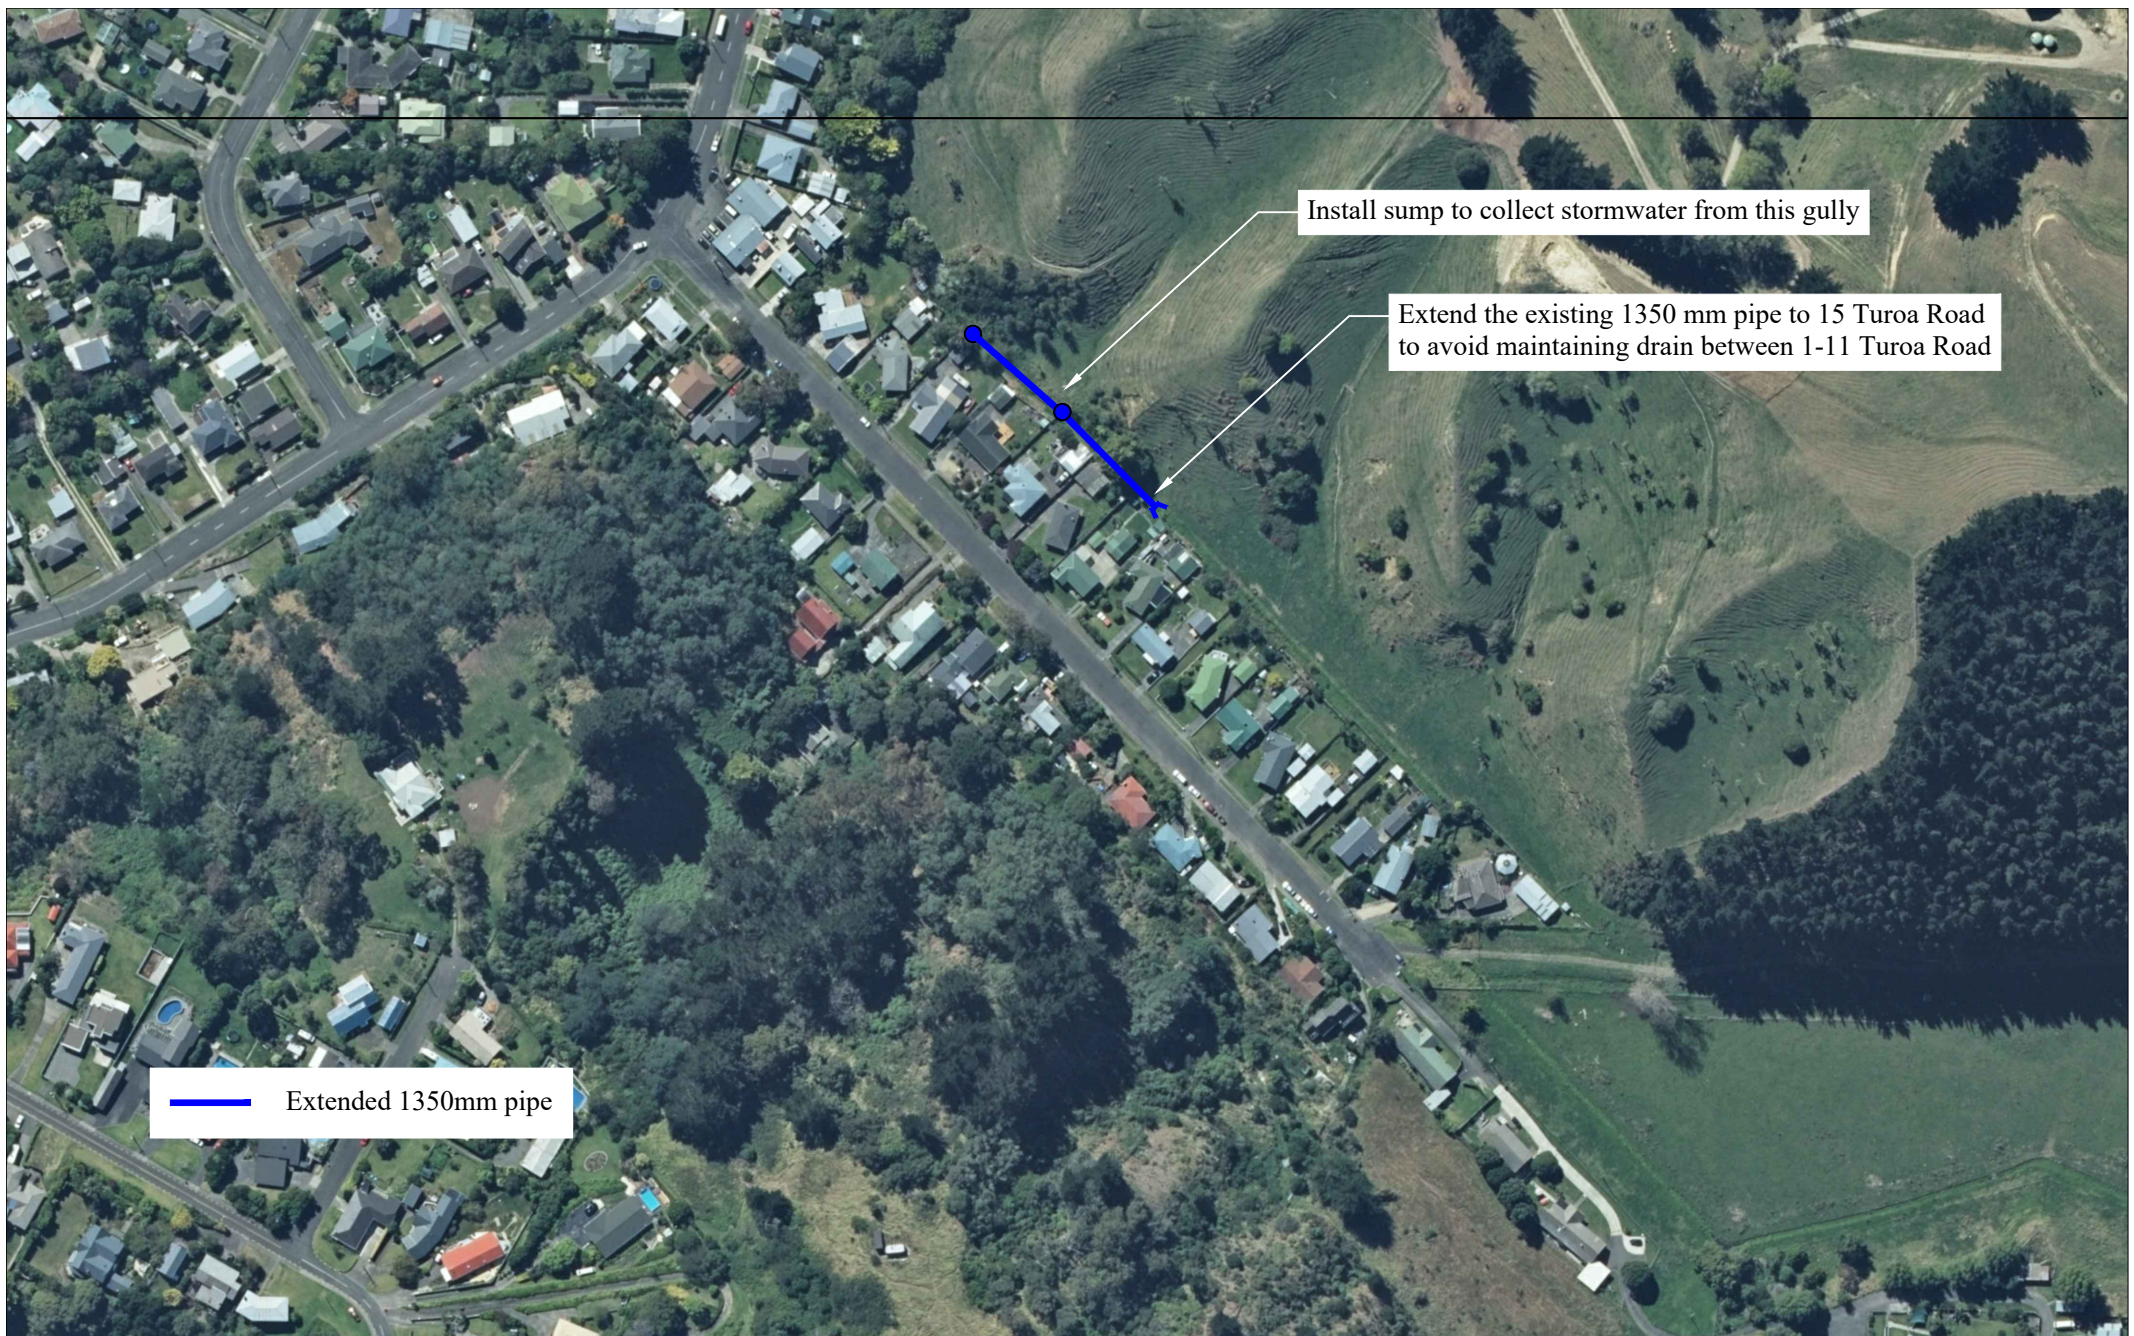
Figure 2
Project Number: 23-033

Option 3 - Partially Extend Pipe to 15 Turoa Road
Scale 1:2500 (A4)

5. Partially extend pipe to 15 Turoa Road.	Lay a 1350mm pipe to the back of 15 Turoa Road.	1 in 1 year storm event.	The farmer can more easily maintain the remaining drain on his farm.	<ul style="list-style-type: none"> Stormwater system capacity approximately has a 1 in 1 year return period. Ongoing maintenance required to drain. Issue maintaining drain on 37 Turoa Road. 	\$150,000 – \$210,000	No retaining wall needed to lay 1350mm dia. pipe.

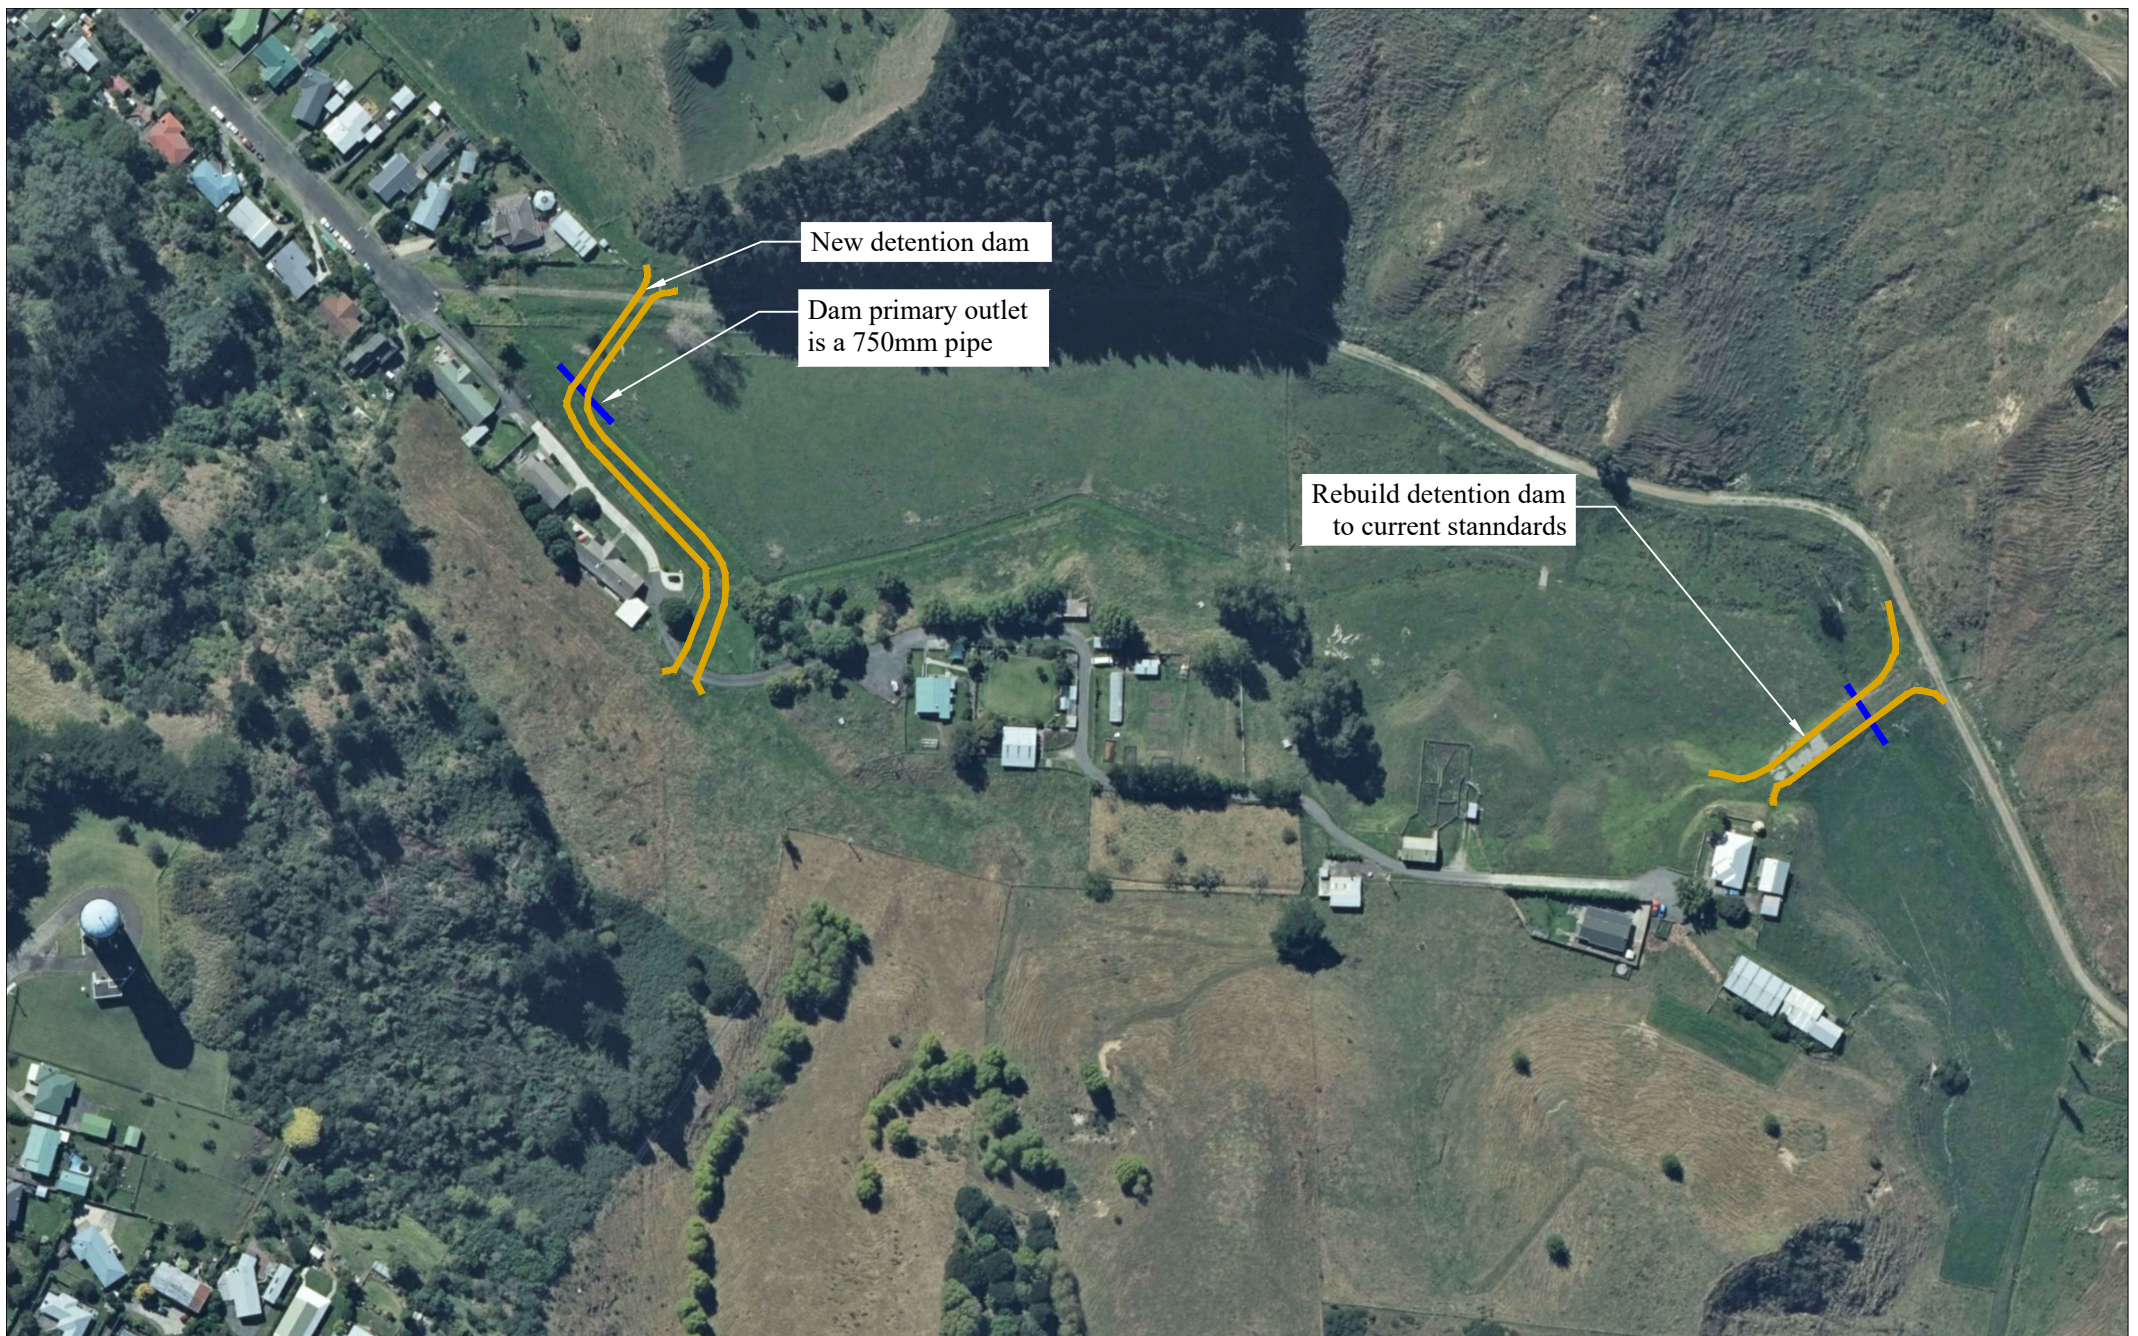
Figure 3
Project Number: 23-033

Option 4 - Detention Dam End of Turoa Road
Scale 1:2500 (A4)

7. Construct a detention dam at the end of Turoa Road on farm land	Construct a new 2 m high earth dam across Turoa Road gully and existing dam is undercut and upgraded.	1 in 100 year storm event.	Can hold up to a 1 in 100 year storm event. Will reduce the peak flow into the Matarawa Stream by 70%.	<ul style="list-style-type: none"> Need to purchase farm land or obtain rights to use land for stormwater detention. Need to rebuild existing dam. In the event the dams primary system is blocked or is overtopped in a 1 in 100 year RP storm, the primary flow path and spillway's peak flow is 1.2m³/sec. This flow of water should be contained with a maintained drain. Ongoing maintenance required to drain. 	\$1.1 – \$1.3 million	Borrow site is within 5 km of dam. Property purchase is estimated at \$400k.

Option 7, constructing two detention dams, is the recommended options because it cost the least to achieve the minimum capacity for a modern stormwater system and causes the least affect to residents on Turoa Road.

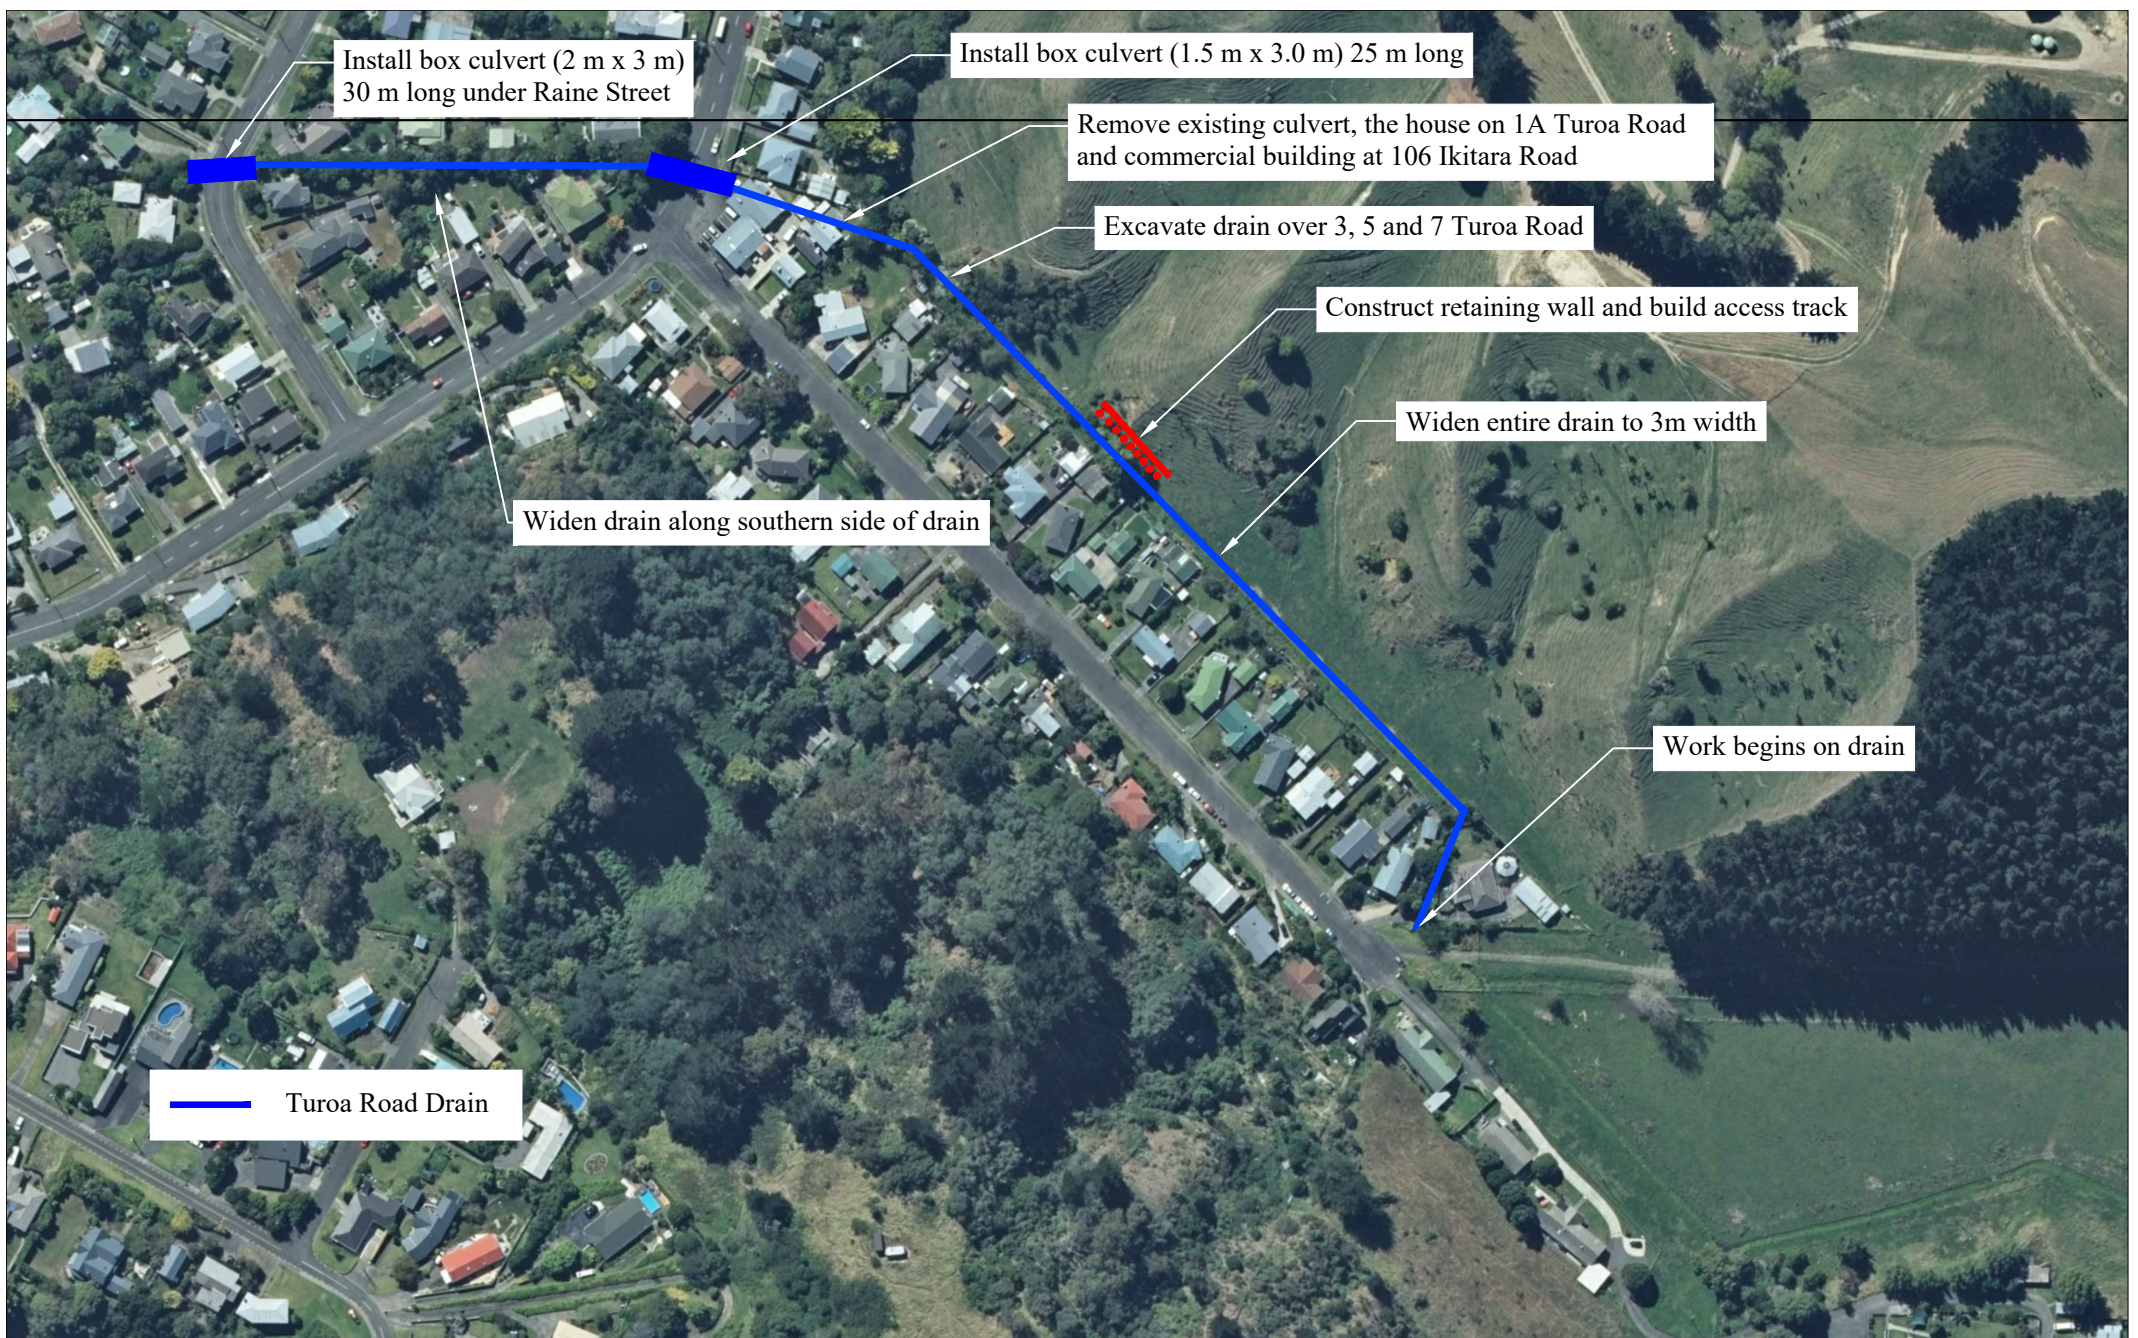
Figure 4
 Project Number: 23-033

Option 5 - Widen Drain and Increase Size of Culverts
 Scale 1:2500 (A4)

Option	Scope of Work	System Capacity	Advantages	Disadvantages	Estimate Costs (Excl GST)	Assumptions
3. Widen Turoa Road Drain and increase culverts size	<ul style="list-style-type: none"> Widen drain to 3m width along Turoa Road. Remove existing 1350mm pipe. Excavate drain through the back yards of 3, 5 & 7 Turoa Road. Remove house at 1A Turoa Road Remove half of the building on 106 Ikitara Road Widen drain to 3 m width between Ikitara Road and Raine Street. Build box culverts under Ikitara Road and Raine Street. 	1 in 100 year storm event.	Can meet a modern SW standard.	<ul style="list-style-type: none"> Need to take approx. 3m wide strip of 3, 5, 7 Turoa Road backyard. Move house off 1A Turoa Road. Remove half of the commercial building on 106 Ikitara Road. Ongoing maintenance required to drain. 	\$1.4 – \$1.8 million	Dump site is within 5 km.

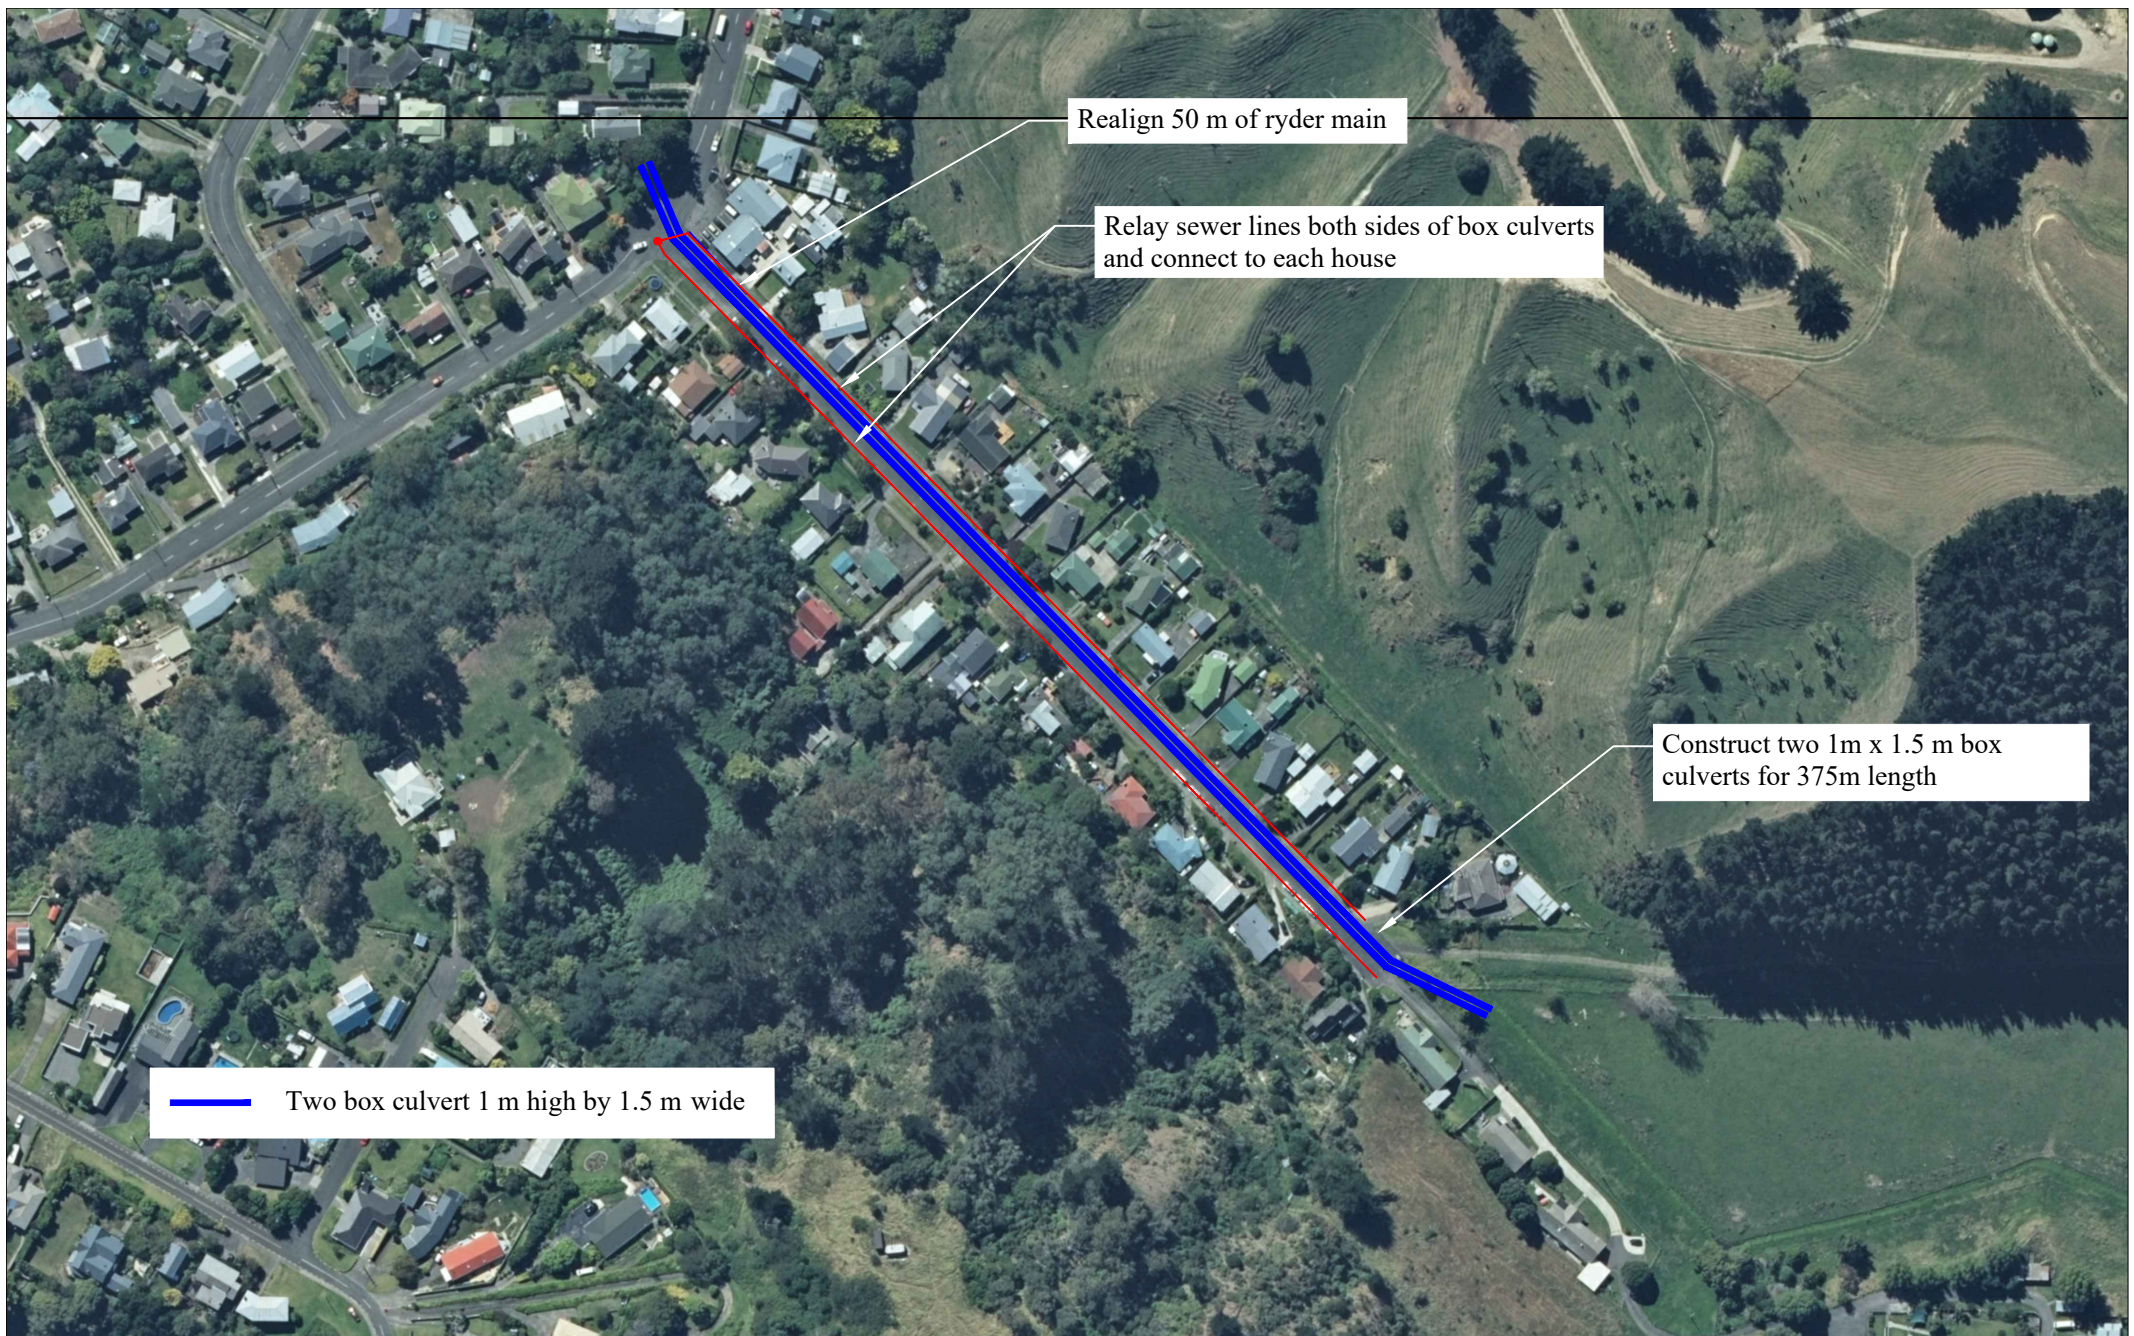
Figure 5
Project Number: 23-033

Option 6 - Construct a Large Overflow Pipe along Turoa Road
Scale 1:2500 (A4)

8. A large overflow box culvert along Turoa Road.	Construct new two sewer lines along Turoa Road and reconnect houses on both sides of street. Realign 40m of water supply line. Install two box culverts (1 m high x 2 m wide).	1 in 100 year storm event.	Can meet a modern SW standard.	<ul style="list-style-type: none"> Silt will build up along the length of the box culverts. This will become an expensive maintenance cost. Traffic disruption on Turoa Road for approximately one year. Relay sewer line along both sides of box culvert. Ongoing maintenance required to drain. 	\$4.3 - \$5.6 million

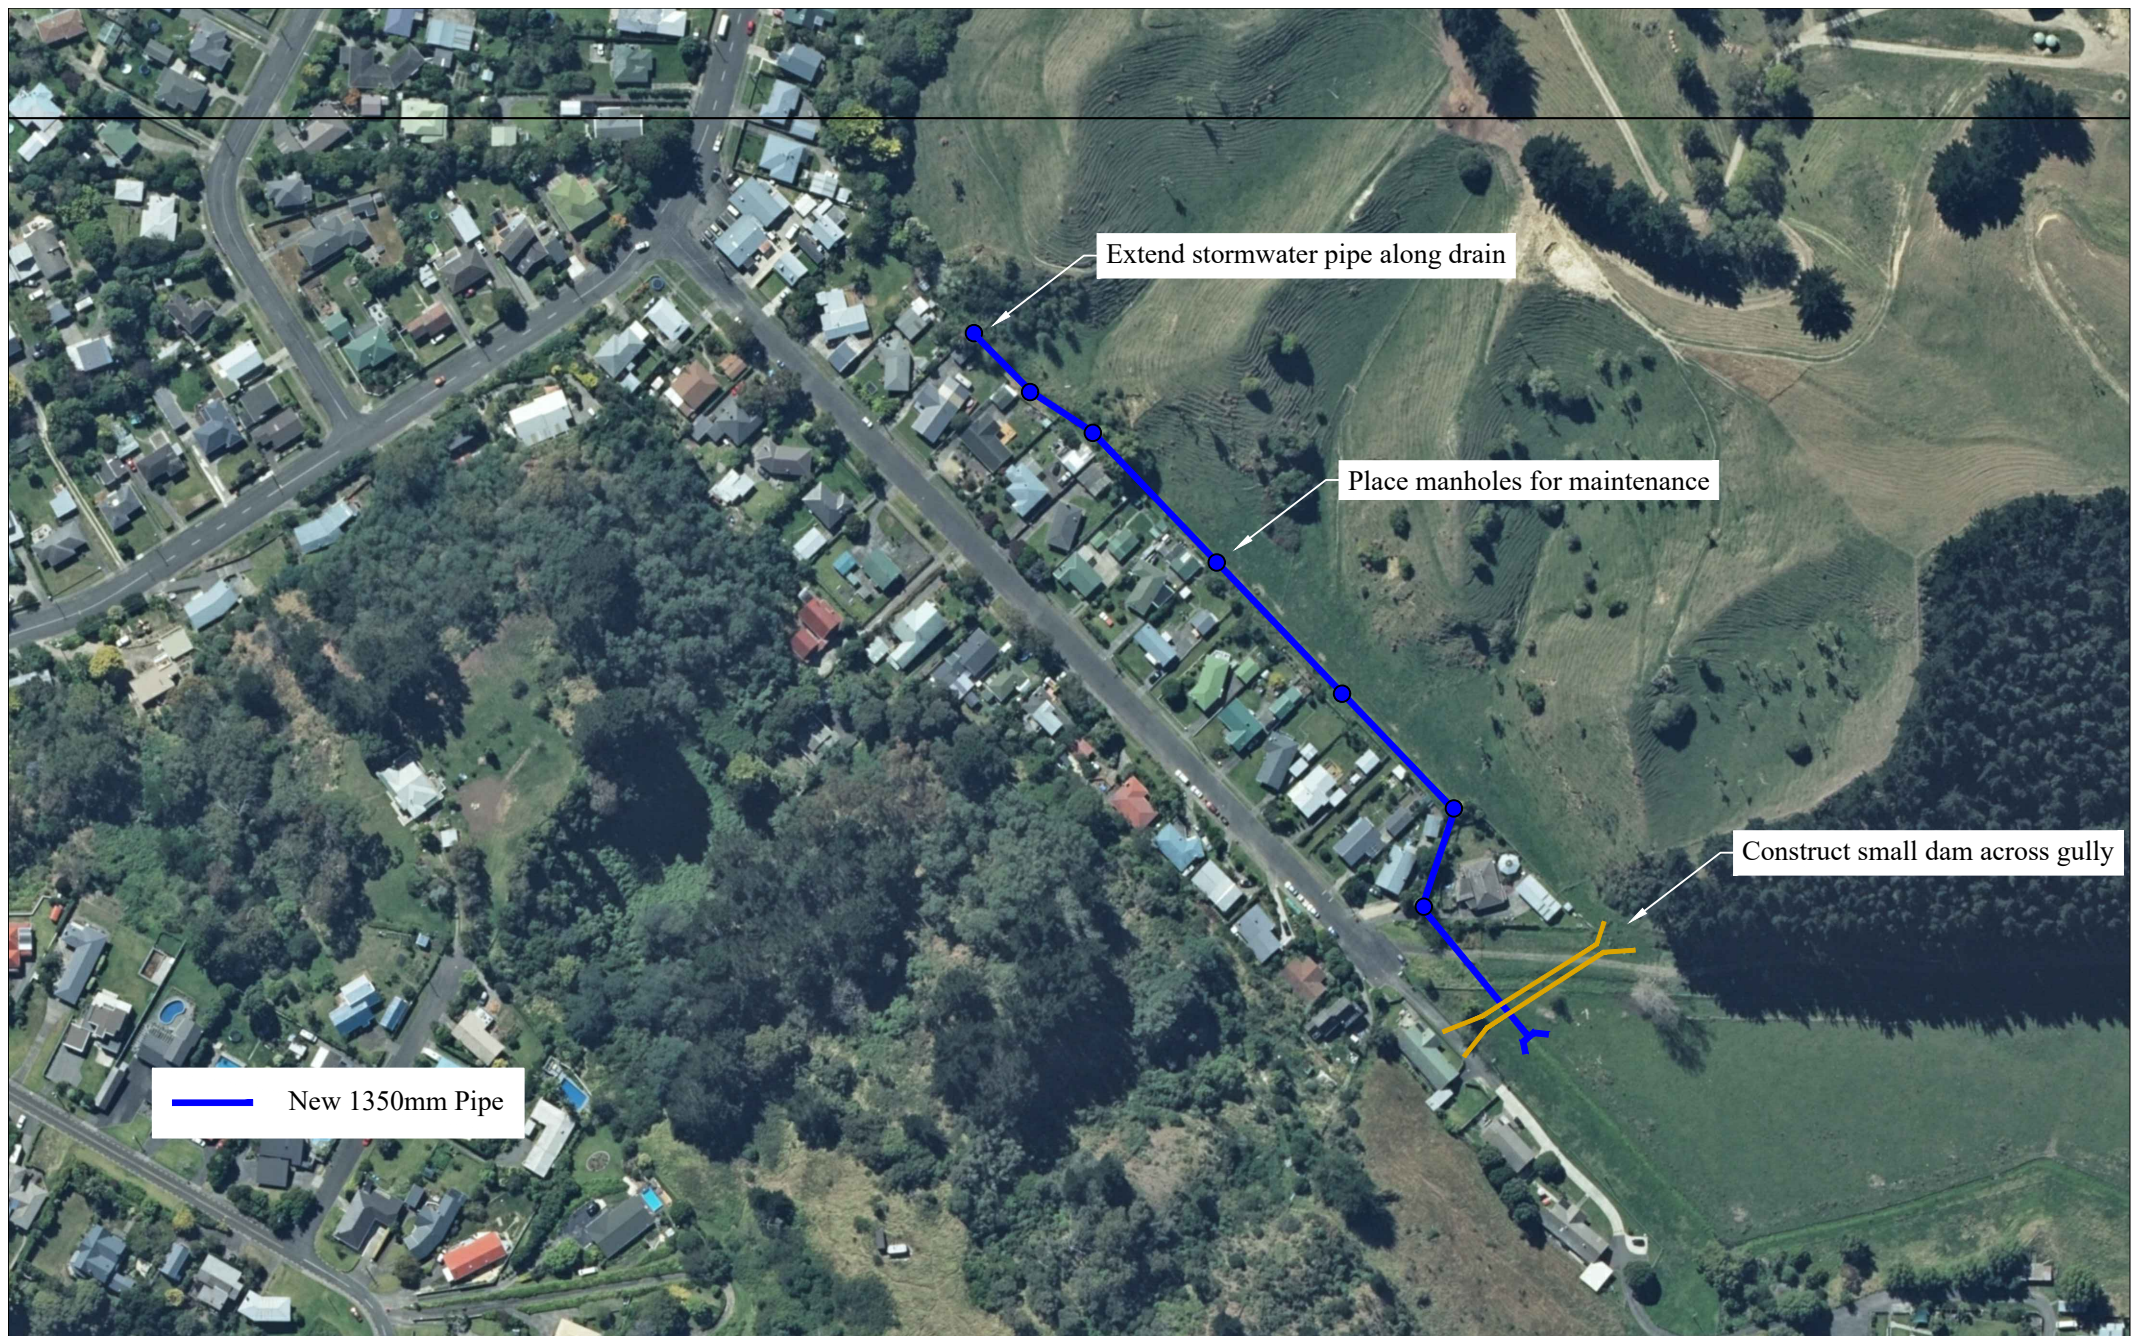
Figure 6
Project Number: 23-033

Option 7 - Extend Stormwater Pipe up Turoa Road Drain
Scale 1:2500 (A4)

4. Extend SW pipe up Turoa Road Drain	Extend the existing 1350mm pipe up the drain into Gudsell Farm and construct a small dam.	1 in 5 year storm event.		<ul style="list-style-type: none"> The drain has been filled in, any storm over a 1 in 5 year return period will flow through Turoa Road properties. 	\$870,000 – \$1,100,000	Borrow site is within 5 km.

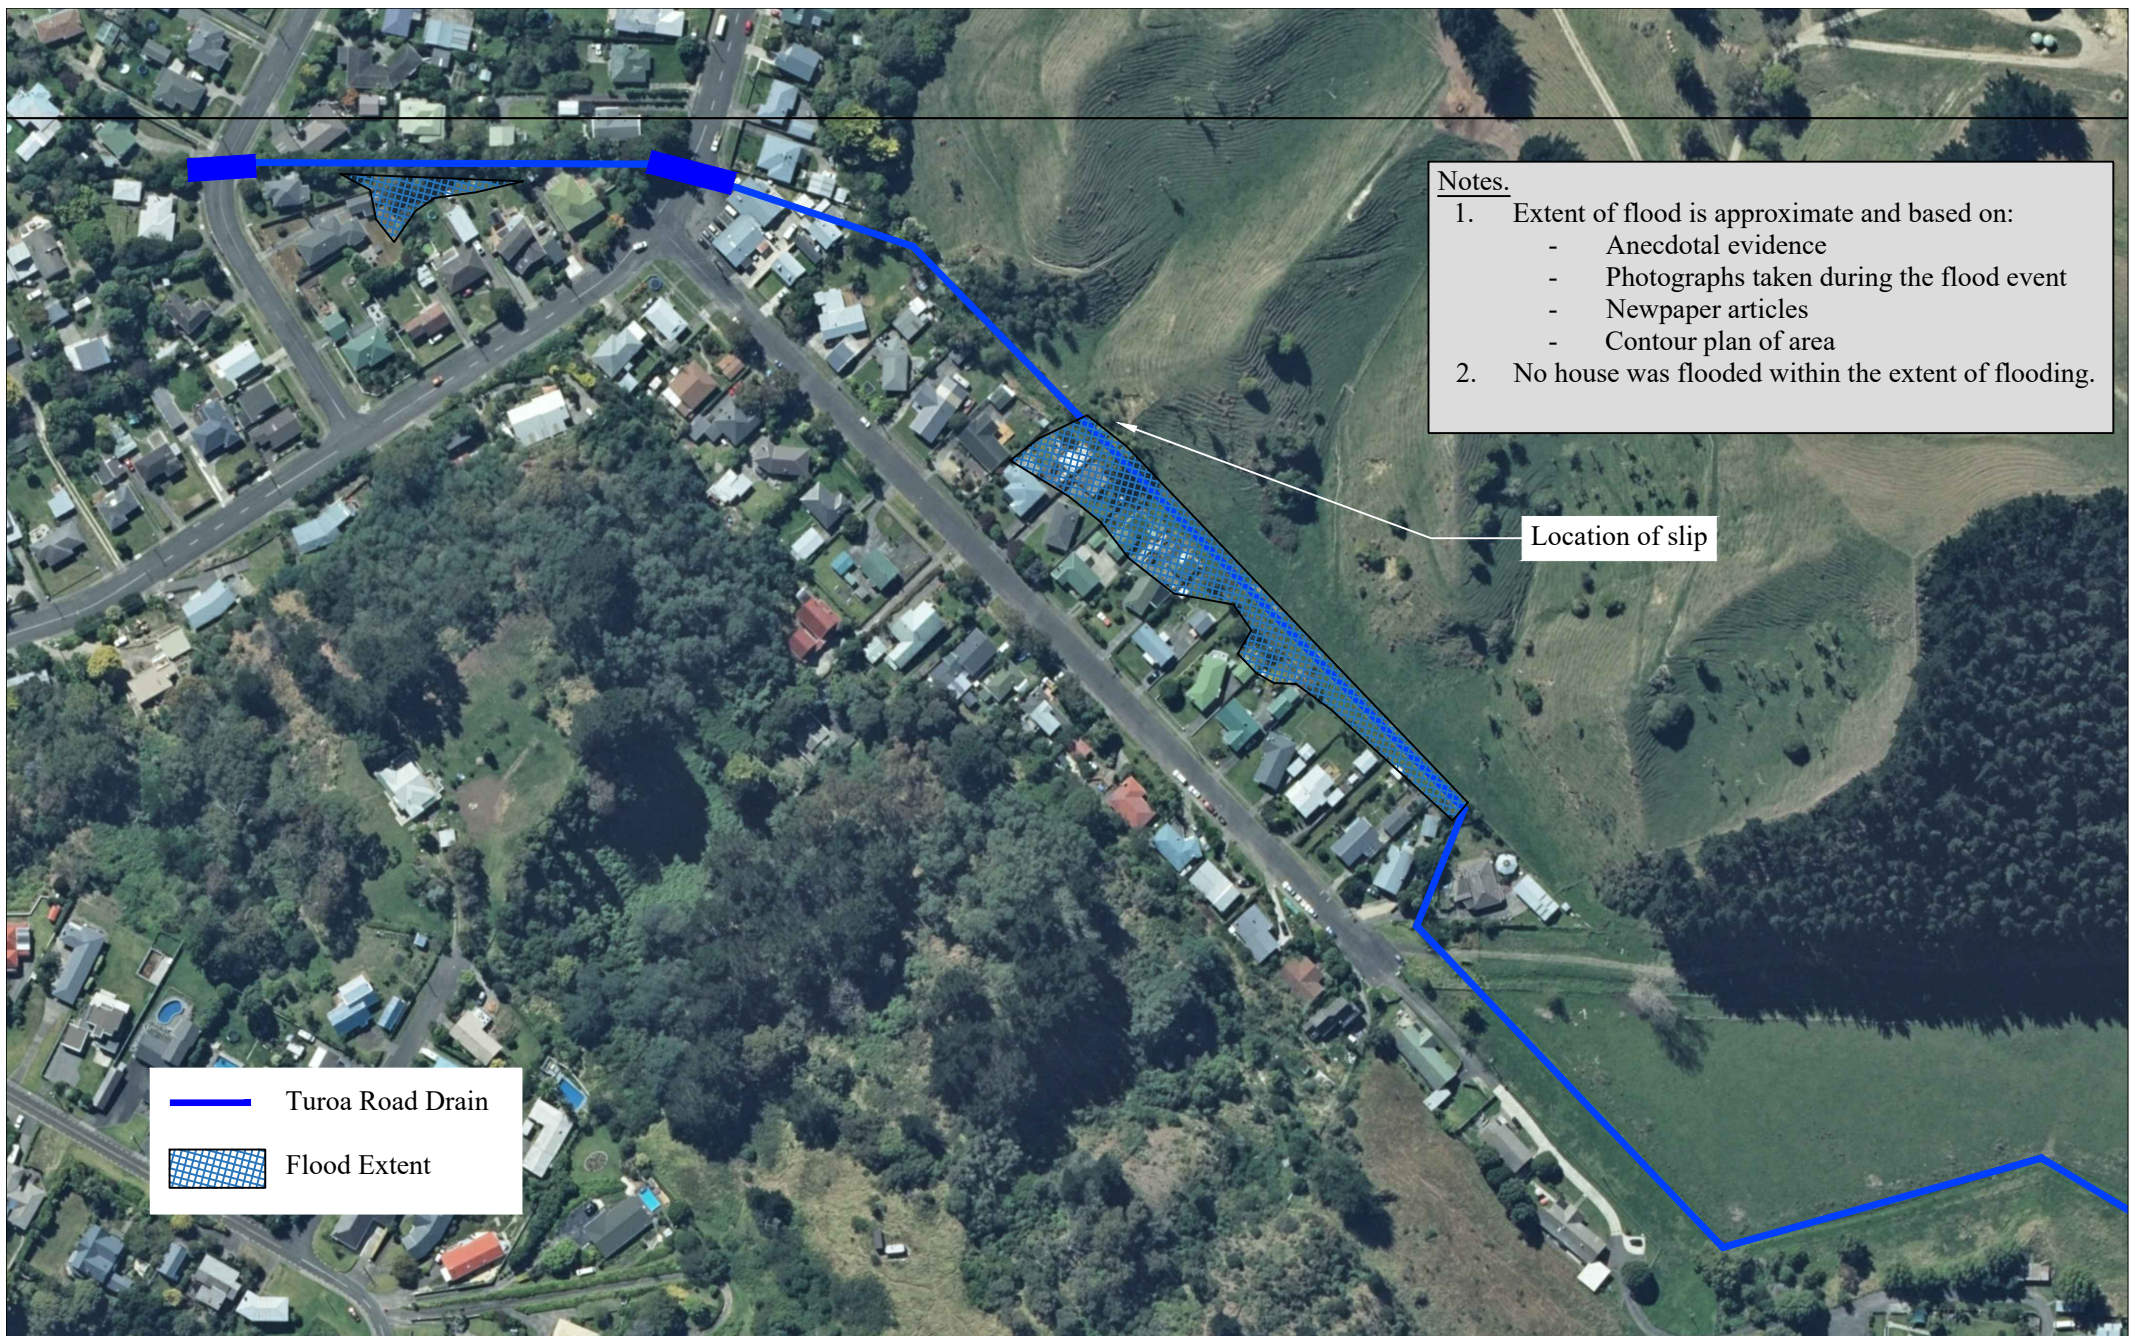
Figure 8
Project Number: 23-033

25 November 2020 - Flood Extent
Scale 1:2500 (A4)

Subsequently there were three smaller flood events, these floods were caused by storms that had very low return periods, between 1-5 years. The extent of the flooding was not as extensive as the 2015 flood but typically confined to backyards and through garages and under some homes. There were between 10-20 properties flooded during these three storm events and 2-5 garages. Refer to Figures 8-10 for an approximate extent of flooding of each storm.

The approximate extent of these floods is shown on Figure 7 - 10. The flood extent is based on anecdotal evidence, historic photographs of the flood events, the contour plans of Turoa Road drain and historic newspaper articles.
