GEOCIVIL
CONSULTING ENGINEERS LTD

Turoa Road Flood Mitigation Options

For Whanganui District Council

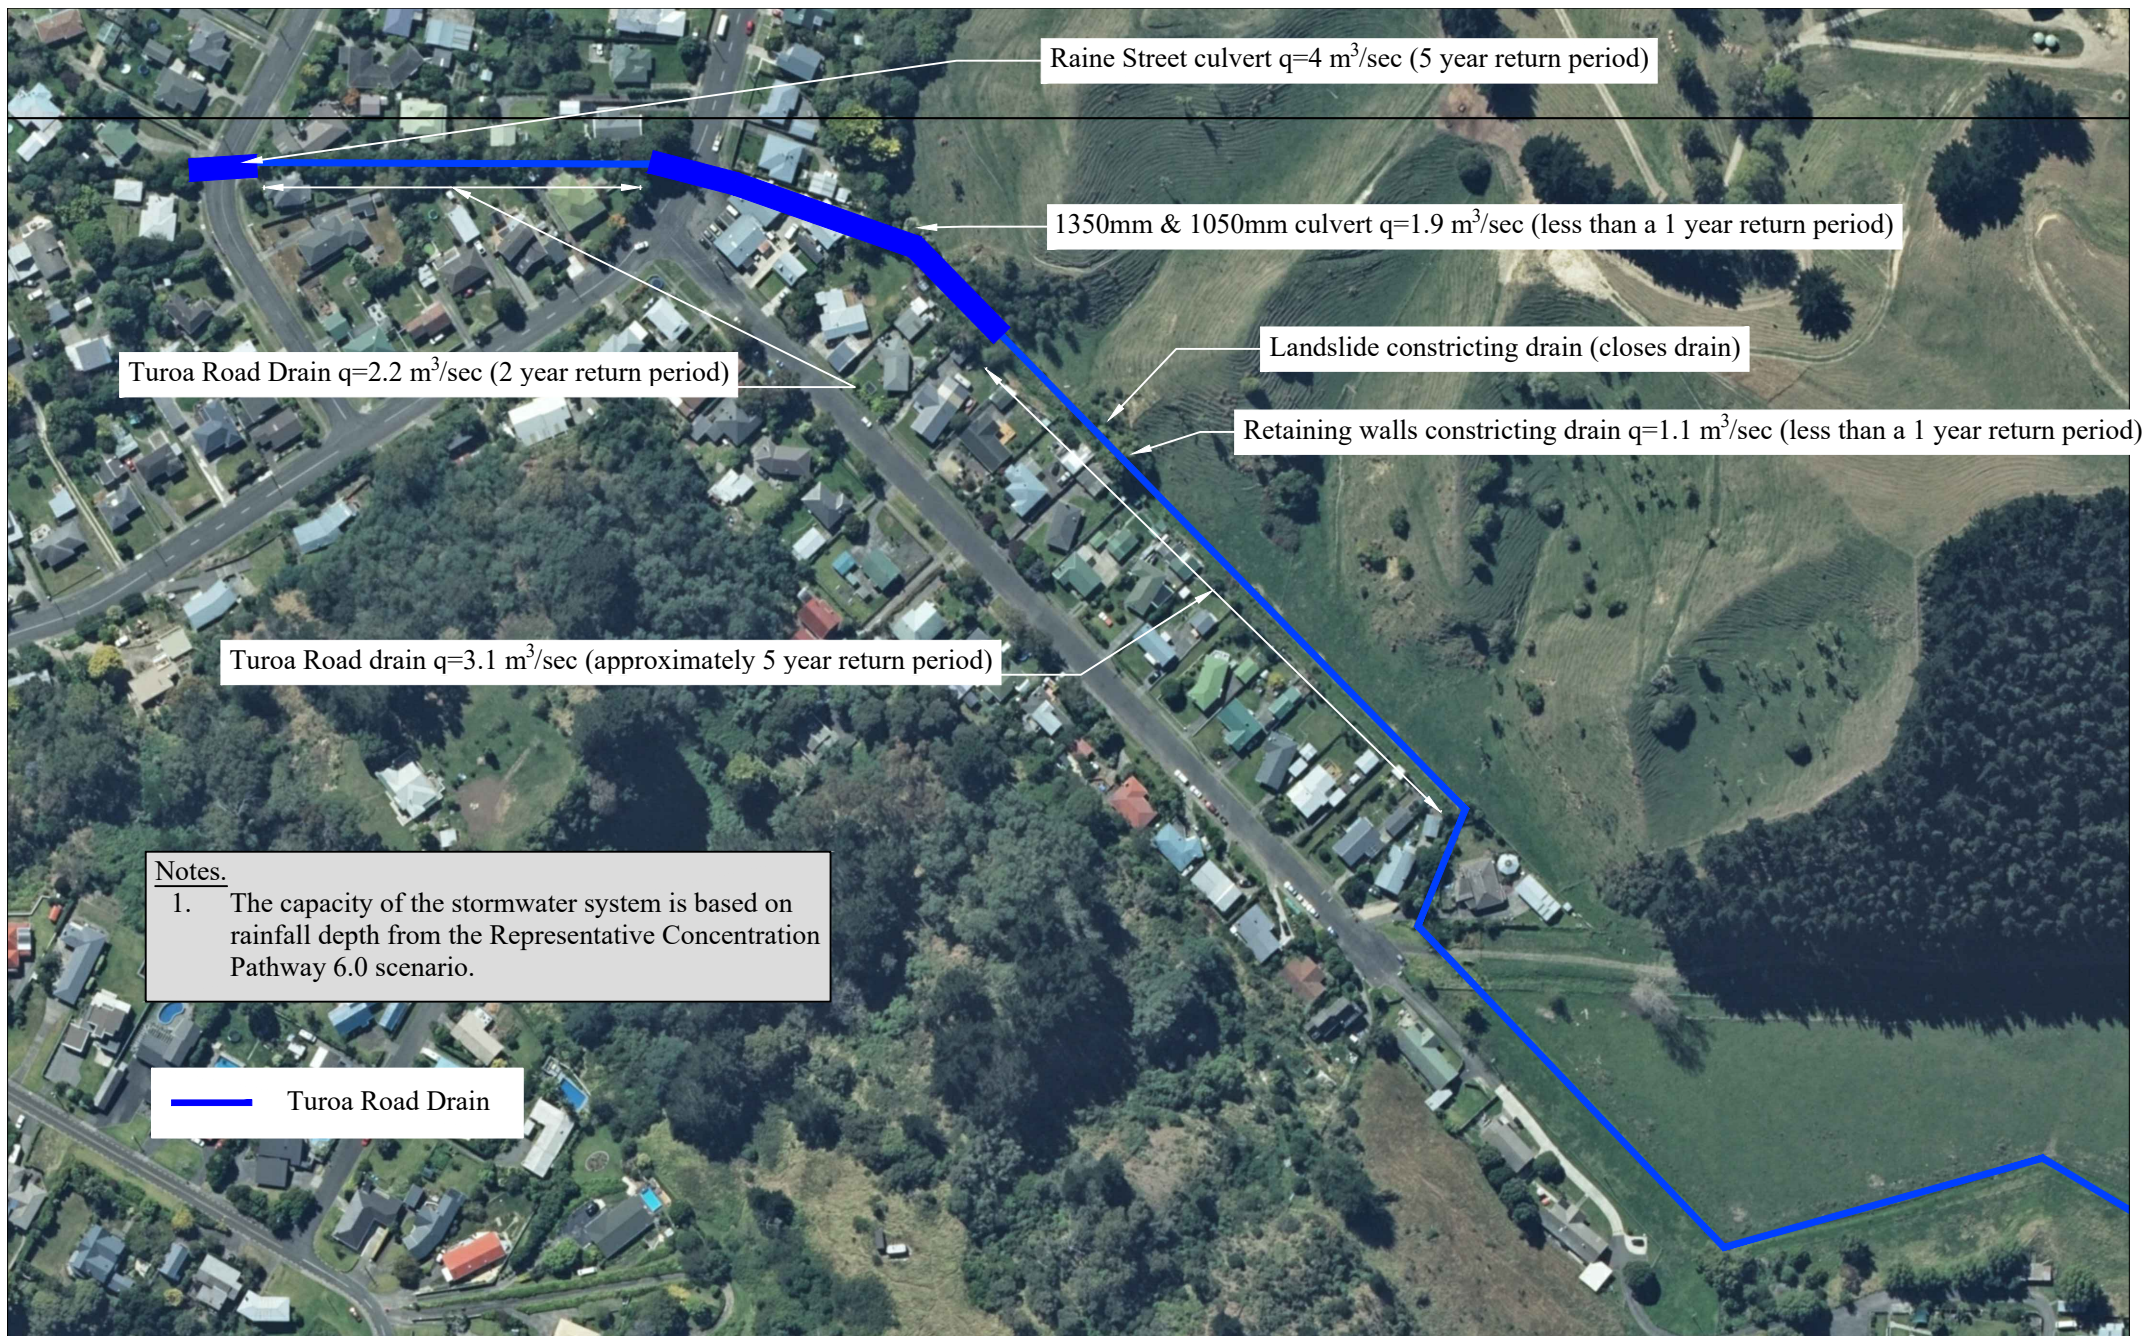
The Turoa Road Drain has been built progressively since the late 19th century and therefore does meet the current national standards. Refer to Figure 11 that shows the capacity of sections of Turoa Road Drain that can pass a flow for a given return period.
