## Appendix C – Geotechnical Assessment

# **Whanganui District Council**

## **Mill Road Structure Plan Geotechnical Assessment**

October 2017

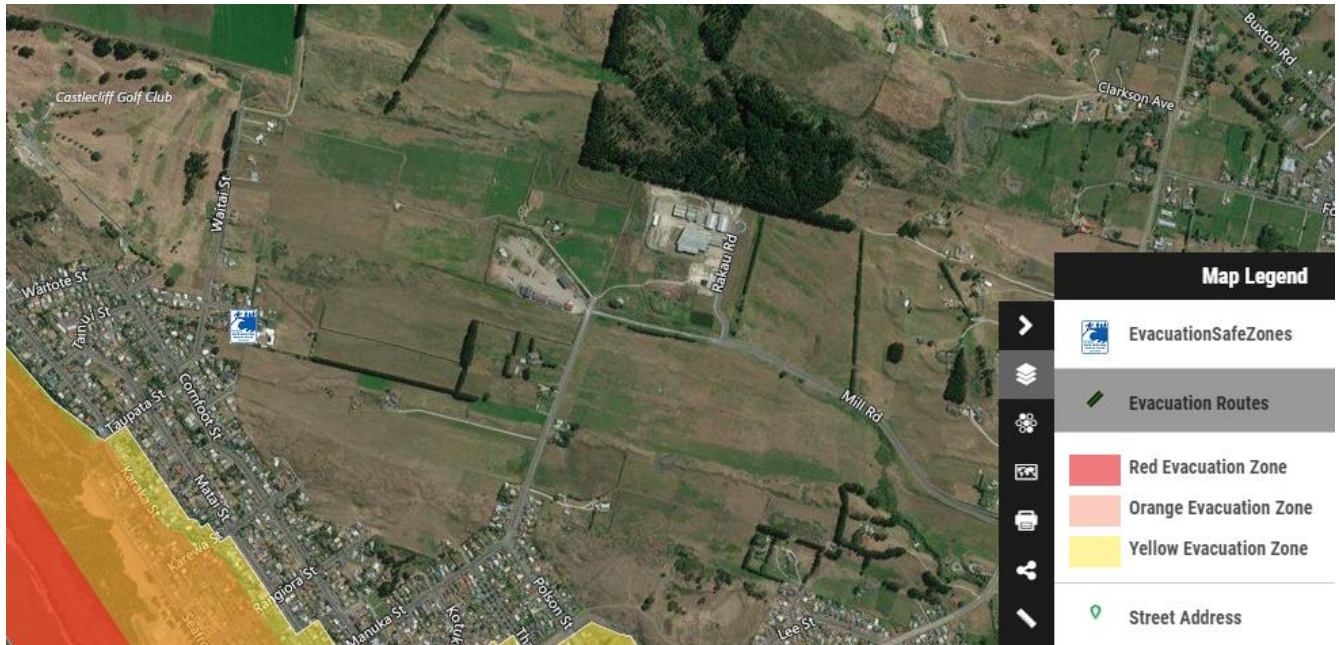
**Figure 2: Tsunami Evacuation Zones<sup>12</sup>**

The site is not located within the Tsunami Evacuation Zones mapped by Whanganui District Council, as shown in Figure 2.

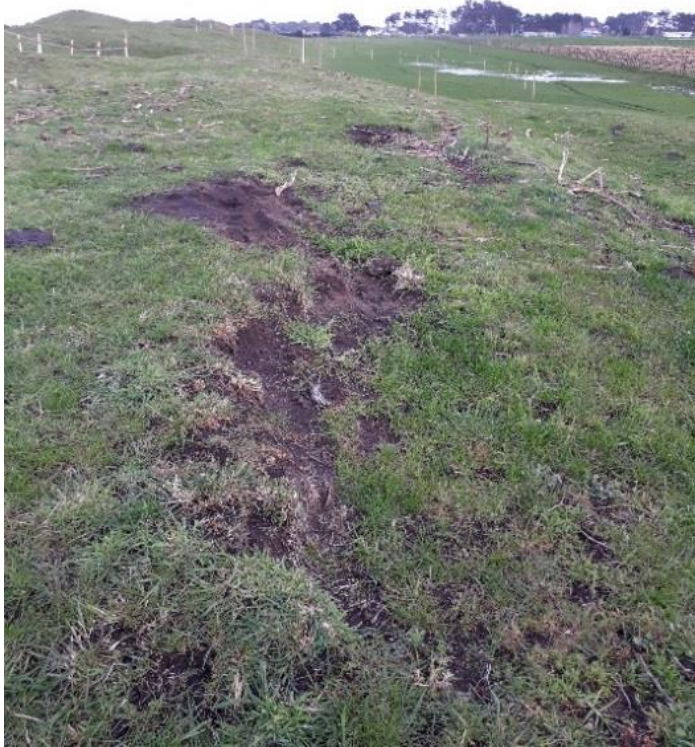
- Evidence of small-scale slope instability was noted within the sand dunes (see Figure 4).
- Standing water was observed in low points between dunes in several locations (see Figure 5).

**Figure 4: View to west along ridge of E-W dune**

Where large dunes are present any development should include specific geotechnical investigation, slope stability analysis and utilise suitable ground retention/retaining structures or batters/terracing. These should be designed/reviewed by a Chartered Professional Engineer (Geotechnical).

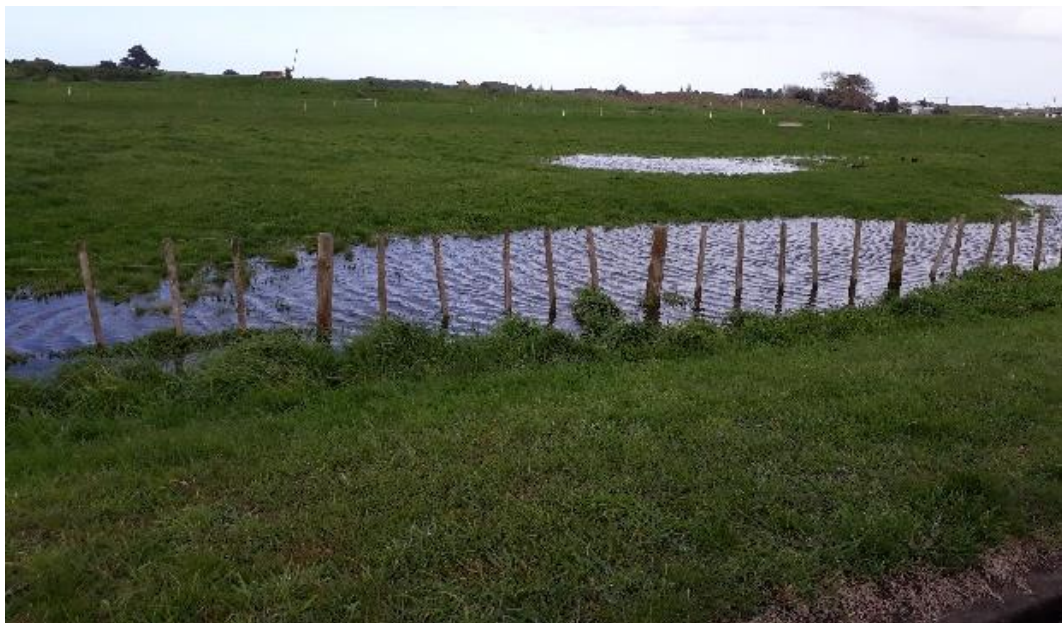
Hollows within the ridges appear waterlogged and boggy indicating poor drainage within the area and high groundwater levels beneath the area.

**Figure 5: Ponded water in a topographic low south of Mill Road**
