Land Stability Assessment Areas

Ikitara Road, Bastia Hill & Durie Hill

Risk Study Report

Date: May 2014
Reference: GER 2014-20
Status: Final

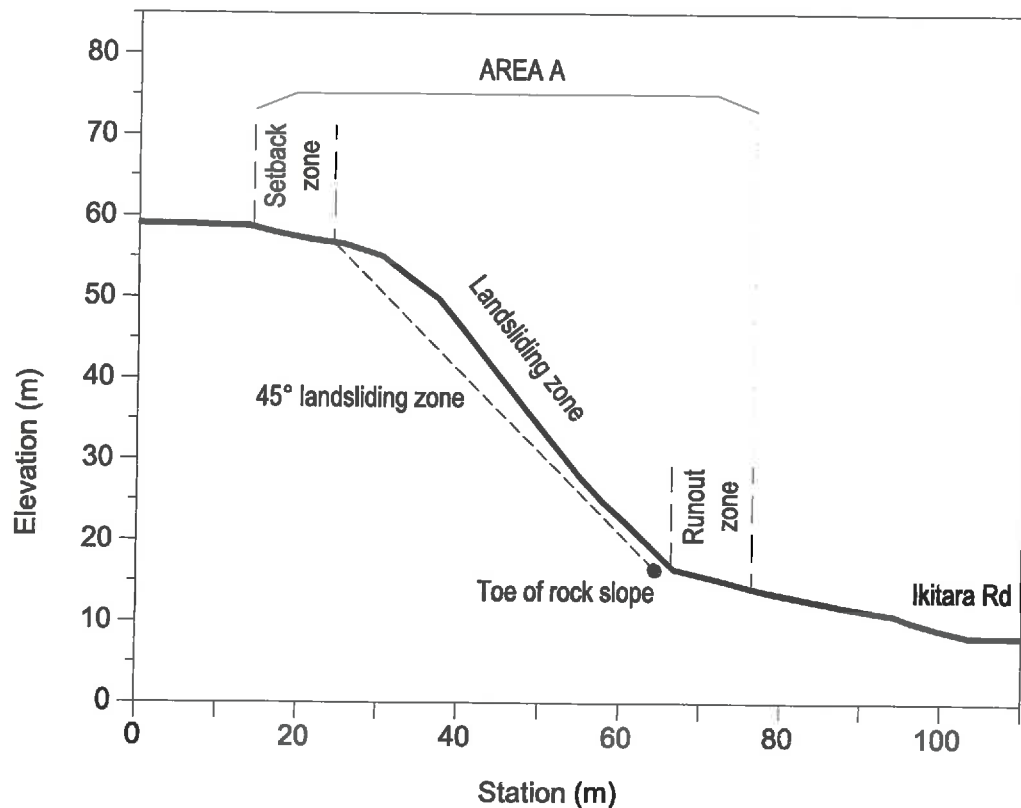
Illustration 6 Typical cross-section through an Area A hillslope section

1. A setback zone at the crest of the cliff, where failure of the slope below will undermine, or to allow for natural regression of the cliff to a more stable slope angle. For the purposes of this assessment we have assumed a characteristic angle of 45° from the toe of the slope for defining the boundary between the setback zone and landsliding zone.
2. The landsliding zone – the steep section of the cliff, where landsliding occurs, or has occurred in the past.
3. The run-out zone, where landslide debris collects at the toe of the slope.

It is recommended that subdivision and new dwellings are actively discouraged within Area A, as the risk of further instability and damage to property or life is very high.

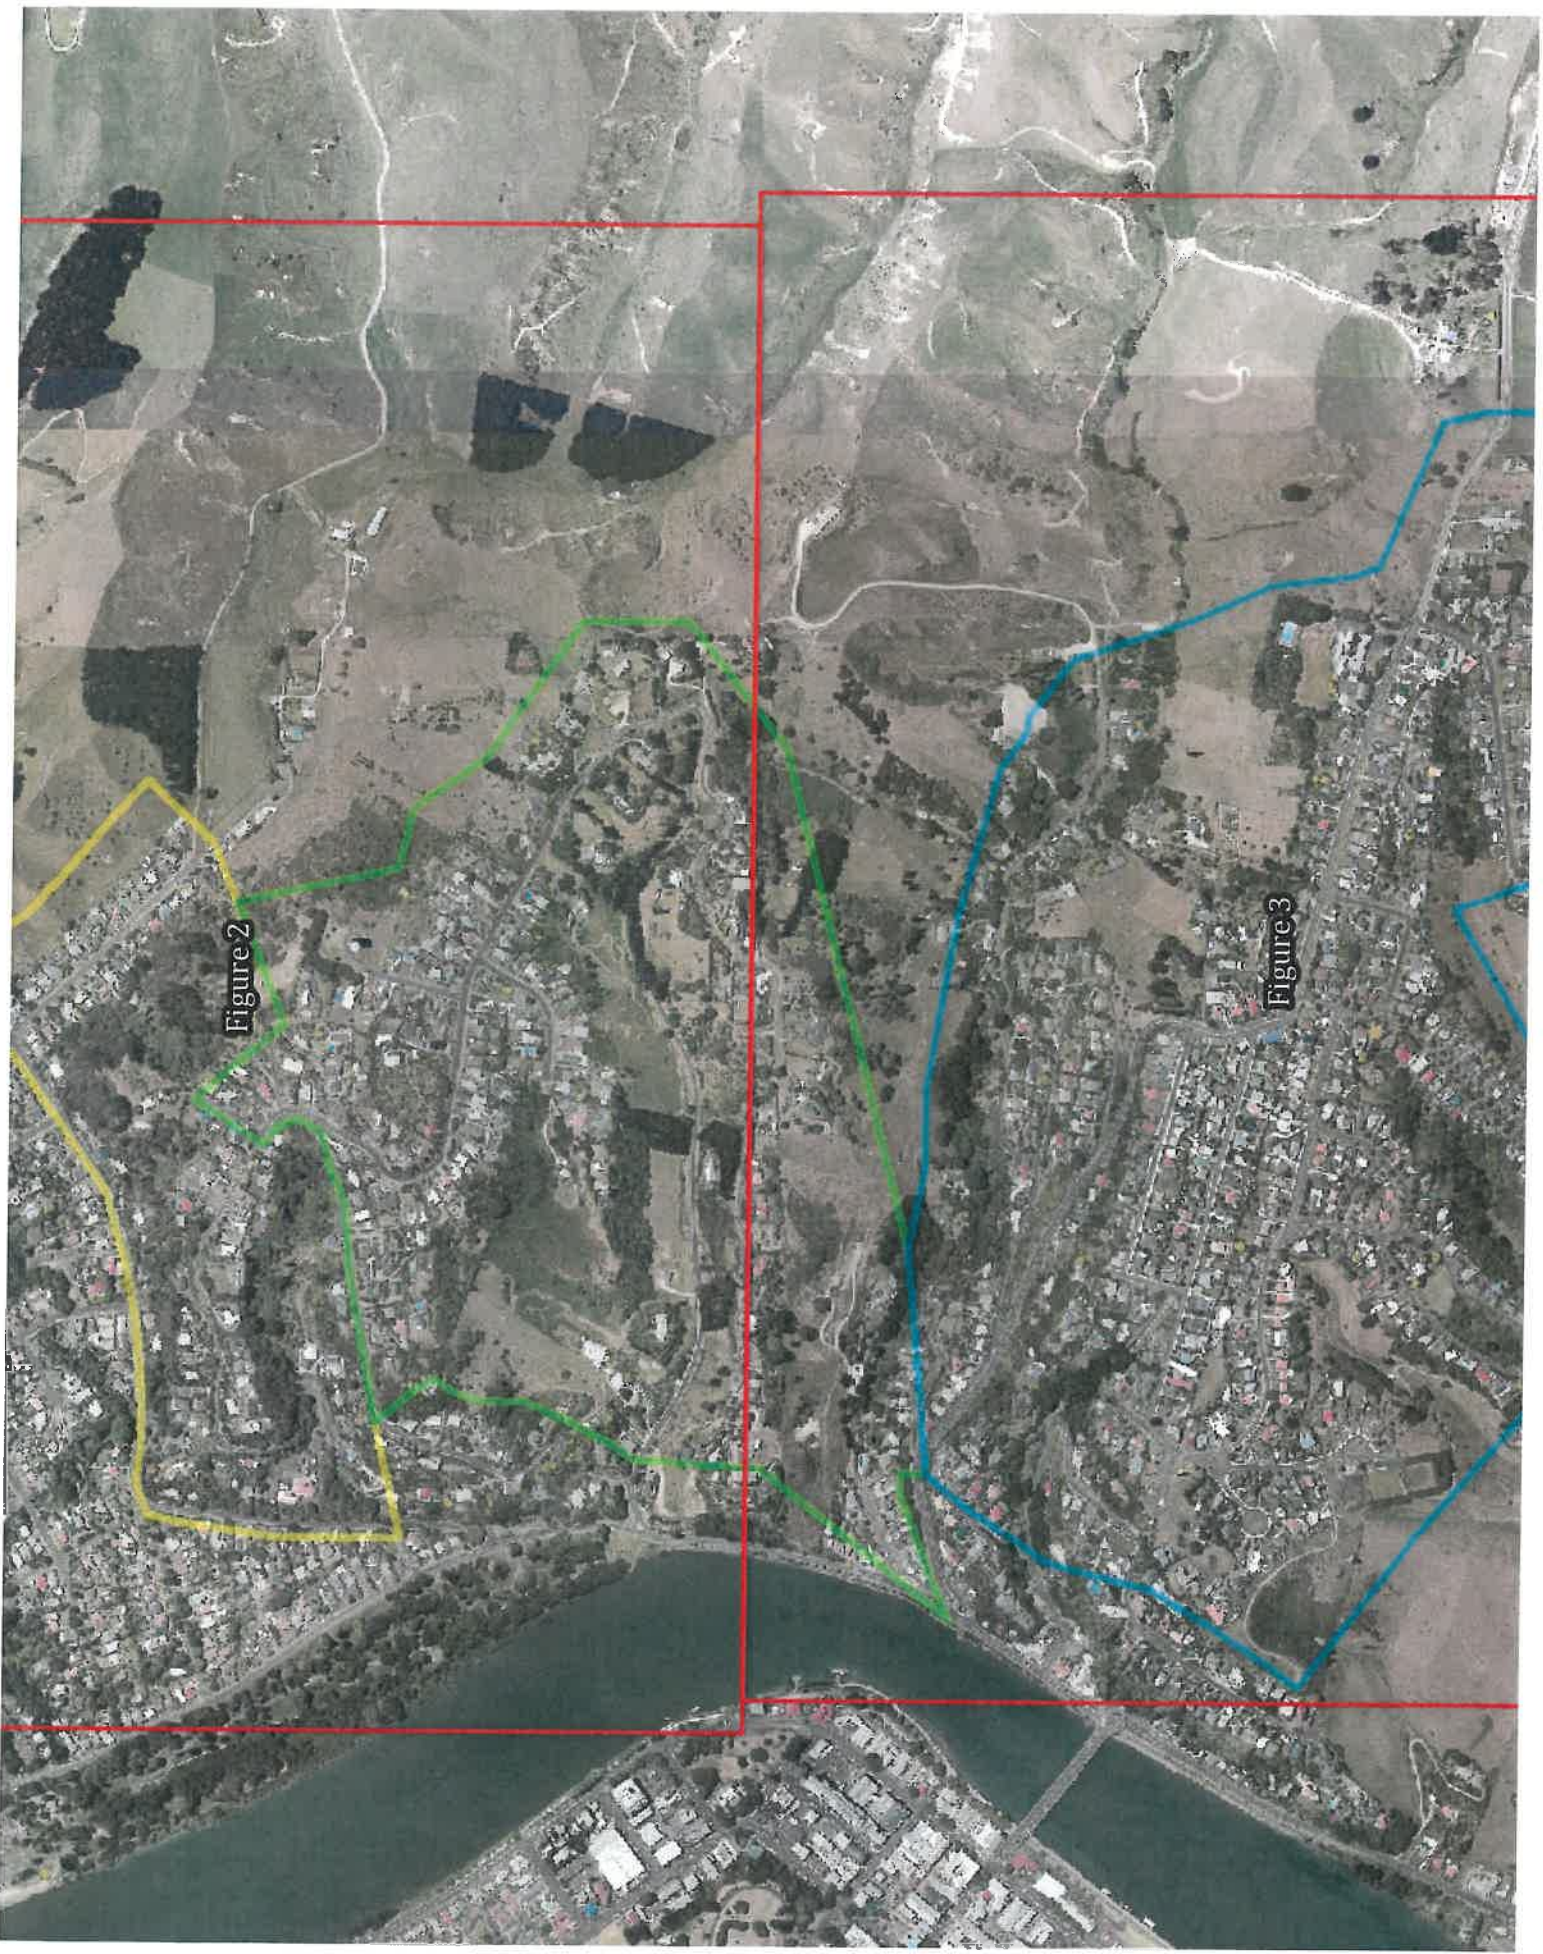
Figure 2

The zonation of the hillslopes in the study areas are given on Figures 2 and 3. The engineering geological mapping was carried out at approximately 1:2,500 scale, and consequently the area boundaries are approximate only. The LSA maps should be used only at the scale provided.
